Tree Assessment

Proposed incline lift

**60 Cabarita Road
Avalon**

Report Prepared by Julia Stanton
Syncarpia Vegetation Management
24 Windsor Street Tarbuck Bay 2428
juliastanton@ozemail.com.au
Mob:04173980
April 2021

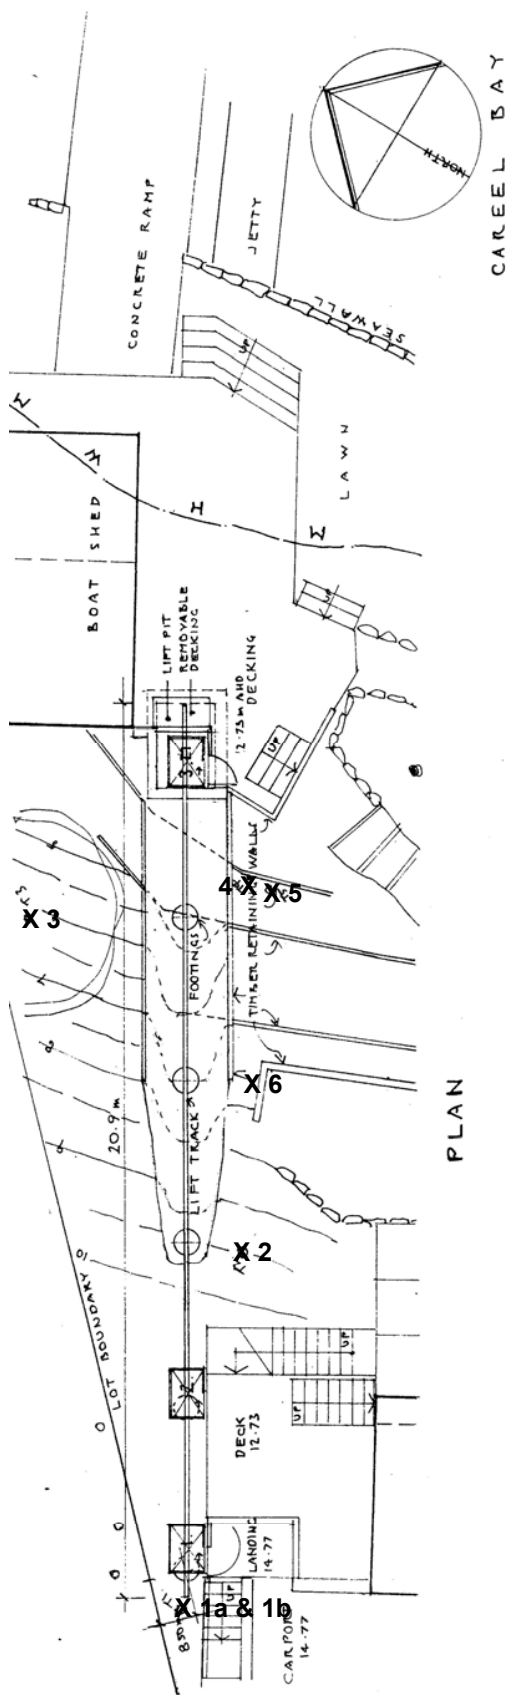
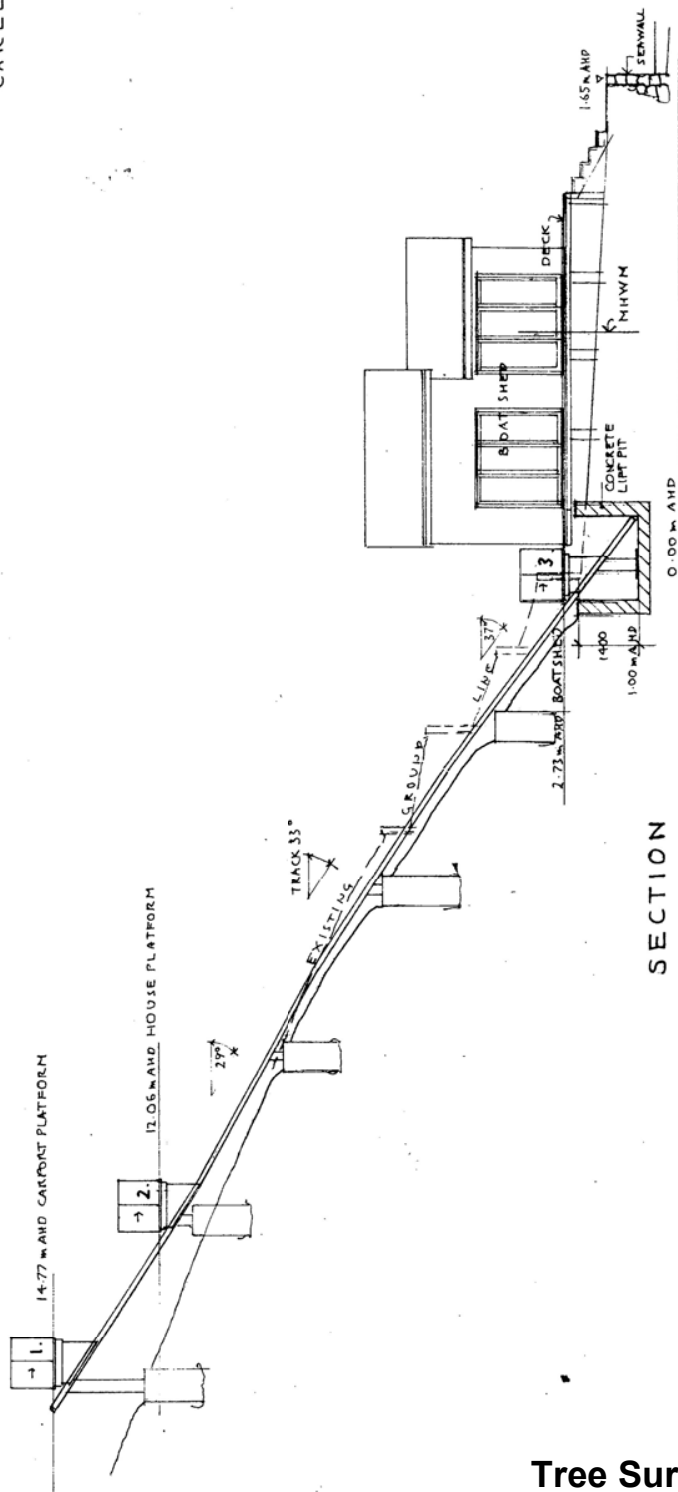
Figure 1

Tree Survey
 60 Cabarita Rd
 Avalon

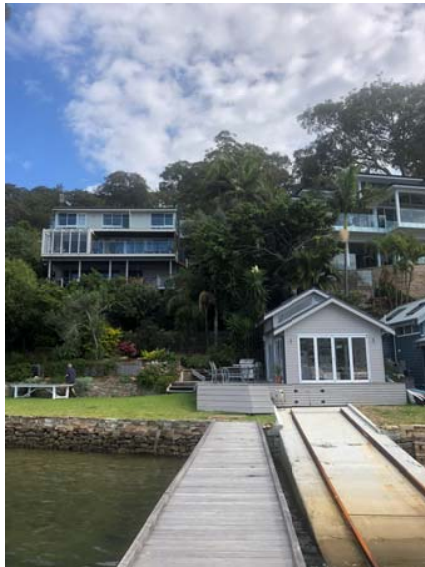
**Photo 1 view from Pittwater location
Of incline lift**

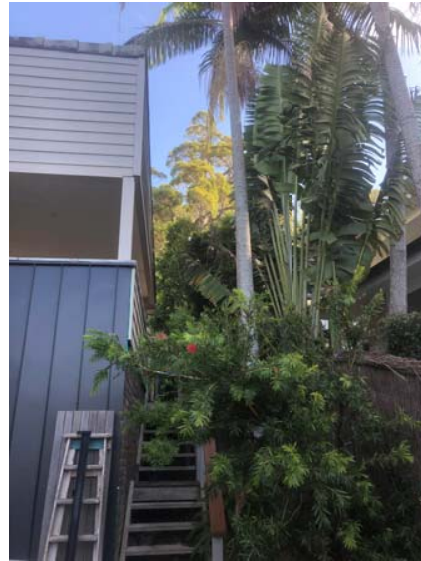
Trees 1a & 1b are planted mature species of (*Archontophoenix cunninghamiana*) Bangalow Palm in good health & condition

Height: 16m Canopy: 4m

Health & Condition Rating: 4 SULE: 2

Trees 1a & 1b mature specimens of (*Archontophoenix cunninghamiana*)
Bangalow Palm in good health & condition are proposed for removal to accommodate the proposed development.
Bangalow Palm is listed as an except species and can be removed without consent.

Photo 4 Trees 1a & 1b Bangalow Palms

To be removed - In direct conflict with proposed inclinor track, **exempt species and can be removed without consent.**

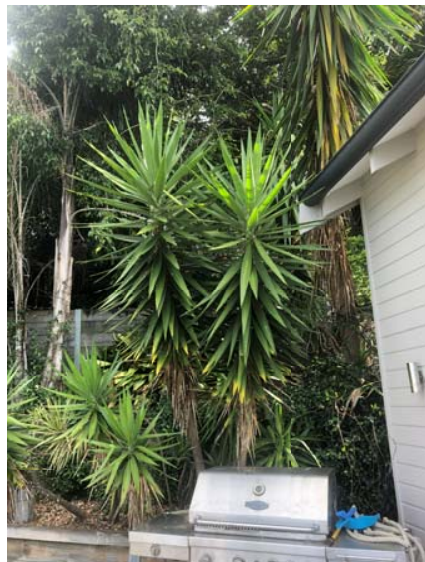
Trees 4 & 5 are semi-mature specimens of *Syragrus romanzoffiana* (Cocos Palm) in good health & condition, typical of the species. Do not require removal to accommodate the proposed development. **An exempt species and can be removed without consent.**

**Photo 2 location of incline lift adjacent
to boat shed Yucca & Trees 4 & 5**

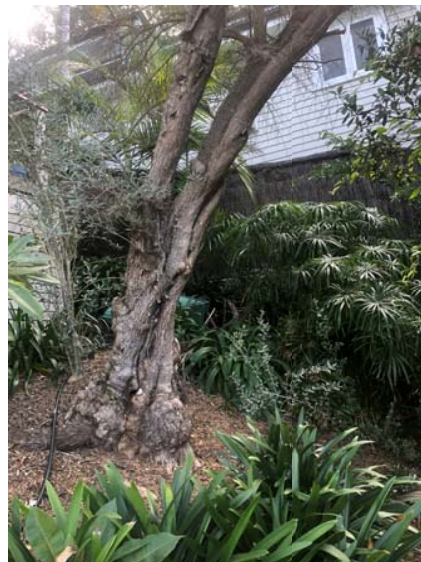
Tree 2 a planted mature specimen of *Olea europaea* (European Olive) in fair health & poor to fair condition, decay through one codominant leader, previous lopped, moderate epicormics growth.

Height: 6m Canopy: 4m DBH: 300, 200 DGL: 500

Health & Condition Rating: 2 SULE: 3a

Photo 5 Tree 2 European Olive

Located 0.5m from excavation to accommodate inclinor track & 1m from footing. May tolerate the impact of the proposed development - **An exempt species and can be removed without consent.**

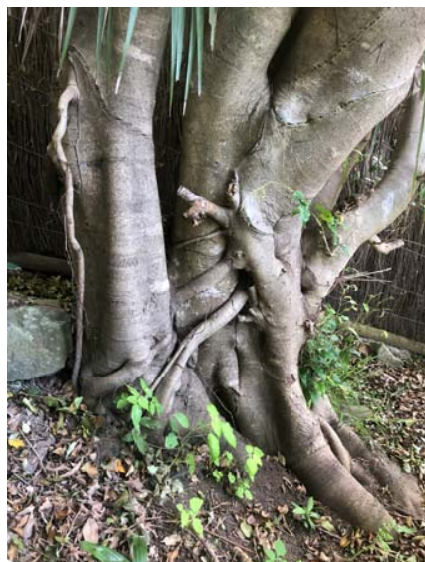
Tree 3 a planted mature specimen of *Ficus benjamina* (Weeping Fig) in fair health & condition. Multi trunk, previous lopping of branches. Height: 12m Canopy: 10m DBH: 400, 200, 220, 450 DGL: 1.2m Health & condition rating: 3 SULE: 3C

Photo 3 Tree 3 *Ficus benjamina*

Located 2.5m from excavation to accommodate inclinator track & 3m from track footing. If retained would require extensive pruning to prevent branch conflict with inclinator cart. **Inappropriately located large species. Exempt species, can be removed without consent. Removal recommended with replacement screen planting of an appropriate large native shrub / small tree.**

Tree 3 is a mature specimen of *Ficus benjamina* (Weeping Fig) and would require extensive pruning to accommodate the inclinor cart. In addition this tree is considered inappropriate in its current location given its size and invasive nature and is recommended for removal and replacement with appropriate screen planting.
