ARBORICULTURAL ASSESSMENT REPORT AND TREE PROTECTION SPECIFICATION

1-3 Gondola Road
North Narrabeen
NSW 2101

Project No: 231214
Date: 14th December 2023
Revision: A

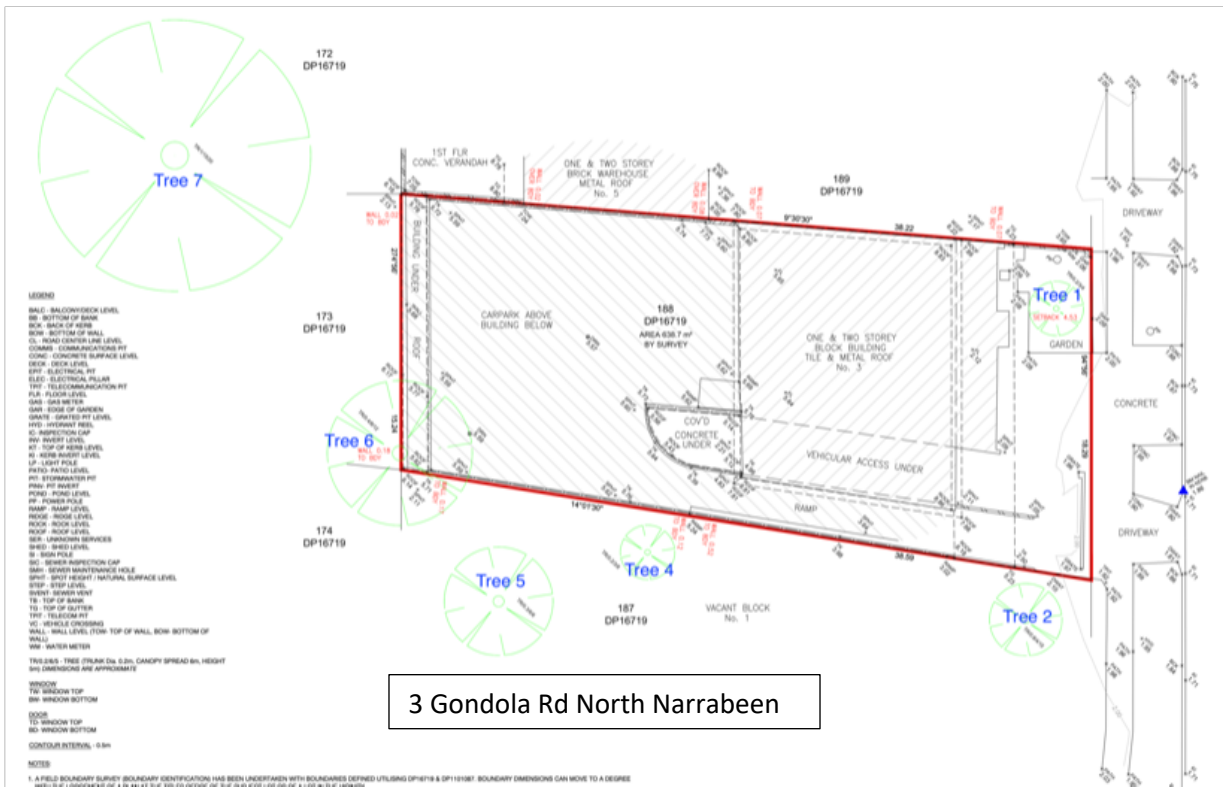
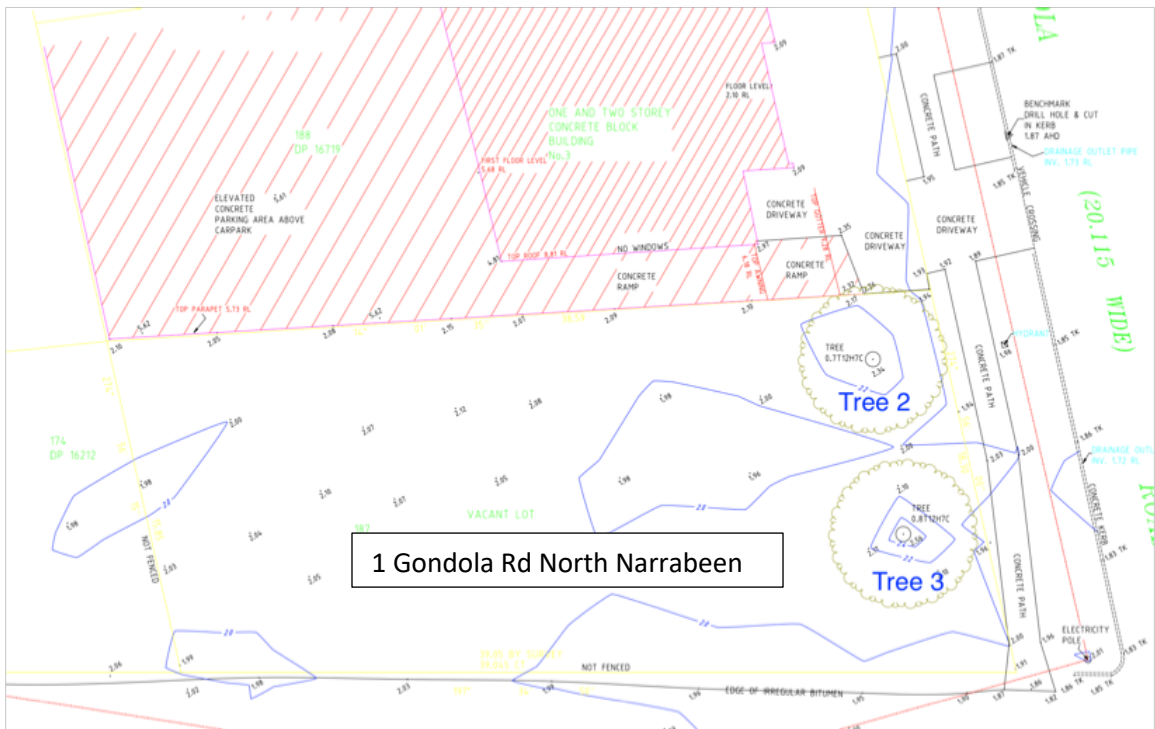
APPENDIX 1. SITE SURVEY PLAN AND TREE NUMBERS

4.11 Site survey plan and tree numbers are shown in Appendix 1
