PRELIMINARY GEOTECHNICAL ASSESSMENT:

2 MacMillan Street, Seaforth

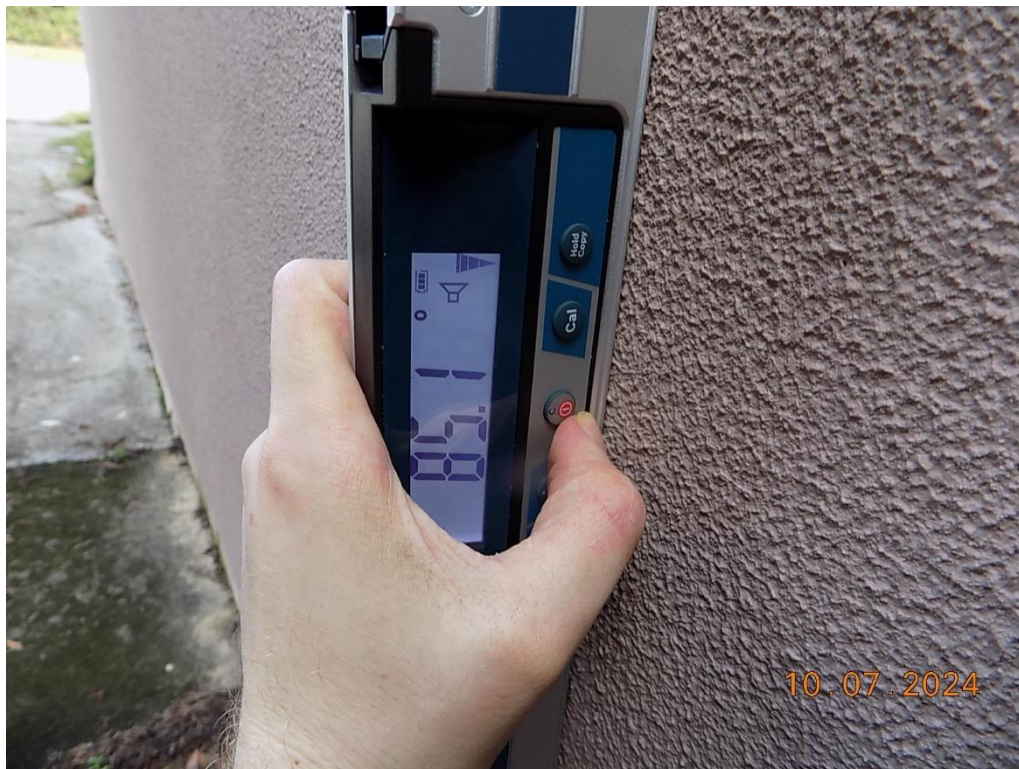
Photo 1

The rendered brick retaining walls which support the cut for the driveway at the Frenchs Forest Road frontage were measured to be cracked up to $\sim 5\text{mm}$ and the uphill wall was measured to be tilting up to $\sim 5^\circ$ downslope (Photo 1). These walls are to be monitored by the owners on a six-monthly basis or after heavy and prolonged rainfall events, whichever occurs first. A photographic record of these inspections is to be kept. Should further movement

occur, the wall is to be remediated so it meets current engineering standards. We can carry out these inspections upon request.
