# Geotechnical Assessment

**Project:** Alterations & Additions  
1100 Barrenjoey Road, Palm Beach NSW

## Geotechnical Assessment

**1100 Barrenjoey Road, Palm Beach NSW**

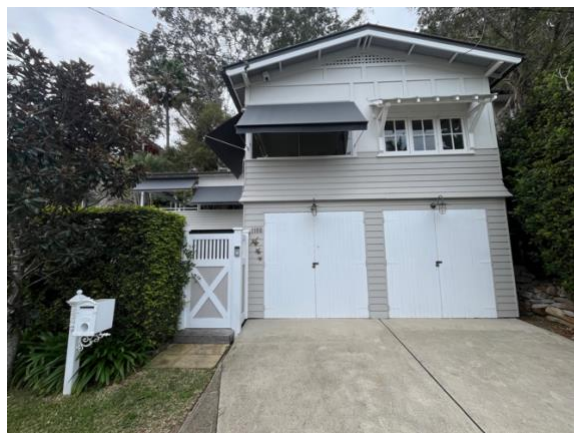
**Photo 1:** Residence frontage

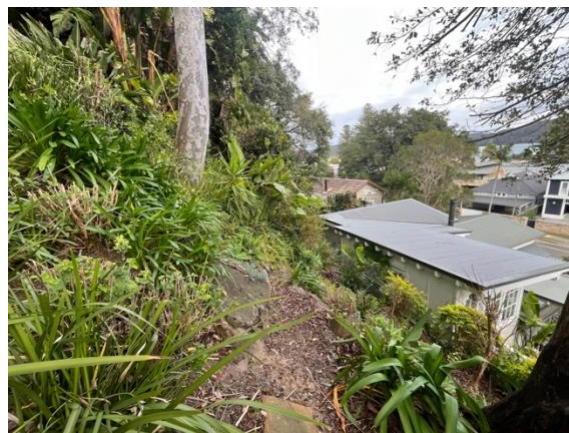
**Photo 2:** Residence rear

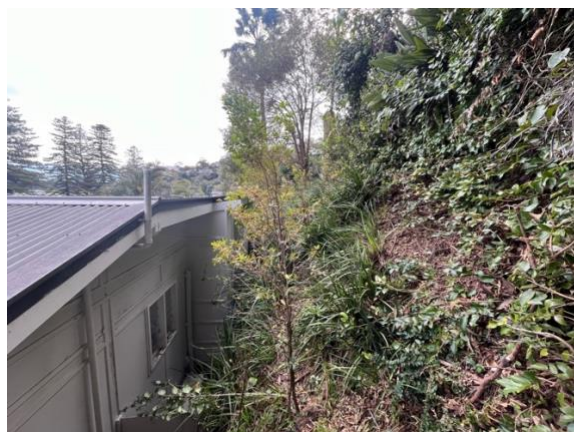
**Photo 3:** Residence rear and area of the proposed works

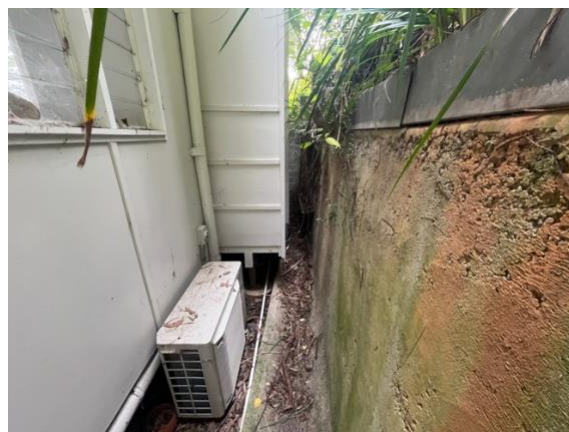
The existing building at the site is a 1 & 2 storey split level clad house and is in good condition. The footings of the house, where visible, are steel posts on concrete piers. At the rear of the dwelling is a concrete block and mass concrete wall, which is in good condition. The southern return of the mass concrete wall encapsulates a large sandstone boulder or overhanging block of the bedrock.

**Photo 4:** Mass concrete wall at the rear of the residence.

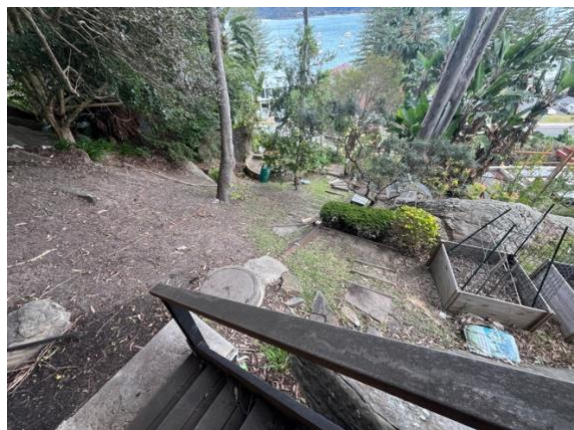
There is low strength, highly fractured bedrock and several sandstone boulders on the slope to the rear of the existing house that may be destabilised during excavation works.

**Photo 5:** Rear yard littered with sandstone boulders

Recommendation	Description
<b>General</b>	<p>Due to the steep slope above the existing house, the fractured nature of the bedrock and the presence of detached boulders within the soil profile, it is strongly recommended that a builder and excavation contractor with demonstrable experience in this type of sensitive excavation be engaged to undertake the proposed works.</p> <p>AscentGeo can provide contacts for local contractors with suitable experience with sensitive excavation on request.</p>
<b>Soil Excavation</b>	<p>All excavation recommendations as outlined below should be read in conjunction with Safe Work Australia's <i>Code of Practice: Excavation Work</i>, published in October 2018.</p> <p>Soil excavation at the rear of the existing house will be required to establish new footings for the proposed works. It is anticipated that these excavations will encounter shallow uncontrolled fill, loose sandy soil, highly fractured bedrock and with detached sandstone boulders in the soil profile. Due to the steep slope and access limitations, it is anticipated that the excavations will be undertaken using handheld equipment.</p> <p>Following the careful removal of vegetation in the area of the proposed works, all sandstone boulders and highly fractured bedrock should be removed prior to beginning the excavation. Any roots to be removed should be cut, not pulled.</p> <p>The excavations should be undertaken carefully and in manor does not undercut boulders or fractured bedrock that may be exposed as the excavation progresses.</p>

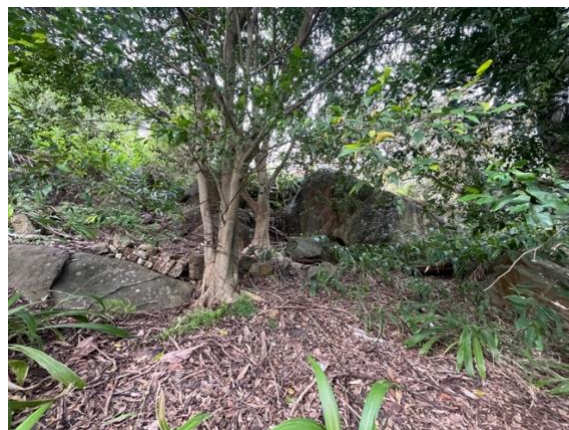
There are small to very large sized sandstone boulders within the soil profile around, under and behind the dwelling. A very large sandstone boulder, sits over the northern boundary of the site and shotcrete has been applied to material underlying this boulder within the site that adjoins the northern boundary. Where visible from the street frontage, this shotcrete application appears to be in good condition. A large sandstone boulder is located to the south of the fire pit in the rear yard. Several very large sandstone boulders litter the rear portion of the site. Generally, the large sandstone boulders across the site are deeply embedded within the soil profile or located on gently sloping portions of the slope and are likely to have been in these positions for long periods of time. Bedrock is outcropping in the slope at the rear of the existing dwelling in the area of the proposed works and is a highly fractured, thinly bedded sandstone.

**Photo 6:** Large sandstone boulders towards the rear of the site.
