## **REPORT ON GEOTECHNICAL SITE INVESTIGATION**

### **PROPOSED DEVELOPMENT**

**2A ALLEN AVENUE, BILGOLA BEACH, NSW**

**Project No.: 2021-086**

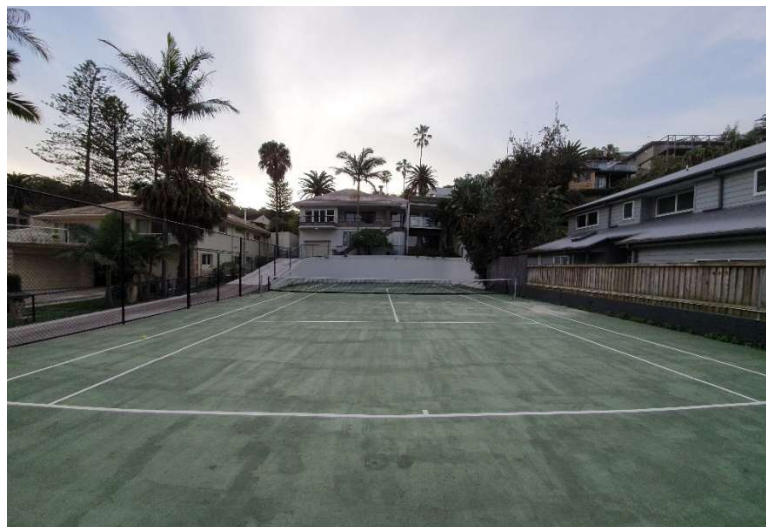
*Photograph-2: Front view of the site. View looking west.*

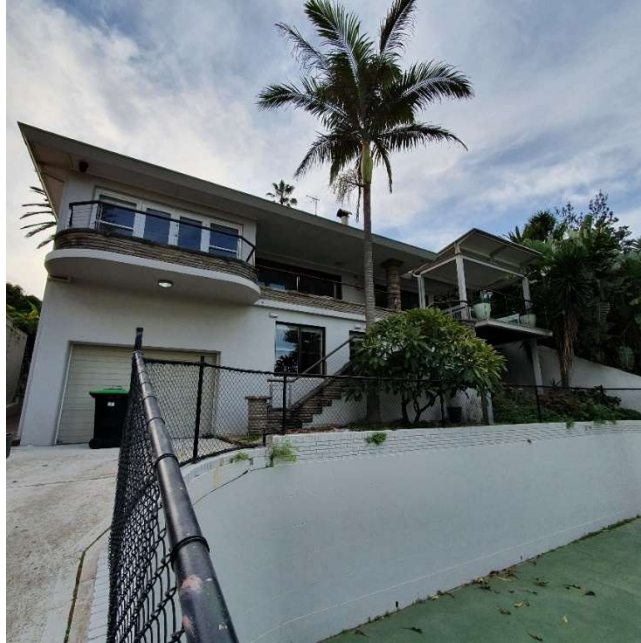
*Photograph-3: Site-dwelling frontage. View looking north-west.*

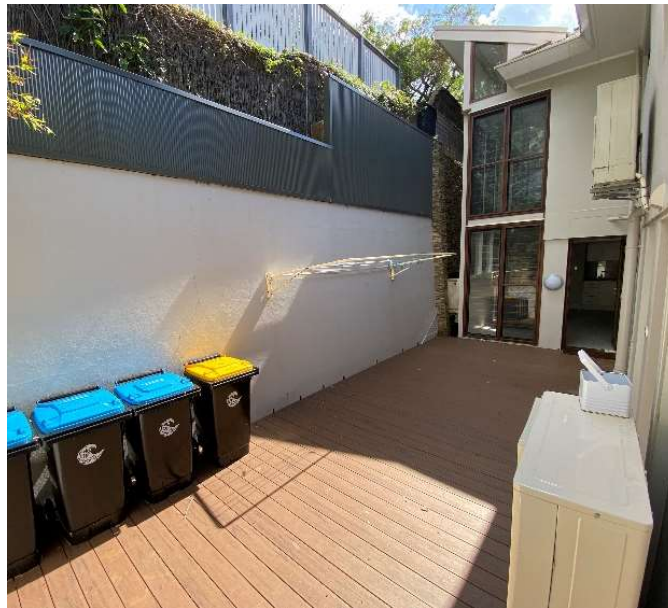
*Photograph-4: Rear deck of the site. View looking north-west.*

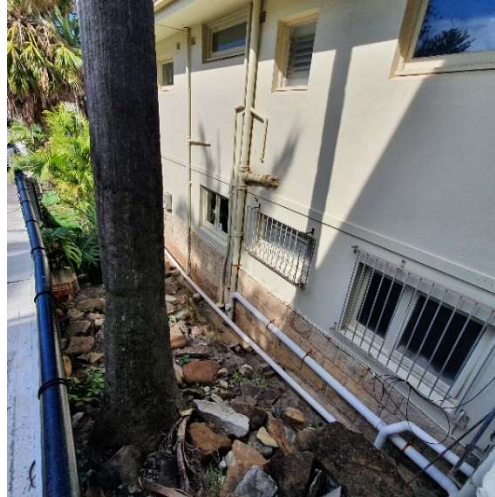
The centre to eastern side of the site contains a concrete driveway and a ramp along the south boundary with a tennis court occupying most of the centre to eastern side to the north boundary. The ramp is supported by what appears to be a rendered brick wall (up to  $\leq 3.0\text{m}$  high) along the northern side that extends north along the western side of the tennis court and supports the higher western side of the site (approximately  $\leq 3.0\text{m}$  higher). The ramp is supported by a low brick wall (up to  $\leq 1.0\text{m}$  high) along the southern side which is founded on a terrace that extends south (approximately  $\leq 2.0\text{m}$  within the neighbouring property) and is supported by a dry stone retaining wall. Directly adjacent to the ramp is a relatively large tree (Photograph-5). Signs of instability, cracking or underlying geotechnical issues were not observed within the retaining structures, large tree or adjacent structures.

*Photograph-5: Large tree located directly adjacent to the site boundary/concrete ramp. View looking south-east.*

The excavation is proposed to extend close to the locations of two large trees in the neighbouring properties (No.8 The Serpentine and No.2 Allen Avenue). It is recommended that an experienced arborist assess the proposed excavation and the potential risk of undermining or affecting the roots/stability of the adjacent trees.

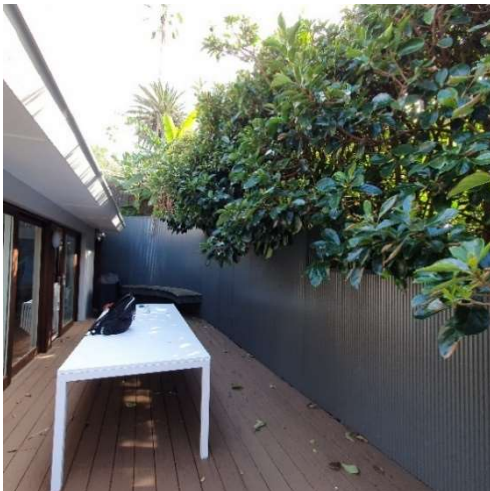
*Photograph-6: Retaining wall covered by metal sheet. View looking north-west.*

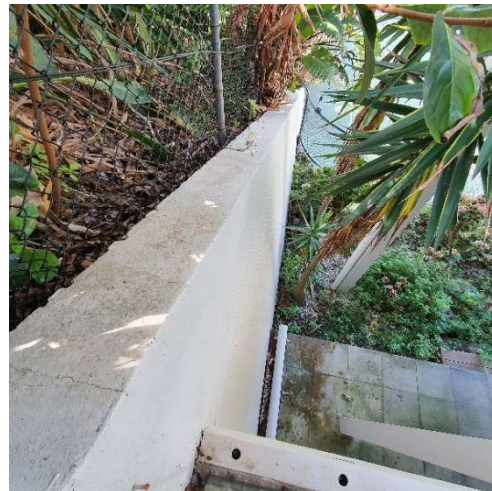
*Photograph-7: Brick retaining wall along the north boundary. View looking down east.*

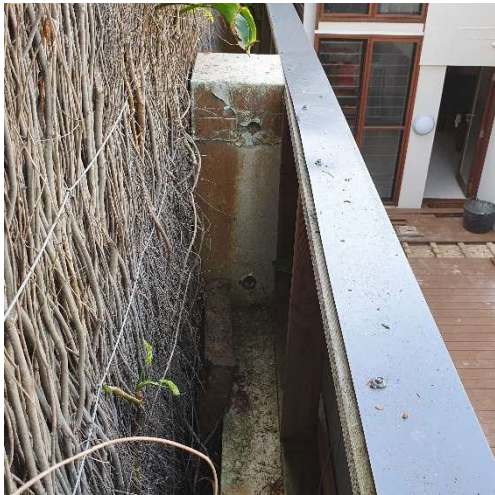
The site-dwelling is detached from the western boundary (approximately  $\leq 1.0\text{m}$  to  $\leq 4.0\text{m}$ ). Along the western boundary is an approximately 4.0m to 5.0m high retaining wall. The southern portion of the wall is rendered (Photograph-4), whilst the northern portion is stone veneer cladded. Observations from the top of the wall identified what appears to be a concrete column/pier which is located on top of the wall (Photograph-8 and 9) (approx.  $\leq 1.0\text{m}$  high and approximately 2.5m spaced along the western boundary). To the rear of the retaining wall (within south-east corner of No8 The Serpentine) a stormwater drainage pit which may be part of the water easement located along the south boundary of the site and a large tree (approximately  $\leq 10\text{m}$  high) are located 1.0m from the retaining wall. The retaining wall contained a semi-vertical crack (up to  $\leq 1\text{mm}$  wide and 3.0m long, Photograph-10), however it appeared stable with no signs of rotation, humidity, or underlying geotechnical issues and appeared in good condition.

*Photograph-8: Brick retaining wall along the north boundary. View looking down east.*

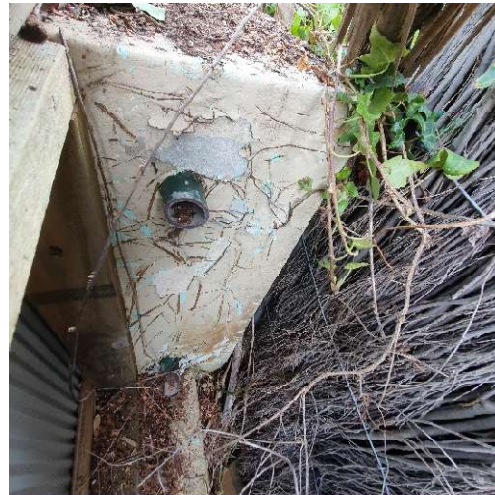
*Photograph-9: Closer look to concrete pier. View looking south.*

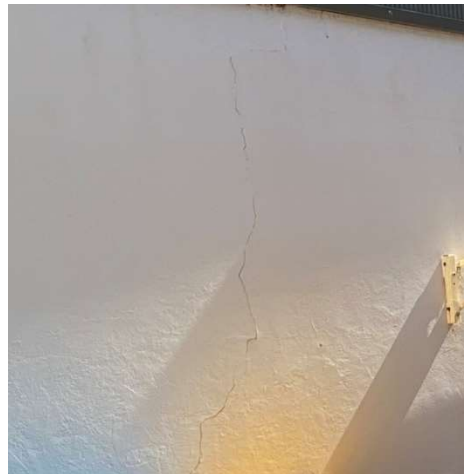
*Photograph-10: Cracking within the retaining wall. View looking west.*

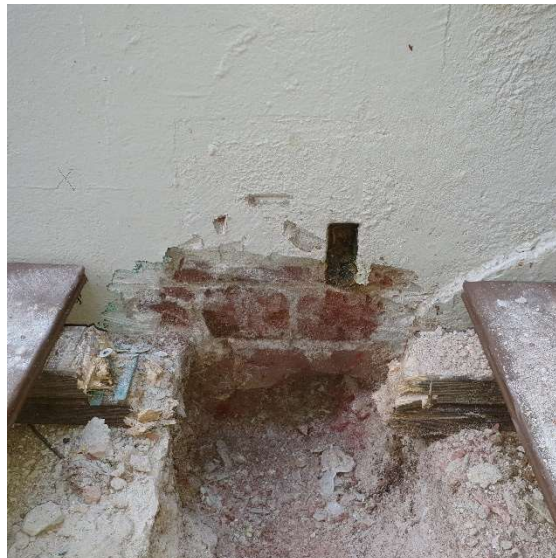
TP1 (Photograph-12) was excavated below the existing retaining wall along the western boundary at the location as specified in Figure 1. TP1 was excavated to approximately 0.30m depth below the deck level and identified that the base of the retaining wall comprised of brick. TP1 is described in Figure 5.

The founding strata below the base of the wall comprised of very stiff clay, becoming hard below 0.50m depth (RL= 8.95m). The base of the retaining wall appeared in good condition, signs of soft soils or water accumulation were not encountered in the test pit.

*Photograph-12: TP1 excavation. View looking down west.*
