139 George Street, Avalon

Geotechnical Comments for Section 4.55

GEOTECHNICAL INVESTIGATION:

Alterations and Additions at **139 George Street, Avalon**

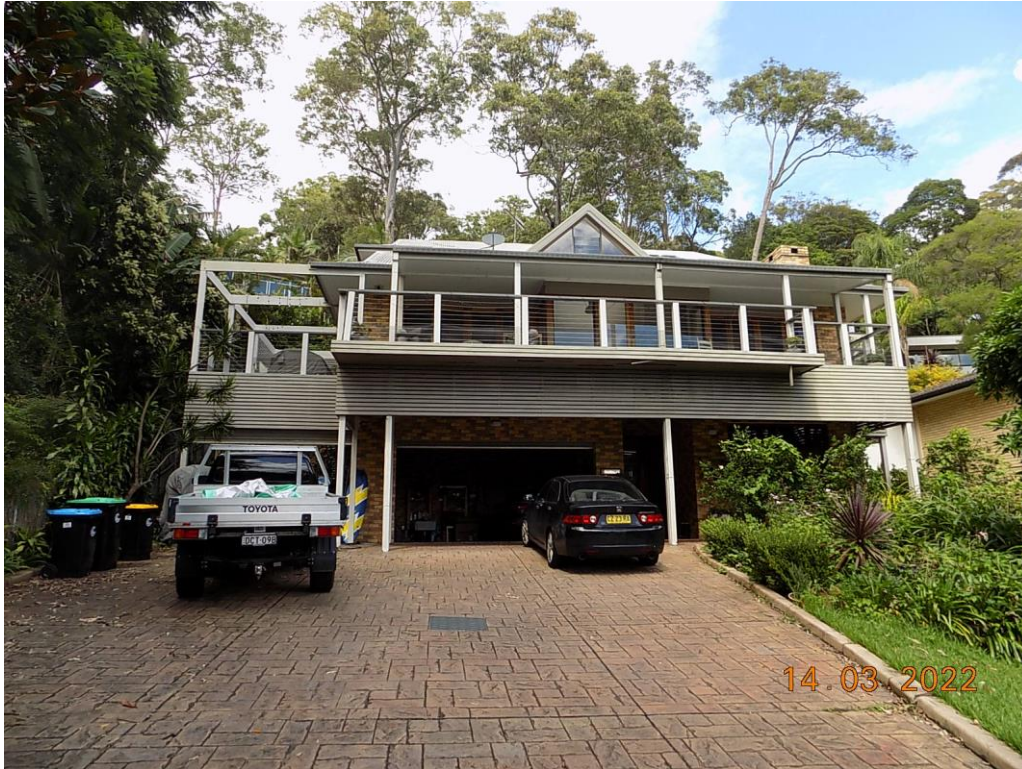
Photo 1

- 2.1** The site was inspected on the 14th March, 2022.
- 2.2** This residential property is accessed by a Right of Carriageway (ROW) off the high side of George Street and has a N aspect. It is located on the moderately graded lower reaches of a hillslope. The natural slope rises across the property at an average angle of ~12°. The slope above the property continues at similar angles, and the slope below the property eases to the waterfront.
- 2.3** At the road frontage, a ROW runs up the slope to a parking area, carport, and garage underneath the downhill side of the house (Photo 1). A stable ~1.3m high

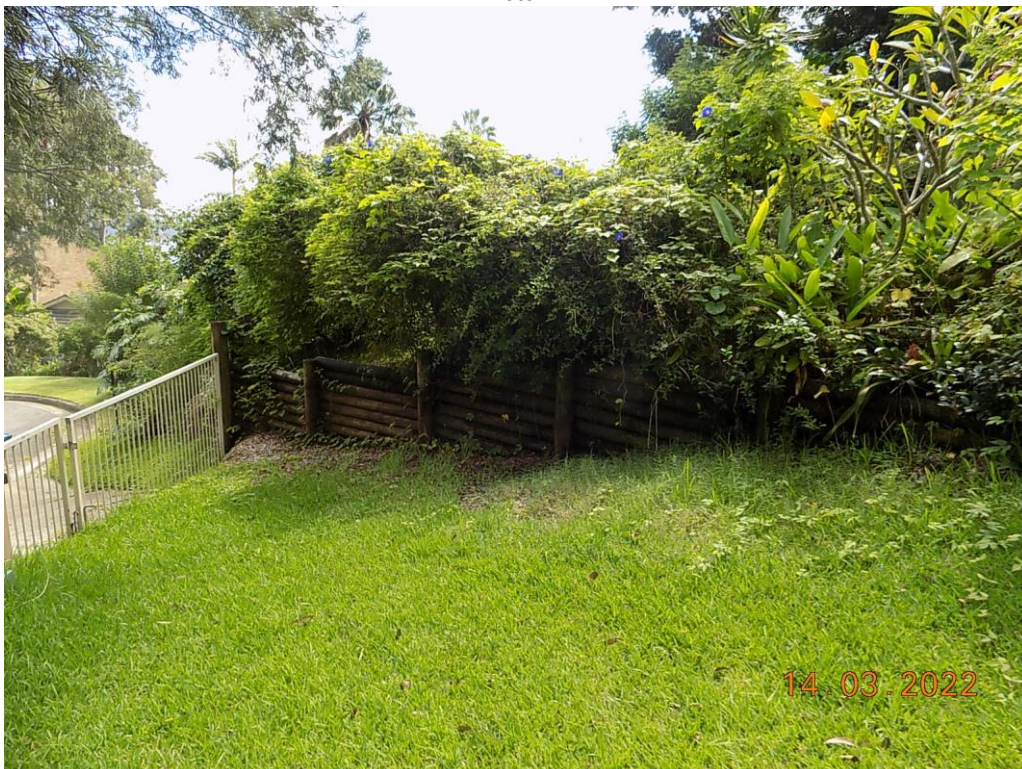
Photo 2

timber log retaining wall supports a fill for the ROW (Photo 2). A second, stable ~1.3m high timber log retaining wall supports a fill for the driveway (Photo 3). The part three-storey brick house is supported on brick walls. The supporting brick walls show no significant signs of movement. A stable ~0.7m high masonry retaining wall supports a cut for a carport attached to the E side of the house (Photo 4). A series of ~1.4m high timber retaining walls terrace the slope on the E side of the property (Photo 5 & 6). One of the supporting soldier posts has separated and the wall has begun to bulge in the middle. See **Section 16** for advice regarding this wall. A moderately sloping lawn extends from the uphill side of the house to the upper common boundary (Photo 7). Several Sandstone boulders can be seen embedded in stable positions in this location (Photo 8).

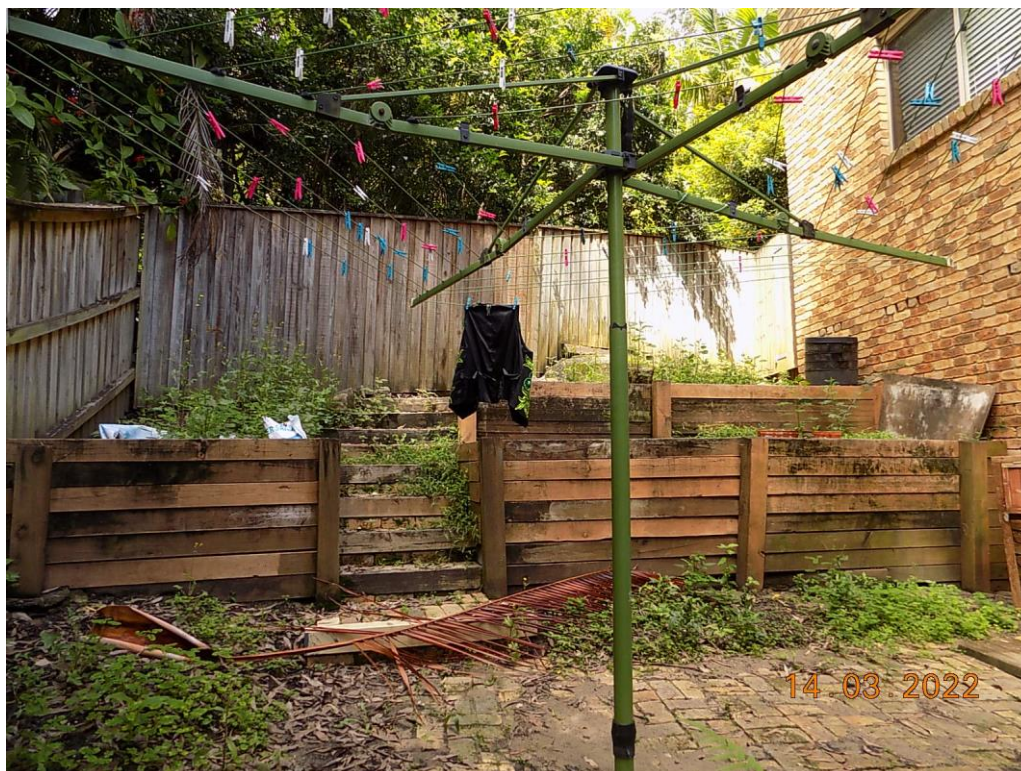
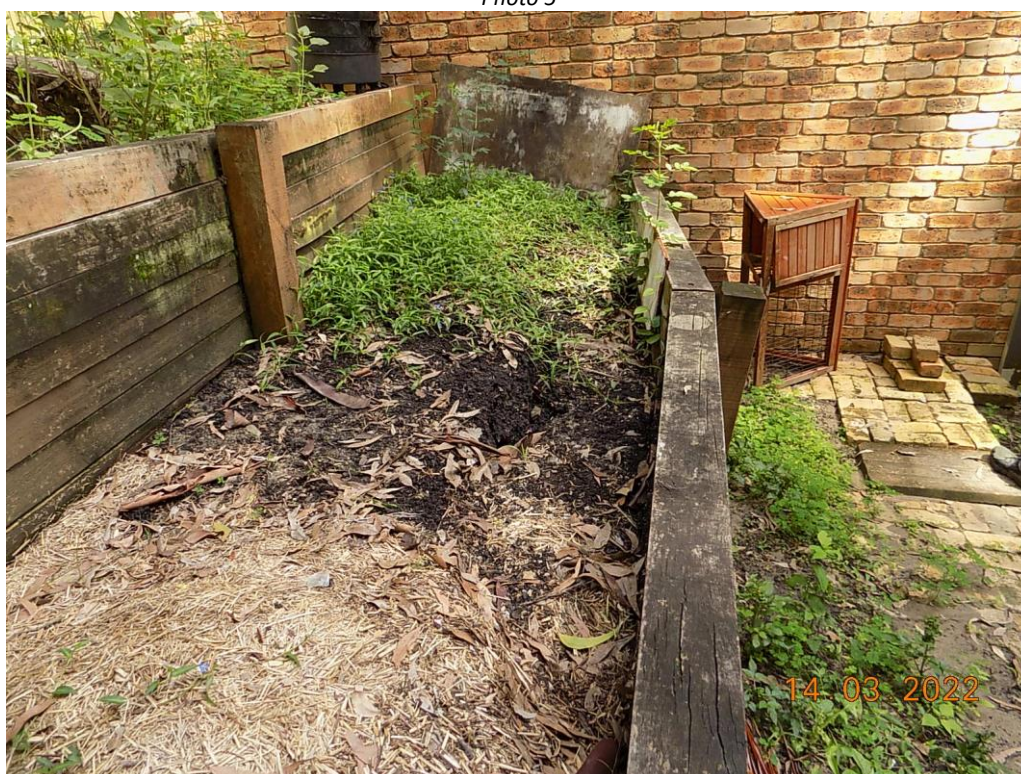
No geotechnical hazards were observed below or beside the property. The moderately graded slope that rises across the property and continues above is a potential hazard (**Hazard One**). The bulging timber retaining wall on the E side of the property is a potential hazard (**Hazard Two**). The proposed excavation is a potential hazard until retaining walls are in place (**Hazard Three**). The proposed excavation undercutting the footings for the house is a potential hazard (**Hazard Four**).

| HAZARDS | Hazard One | Hazard Two |
|---|---|---|
| TYPE | The moderate slope that rises across the property and continues above failing and impacting on the proposed works. | Further movement of the timber retaining wall on the E side of the property that causes damage or failure (Photos 5 & 6). |
| LIKELIHOOD | 'Unlikely' (10^{-4}) | 'Likely' (10^{-2}) |
| CONSEQUENCES TO PROPERTY | 'Minor' (5%) | 'Minor' (10%) |
| RISK TO PROPERTY | 'Low' (2×10^{-5}) | 'Moderate' (5×10^{-4}) |
| RISK TO LIFE | 5.5×10^{-7} /annum | 1.3×10^{-5} /annum |
| COMMENTS | This level of risk is 'ACCEPTABLE'. | This level of risk to life and property is 'TOLERABLE'. To move the risk to 'ACCEPTABLE' levels, the recommendations in Section 16 are to be followed. |

The timber retaining wall on the E side of the property is in the slow process of collapse (Photos 5 & 6). We recommend consideration be made to repairing/replacing the retaining wall during the proposed works. Alternatively, the retaining wall can to be inspected by the owners on an annual basis or after heavy prolonged rainfall, whichever occurs first, keeping a photographic record of the inspections. We can carry out these inspections upon request. Should any new movement be observed, the retaining walls are to be remediated or rebuilt to current engineering standards.

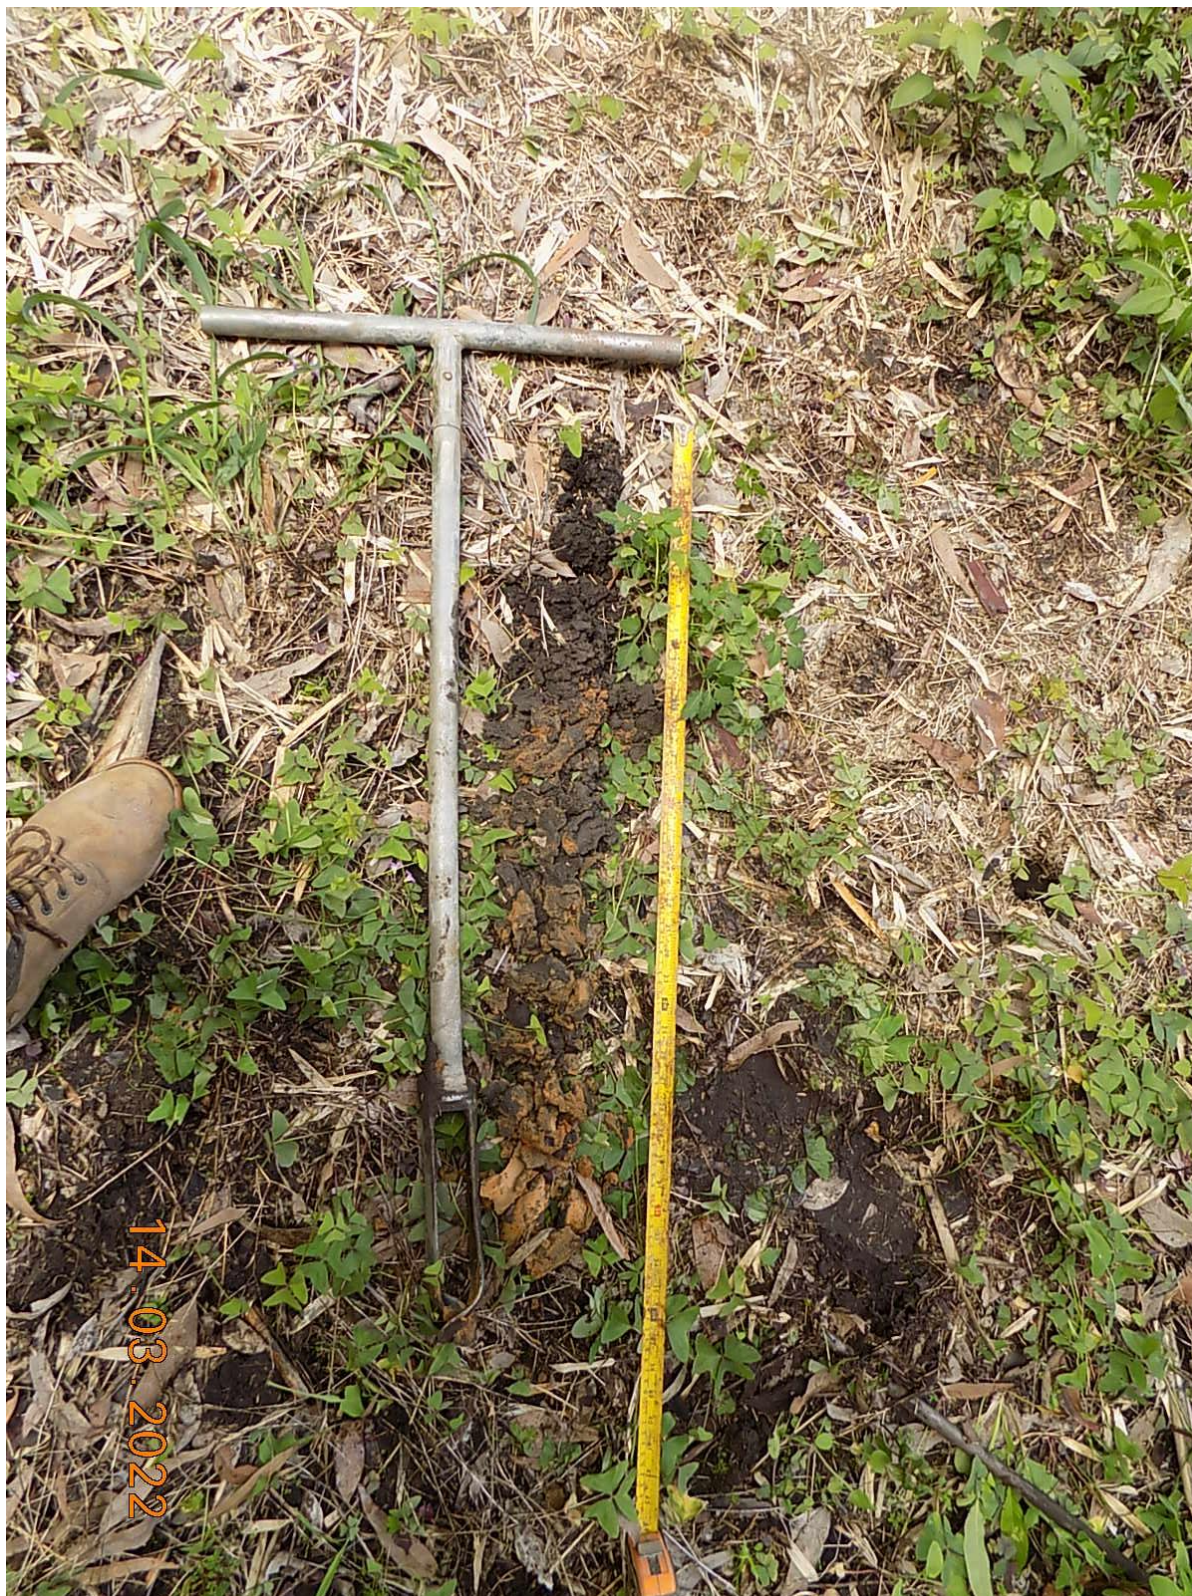
Photo 9 (Top to Bottom)

AUGER HOLE 1 (~RL15.9) – AH1 (Photo 9)

| Depth (m) | Material Encountered |
| 0.0 to 0.2 | TOPSOIL , dark brown clayey soil, medium grained, loose, fine trace of organic matter, dry. |
| 0.2 to 0.6 | CLAY , brown, fine grained, firm to stiff, dry. |
| 0.6 to 0.8 | CLAY , orange, yellow, fine grained, stiff, dry. |

End of test @ 0.8m. No water table encountered.

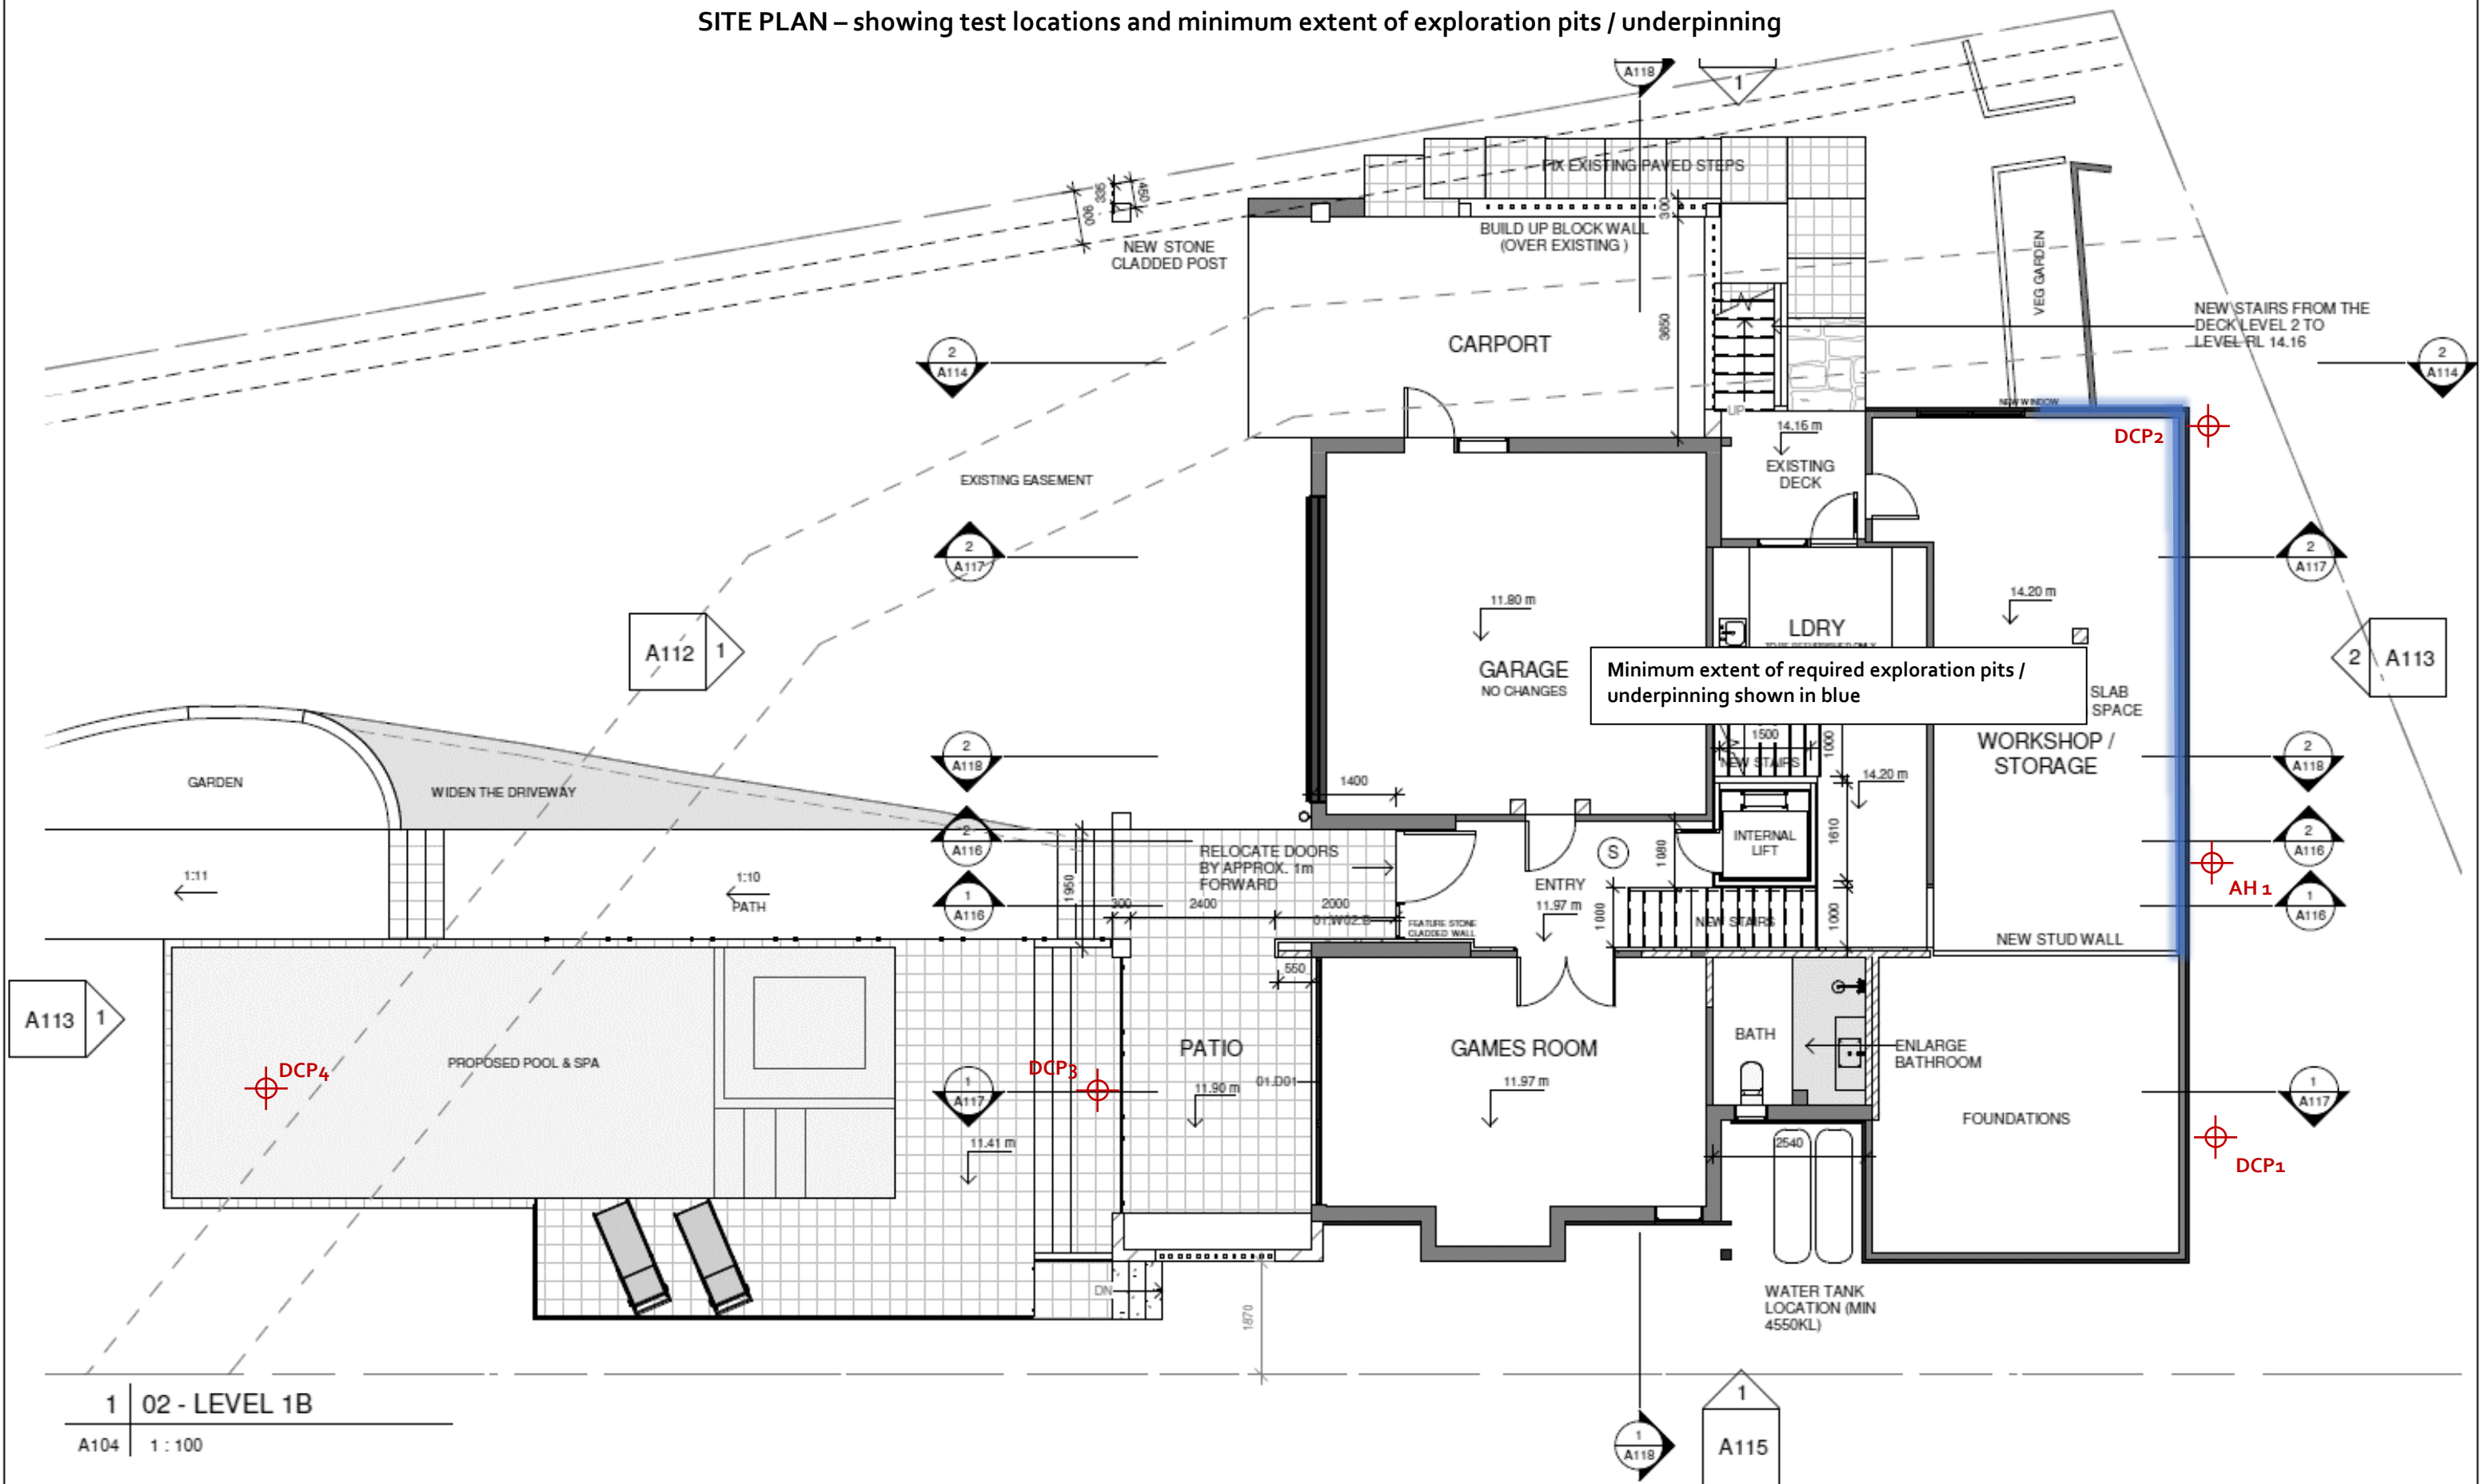
SITE PLAN – showing test locations and minimum extent of exploration pits / underpinning

One hand Auger Hole (AH) was put down to identify soil materials. Four Dynamic Cone Penetrometer (DCP) tests were put down to determine the relative density of the overlying soil and the depth to weathered rock. The locations of the tests are shown on the site plan attached. It should be noted that a level of caution should be applied when interpreting DCP test results. The test will not pass through hard buried objects so in some instances it can be difficult to determine whether refusal has occurred on an obstruction in the profile or on the natural rock surface. This is not expected to be an issue for the testing on this site. However, excavation and foundation budgets should always allow for the possibility that the interpreted ground conditions in this report vary from those encountered during excavations. See the appended "Important information about your report" for a more comprehensive explanation. The results are as follows:

If the foundations are confirmed to extend below the zone of influence of the proposed excavation, the excavation may commence. If they are not, the walls will need to be underpinned to below the zone of influence of the cut prior to the excavation commencing. See the site plan attached for the minimum extent of the required exploration pits/underpinning.

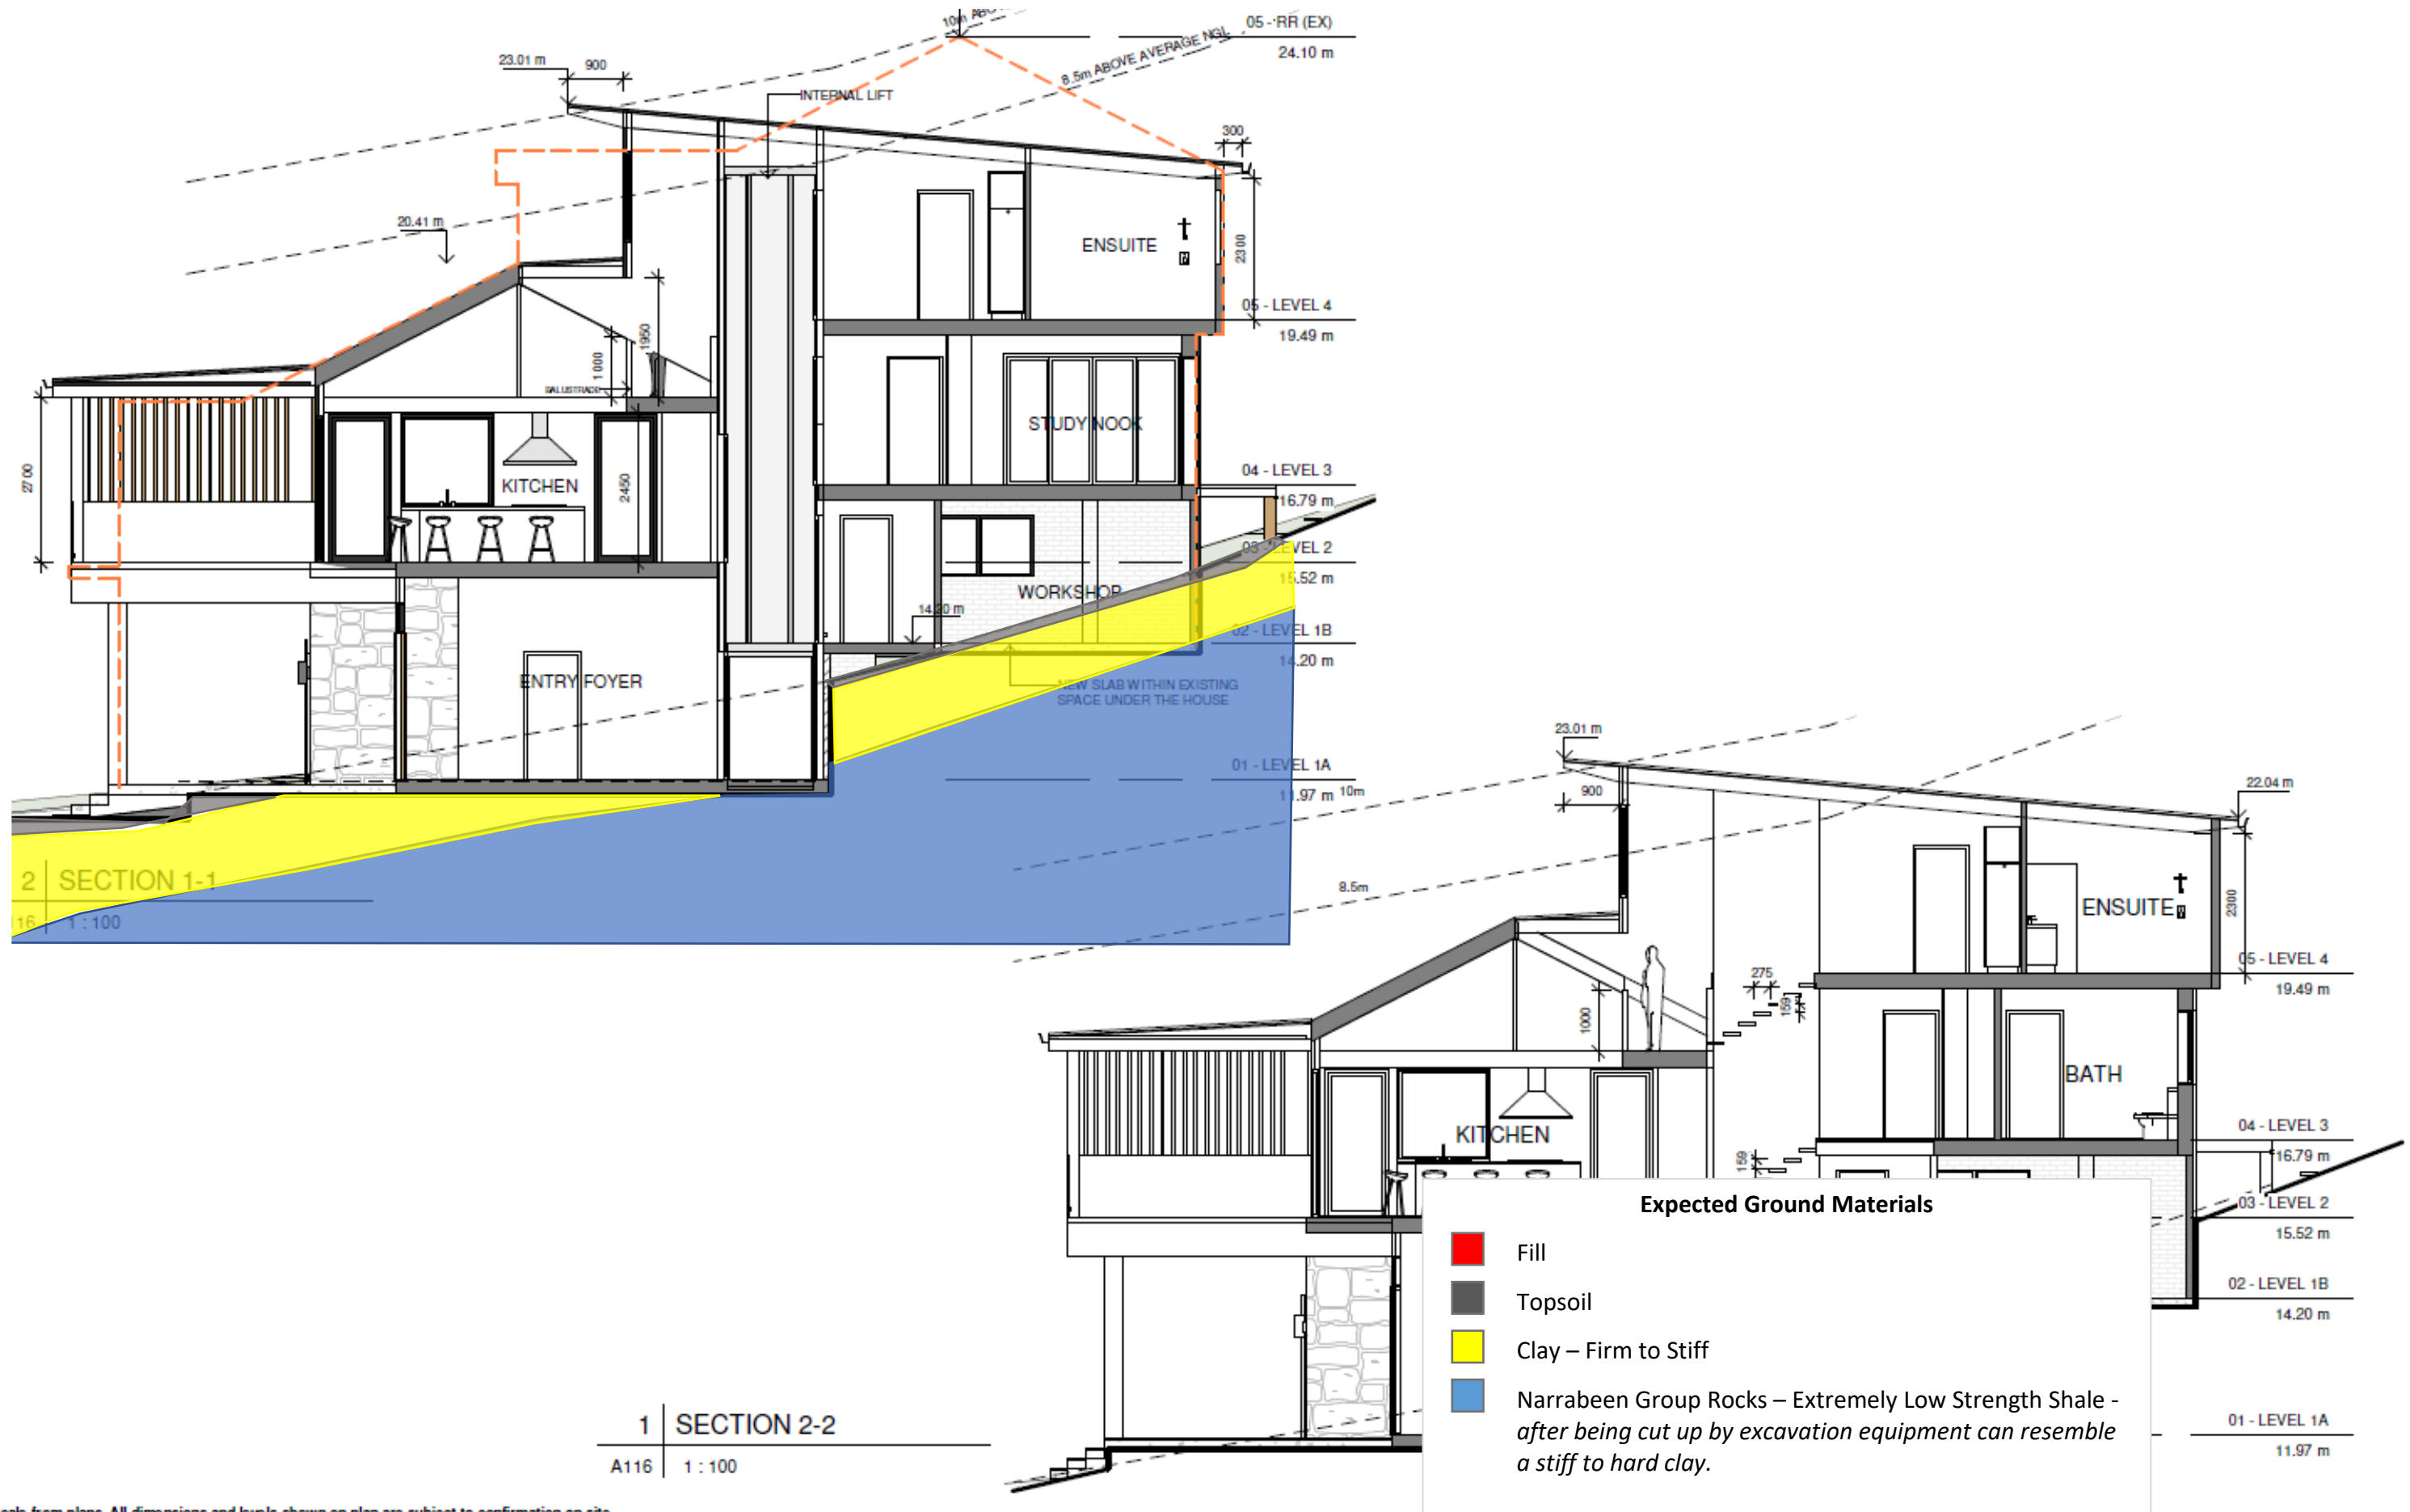
TYPE SECTION – Diagrammatical Interpretation of expected Ground Materials

The slope materials are colluvial at the near surface and residual at depth. In the test locations, the ground materials consist of shallow soils over clays. The clay merges into the underlying weathered rock at depths of between ~1.2m to ~1.8m below the current surface. The weathered zone is interpreted to be Extremely Low Strength Shale. Sandstone boulders were observed embedded in the slope above the house. It is interpreted that DCP 1 refused on an underlying boulder similar to the ones at the surface. See Type Section attached for a diagrammatical representation of the expected ground materials.
