9 July 2017

**RE: ENGINEER ASSESSMENT OF FAILED RETAINING WALL  
PEDESTRIAN WALL ON SOUTH SIDE OF WALKWAY  
TREE DAMAGE TO WALL  
15 EAST ESPLANADE MANLY  
FOR SP 6749**

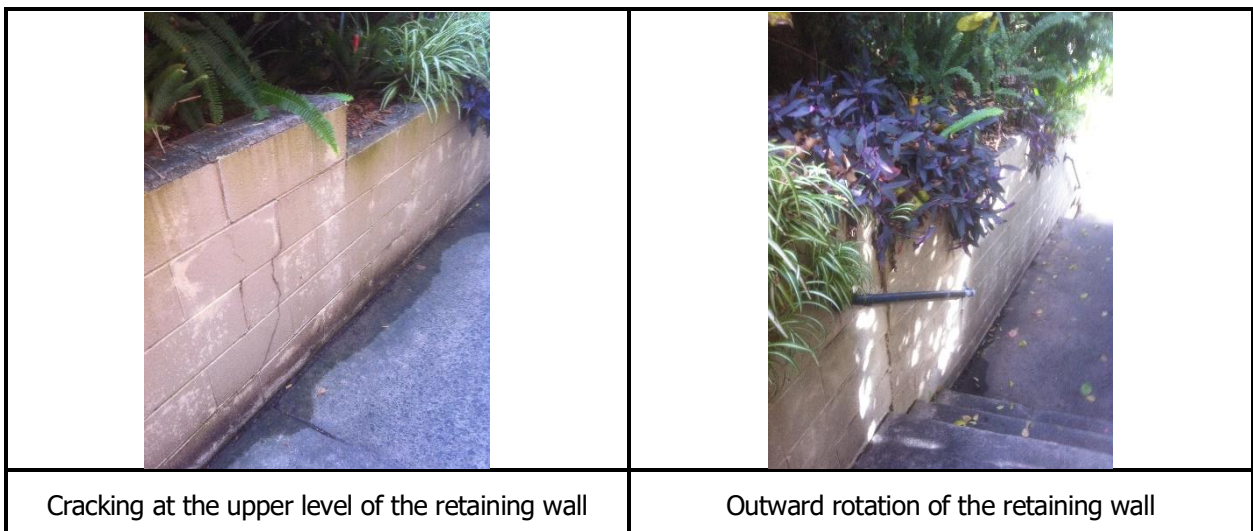
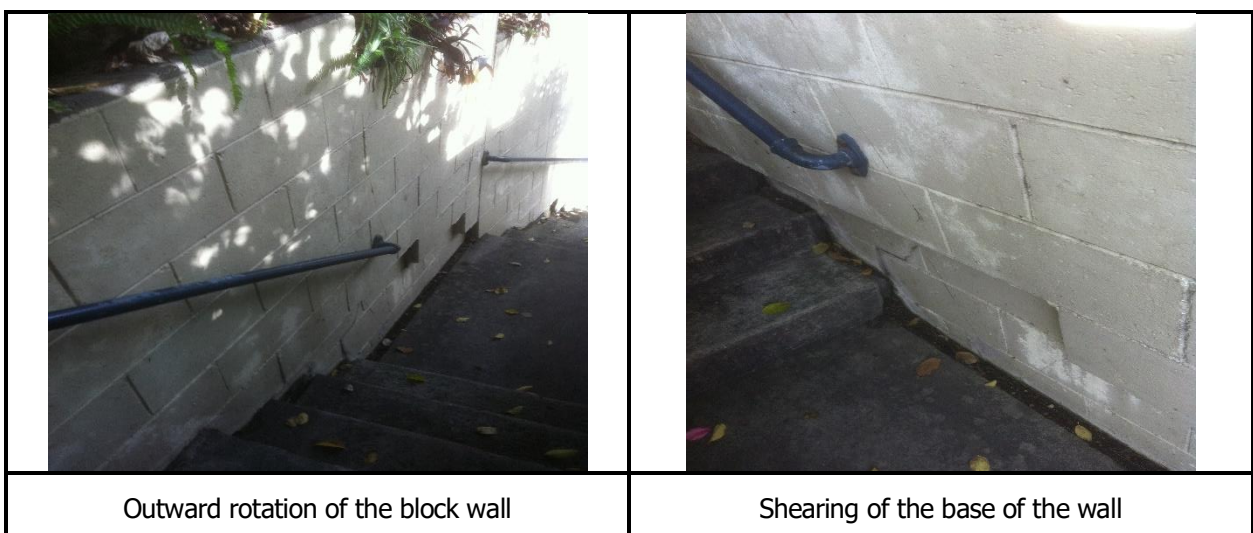
The wall is leaning outwards by approximately 100mm and has sheared at the lower level course.

The length of wall failure is approximately 8.5m long. The wall height varies from 800mm to 1800mm in height.

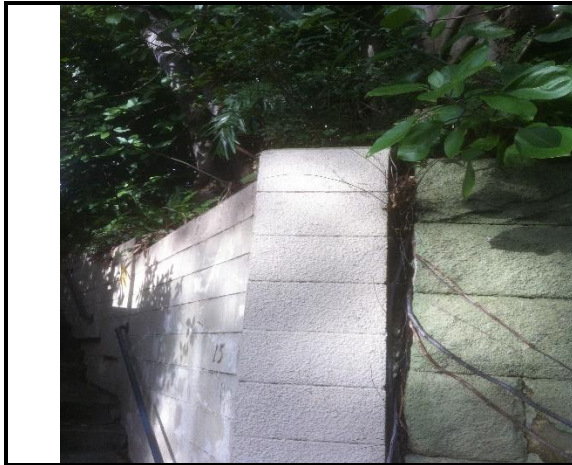
The subject tree roots are visible from the opened joints in the wall adjacent to a an engaged pier located on the corner of the wall. The tree roots are visible directly up against the wall.

The engaged pier whereby roots are visible at the construction joint

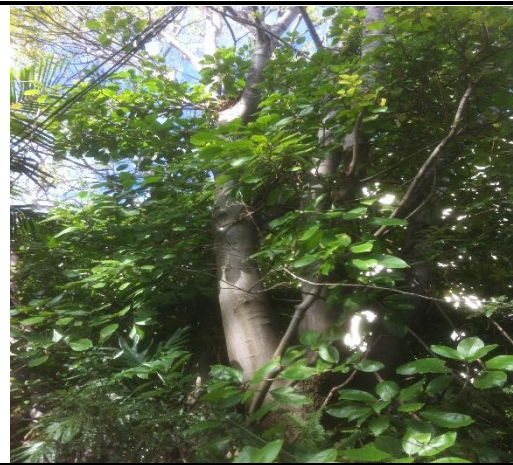
Tree and electrical wires overhead

In order to remove the tree, the overhead electrical wires will need to be "tiger tagged" for safety reasons.

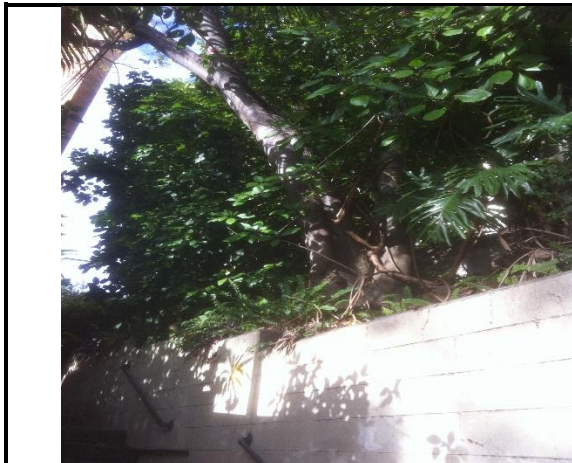
Close proximity of tree and roots to the retaining wall

The cause of the damage is in our view as a result of inappropriate tree location to the retaining wall structure and limited space in the planter box. This being that the tree is planted too close to the retaining wall.

As the subject tree is around 9m in height the planting distance to any structure would need to be around 6m from the wall. The tree is planted around 0.5m from the retaining wall and therefore has compromised the structural integrity of the retaining wall.

The wall is unsafe and it is imminent complete collapse will eventually occur unless the tree is removed and replaced with suitable shrubs.

The section of failed wall will need to be demolished and replaced which is around 8.5 m in length.

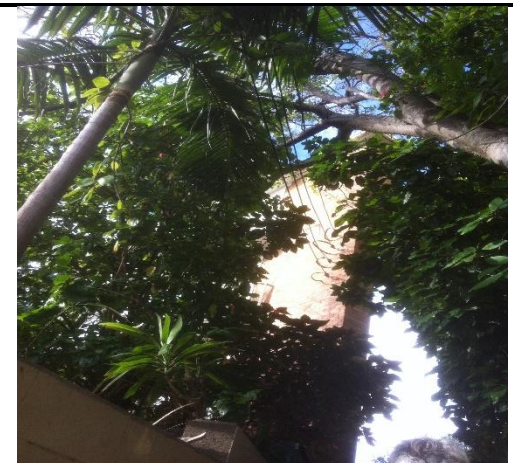
Electrical wires overhead
