Geotechnical Assessment

Project: Alterations & Additions
72 Cooyong Road, Terrey Hills NSW

Ref: AG 24030
13 February 2024

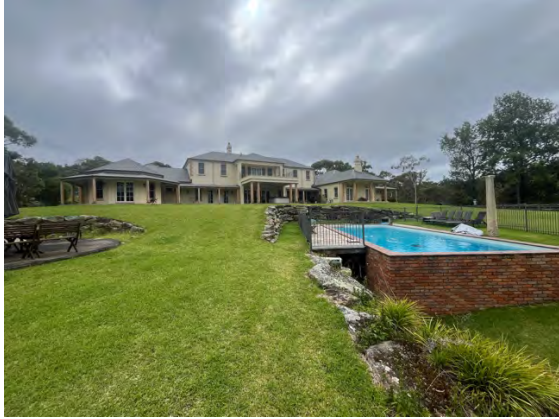
Photo 1: Swimming pool looking towards southern side of the residence & area of the proposed works

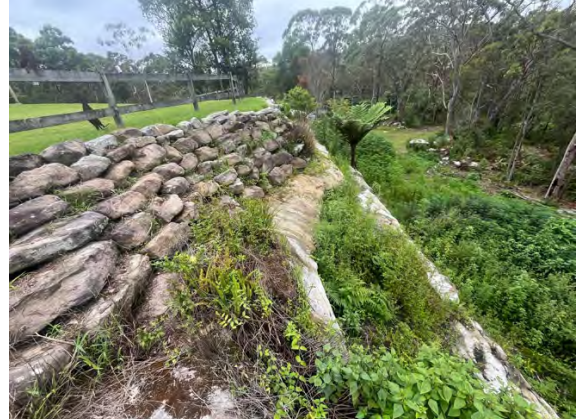
Photo 2: Sandstone bedrock outcropping to the south of the area of the proposed works

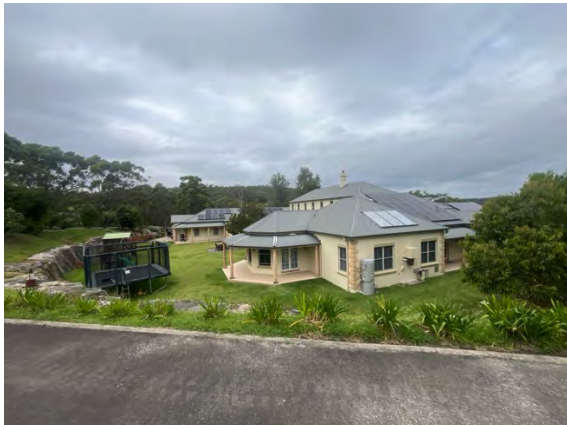
Photo 3: North-eastern corner of the residence

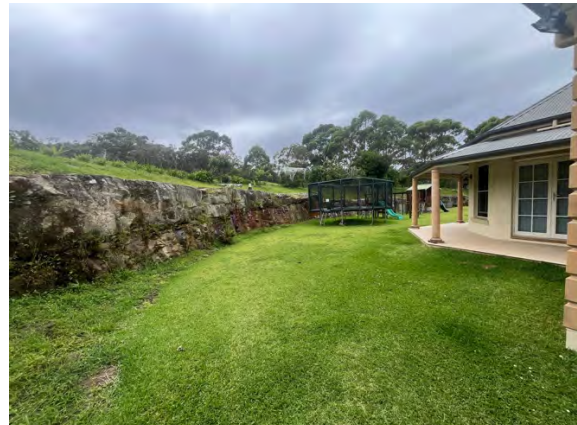
Photo 4: Outcropping rock to the north of the residence

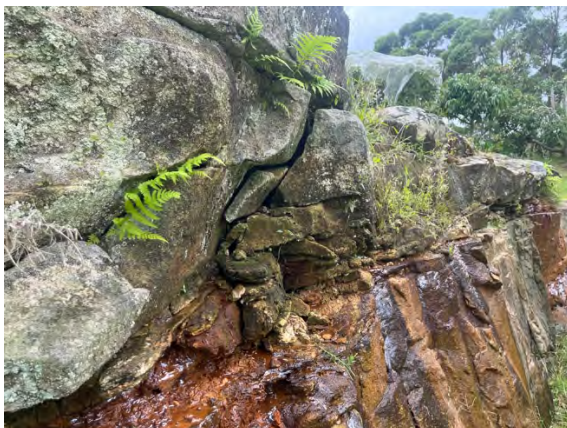
The outcropping rock to the north of the residence contains limited areas of blocky fracturing within the upper portions of the outcrop (photos 5 & 6) with the potential to fall within proximity of children's play equipment or be mobilised by children climbing the rock face.

- **Hazard One:** Failure of the proposed excavations.
- **Hazard Two:** Failure of blocky weathered rock in the outcropping bedrock to the north of the residence (Photos 5 & 6)

HAZARDS	HAZARD ONE	HAZARD TWO
TYPE	Failure of the proposed excavations	Failure of blocky weathered rock in the outcropping bedrock to the north of the residence (Photos 5 & 6)
LIKELIHOOD	'Possible' (10^{-3})	'Possible' (10^{-3})
CONSEQUENCES TO PROPERTY	'Minor' (5%)	'Insignificant' (0.1%)
RISK TO PROPERTY	'Moderate' (2×10^{-3})	'Very Low' (0.5×10^{-3})
RISK TO LIFE	5.3×10^{-4} /annum	3.2×10^{-5} /annum
COMMENTS	Following implementation of the recommendations outlined in Section 3.7, the above risk levels would reduce to 'Acceptable' levels within the site.	Following implementation of the recommendations outlined in Section 3.7, the above risk levels would reduce to 'Acceptable' levels within the site.

Photo 5: Fractured rock within the outcropping bedrock to the north of the residence

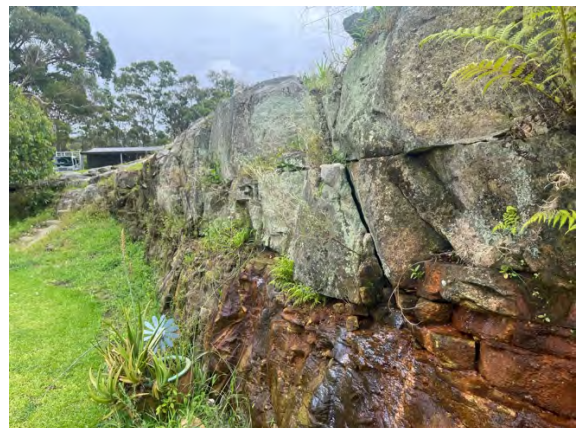
Photo 6: Fractured rock within the outcropping bedrock to the north of the residence
