Geotechnical Assessment

Project: Alterations & Additions
12 Capua Place, Avalon Beach NSW

Ref: AG 24301
2 August 2024

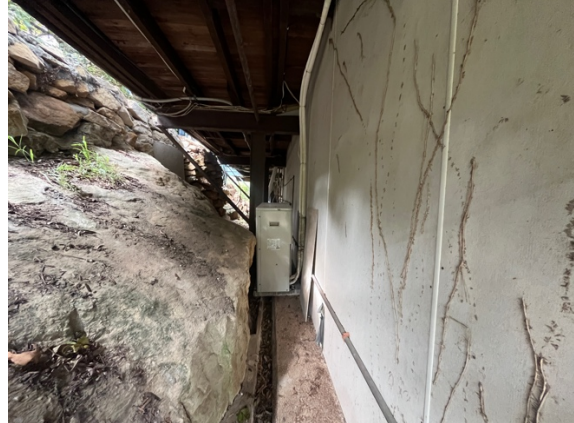
Photo 2: Sandstone outcropping on the northern side of the residence

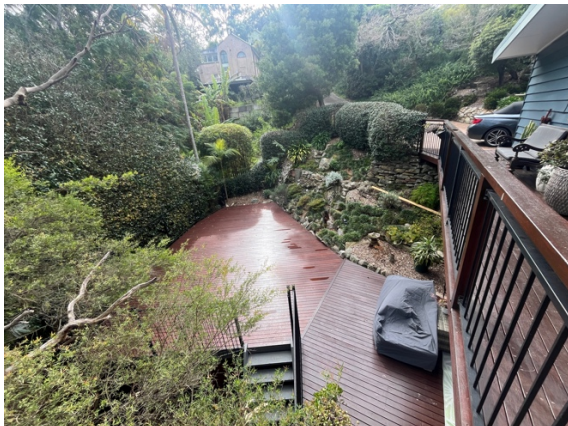
Photo 3: Timber deck & general area of the proposed works

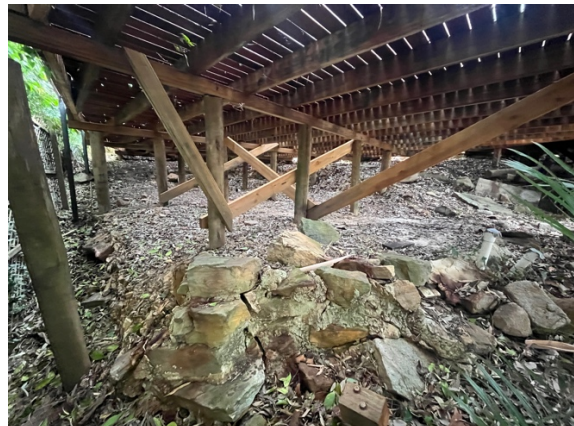
Photo 4: Underside of timber deck in the general area of the proposed works.

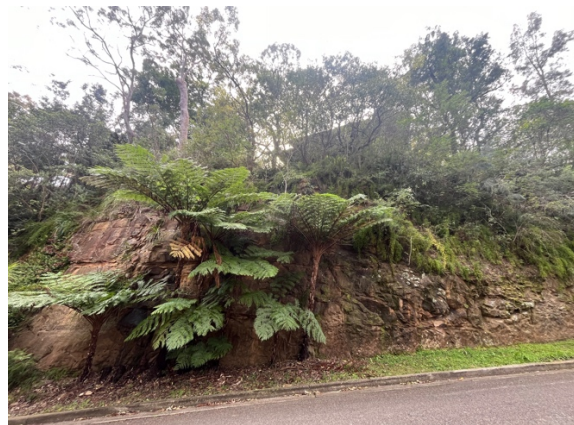
At the southern boundary of the site is a vertical escarpment that drops to Capua Place, the outcropping rock in the escarpment is inferred to be Hawkesbury Sandstone, low to medium strength, with generally widely spaced horizontal bedding defects and limited localised vertical fractures. Bedrock is also visible outcropping in limited areas on the subject site towards the western boundary and at the upslope cut batter for the house.

Photo 6: Vertical sandstone escarpment at Capua Avenue boundary
