J3814.

12<sup>th</sup> November, 2021.

# **GEOTECHNICAL INVESTIGATION:**

Subdivision and New Houses at 120 Prince Alfred Parade, Newport

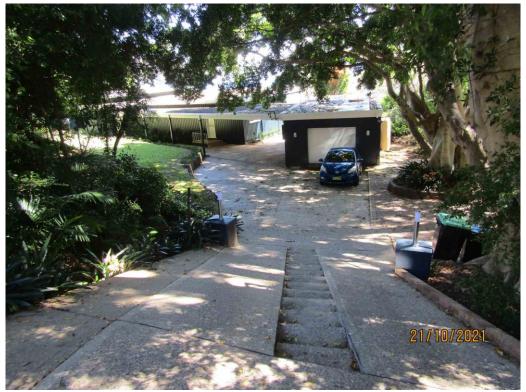
Photo 1

2.3 At the road frontage, a concrete driveway runs down the slope to a rendered masonry and timber clad garage and studio (Photo 1). A concrete crib and concrete retaining wall up to ~2.0m high supports the fill batter for the road (Photo 2). The wall is partially obscured by vegetation, but from what can be seen of the wall it appears to be stable. Low brick retaining walls terrace the slope downhill of the road (Photo 3). The walls display significant cracking, bulging and tilting downslope, but will be demolished as part of the proposed works. A level lawn area is located on the downhill side of the terraced area (Photo 4). The single storey weatherboard clad house is supported by brick walls and brick piers (Photos 4 & 5). The supporting walls and piers stand vertical and show no significant signs of movement (Photo 6). A level lawn area extends off the downhill side of the house (Photos 5 & 7). A low sandstone block seawall supports the fill for the lawn. A fibre cement and weatherboard clad boatshed is located at the waterfront NE of the house (Photo 8). The adjoining neighbouring properties were observed to be in good order as seen from the street

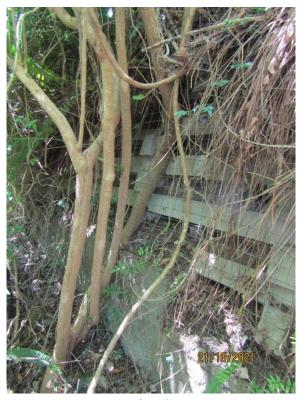
Photo 2

structures are in place (Hazard Three). The additional surcharge loads from the proposed

suspended driveway and walkway structures are a potential hazard to the existing retaining

wall (Photo 2) (Hazard Four).

The proposed suspended driveway at 120A and suspended walkway at 120B are to be

supported on piers embedded into Extremely Low Strength Shale and taken to beyond the

zone of influence of the existing concrete crib/concrete retaining wall supporting the fill for

the road reserve (Photo 2). Provided the footings are taken to and embedded into this ground

material at the required depths, no additional loads will be transferred onto the existing

retaining wall. A maximum allowable bearing pressure of 600kPa can be assumed for footings

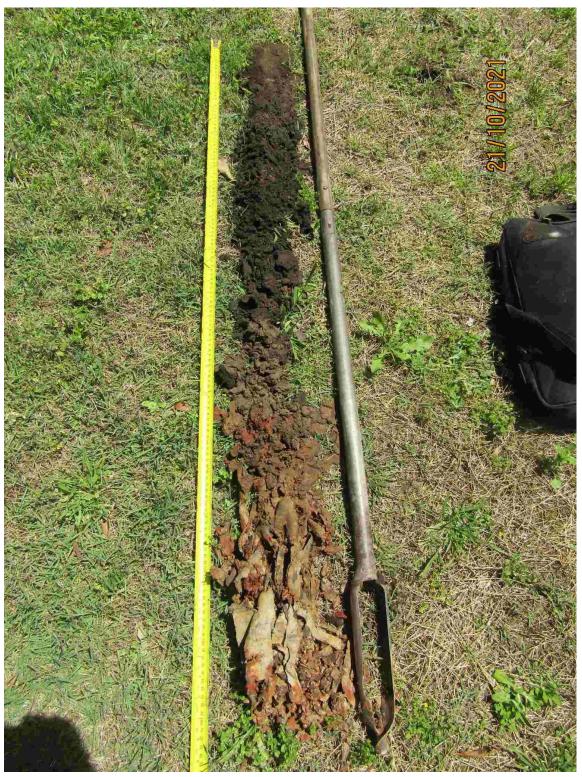
Photo 9: AH1 – Downhole is from top to bottom.

# **AUGER HOLE 1** (~RL2.8) – AH1 (Photo 9)

Depth (m)	Material Encountered
0.0 to 0.8	TOPSOIL, sandy soil, dark brown, damp, fine to course grained.
0.8 to 1.0	CLAYEY SAND, light brown, damp.
1.0 to 1.4	CLAY, brown, orange, grey and red, mottled, firm to stiff.

Refusal @ 1.4m in firm to stiff clay. No watertable encountered.

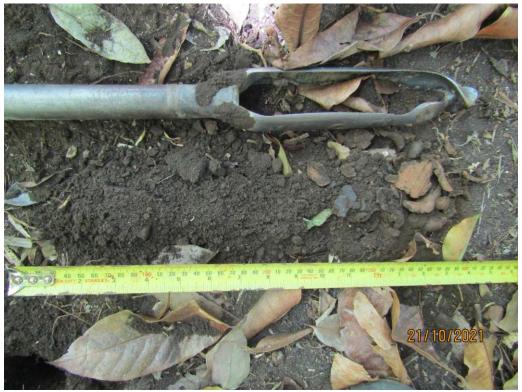
Photo 10: AH2 – Downhole is from left to right.

#### **AUGER HOLE 2** (~RL6.1) – AH1 (Photo 10)

Depth (m)	Material Encountered
0.0 to 0.3	<b>TOPSOIL</b> , sandy soil, dark brown, damp, fine to medium grained.
0.3 to 0.4	CLAY, orange/brown, firm to stiff, moist.

End of Hole @ 0.4m in firm to stiff clay. No watertable encountered.

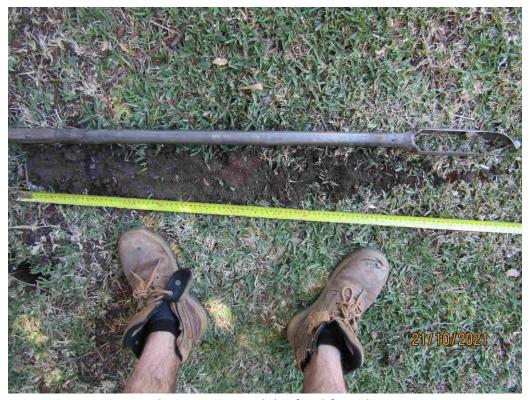
Photo 11: AH3 – Downhole is from left to right.

#### **AUGER HOLE 3** (~RL2.0) – AH1 (Photo 11)

Depth (m)	Material Encountered
0.0 to 0.9	FILL, sandy soil, dark brown, dry, fine to medium grained.
0.9 to 1.1	FILL, sandy clay, orange, stiff, moist.

Refusal @ 1.1m in fill. No watertable encountered.

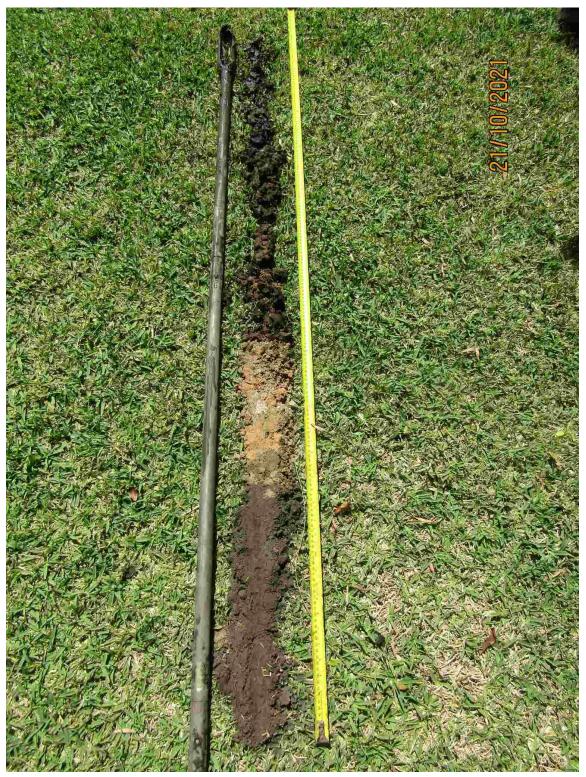
Photo 12: AH4 – Downhole is from bottom to top.

# **AUGER HOLE 4** (~RL1.8) – AH1 (Photo 12)

Depth (m)	Material Encountered
0.0 to 0.4	FILL, sandy soil, dark brown, dry to moist, fine to medium grained.
0.4 to 0.8	FILL, sand, light yellow/brown, dry to moist, fine to medium grained.
0.8 to 1.3	SANDY SOIL, with some clay, dark brown/grey, damp, fine to medium
	grained.
1.3 to 1.9	<b>SANDY SOIL</b> , with some clay, dark brown/grey, wet to very wet, fine to
	medium grained.

End of hole @ 1.9m in very wet sandy soil. Watertable encountered @ ~1.5m.
