16 March 2020

1 - 3 FLORIDA ROAD PALM BEACH, NSW

ADDITIONS & ALTERATIONS ARBORICULTURAL IMPACT ASSESSMENT REPORT

Report Ref No- RTC-5520

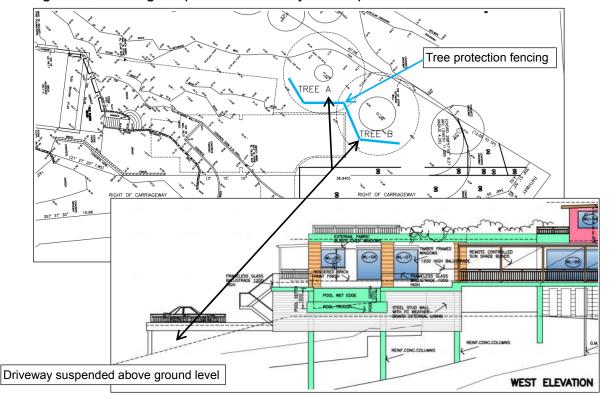
Figure 1, showing suspended driveway & tree protection area

1.2.1 As shown within Figure 1 below the driveway design is suspended above ground level, where the footprint of design is located outside of tree protection zones radiuses.

To ensure the trees remain viable tree protection fencing is recommended to be constructed under the guidance and certification of an appointed project arborist, positioned at or near the extremity of TPZ radiuses as indicated below.

Within the fenced zone the area is to be considered a tree protection area (TPA) where no works are to occur without prior arborist advice.

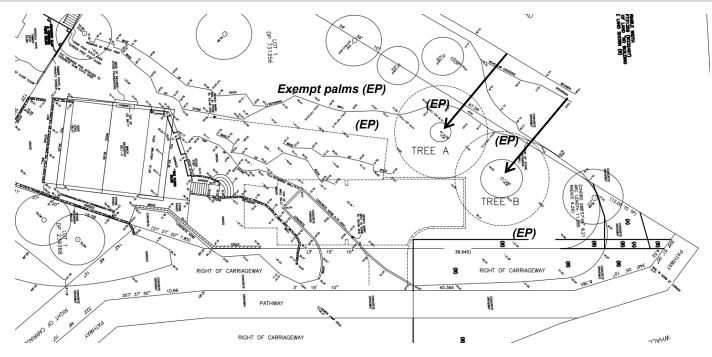
Tree Location Plan

Trees requiring removal subject to Local Government				ition -		Trees with low retention values: senescence, developing defects or being *exempt trees from the LGA Tree Preservation Order (TPO)					
Tree No	Botanical Name COMMON NAME	Height x spread (m)	DBH (mm)	SRZ TPZ	Age	Health	Condition	Signifi- cance	VTA	RV	U. L.E.	Comments CV = Council verge tree NT= Neighbouring tree
A	<i>Allocasuarina littoralis</i> Black She Oak	5 x 2.5	200	1.8m 2.4	ESM	Fair	Fair	4	2C/4	2	3	Vine covered upper branch scaffolds, appears environmentally stressed with slight decline in canopy & bowing lower trunk form
В	Angophora floribunda Rough Barked Apple	8 x 5	300	2.1 3.6	ESM	Fair / Good	Fair	3	2C/4	2	2	Skewed trunk at 3m, bowing upper branch scaffolds to NE, appears environmentally stressed
