Report Title: Geotechnical Report 81 Hilltop Road, Avalon  
Report Date: 21/5/19  
Author: BEN WHITE  
Author's Company/Organisation: WHITE GEOTECHNICAL GROUP PTY LTD

## **GEOTECHNICAL INVESTIGATION:**

New Carport, Pool, and Alterations and Additions at **81 Hilltop Road, Avalon**

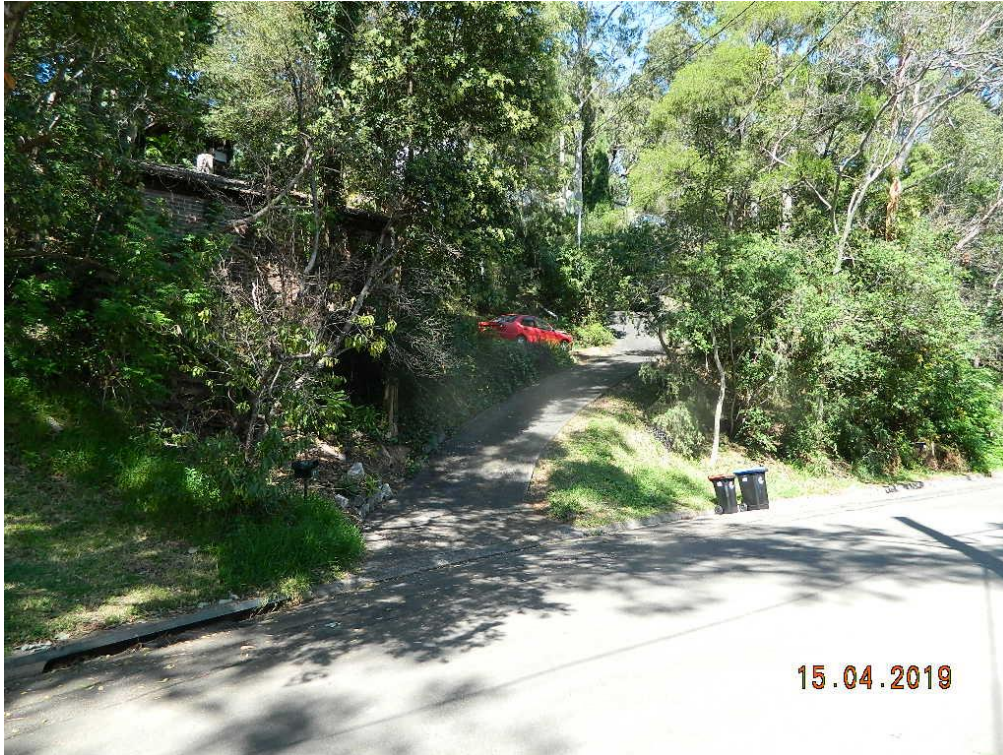
Photo 1

- 2.3** At the road frontage, a concrete Right of Carriageway (ROW) runs across the lower boundary of the property (Photo 1). A concrete driveway extends off the ROW up the slope to a concrete parking area on the downhill side of the property (Photo 2). A ~0.5m stable dimensioned sandstone block retaining wall and an old timber retaining wall support a cut for the ROW (Photos 3 & 4). The old timber

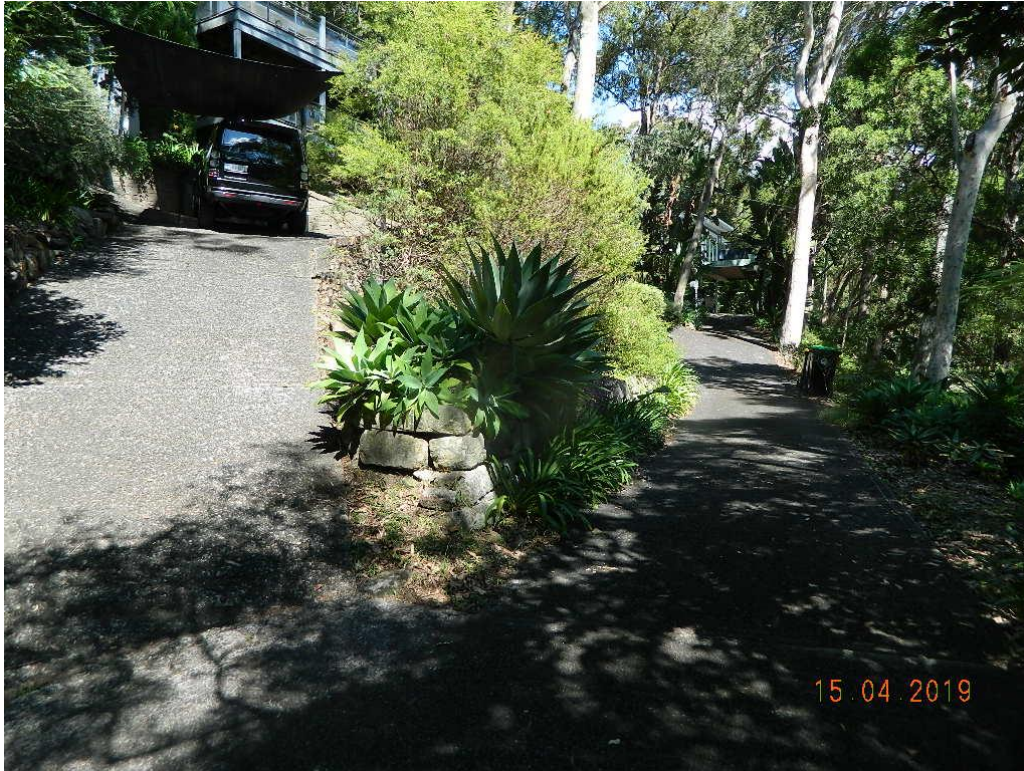
Photo 3

retaining wall will be remediated as part of the proposed works. Native vegetation covers the slope between the road frontage and the house. An excavation to a maximum depth of ~1.5m has been made for the concrete parking area. The excavation is supported by a brick retaining wall that is cracked and tilting but has been temporarily shored up with timber propping (Photo 5). The wall will be demolished as part of the proposed works. The part three-storey rendered brick house is supported on brick walls and brick piers (Photo 6). No significant signs of movement or cracking were observed in the external supporting brick walls. Some of the supporting brick piers in the foundation space are tilting at a maximum angle of ~8° downslope (Photo 7). We were informed by the owner the tilting piers will be repaired/remediated as part of the proposed works. See **Section 16** for recommendations. A ~1.5m excavation has been made to level the lower ground floor of the house. The cut is supported by the uphill supporting brick wall of the house. The slope above the house is terraced by a series of three retaining walls. The lower brick retaining wall is ~1.0m high and levels a lawn on the uphill side of the house (Photo 8). The middle timber retaining wall is ~0.4m high and is tilting at a maximum angle of ~10° downslope. As the wall is low it doesn't pose a significant risk to life or property should it collapse. The upper timber retaining wall is in a stable condition (Photo 9). Medium Strength Sandstone bedrock outcrops and steps up to the crest of the slope.

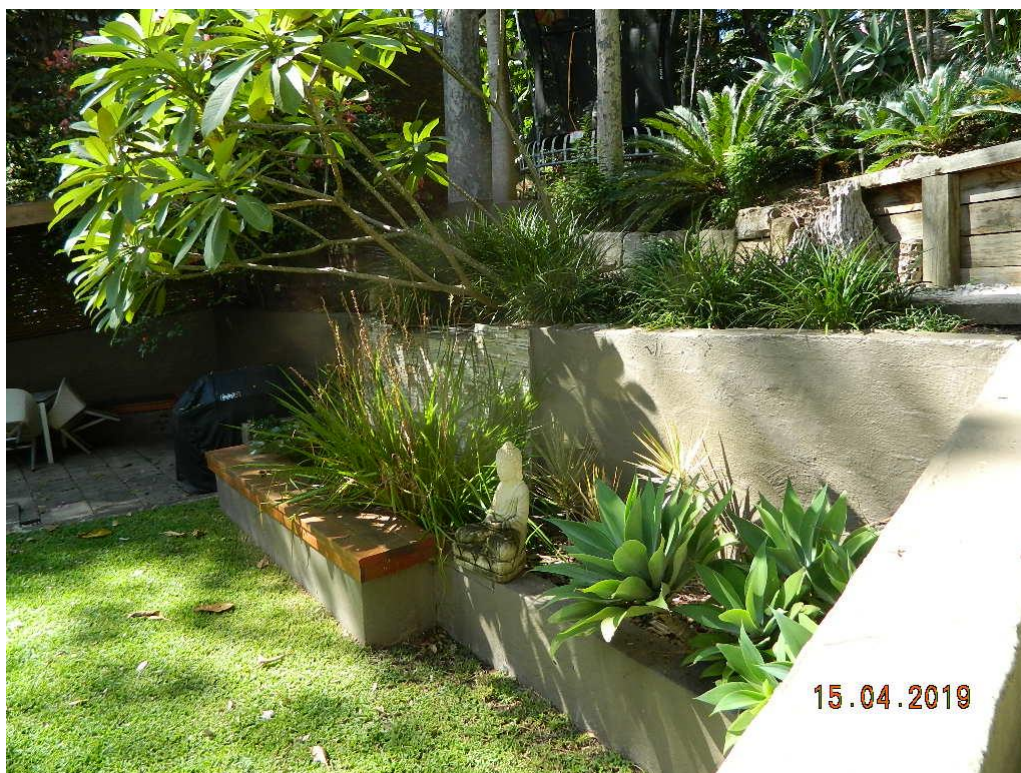
Photo 8

Some of the supporting brick piers in the foundation space are tilting at a maximum angle of ~8° downslope (Photo 8). We recommend any piers tilting more than 5° be remediated as part of the proposed works.

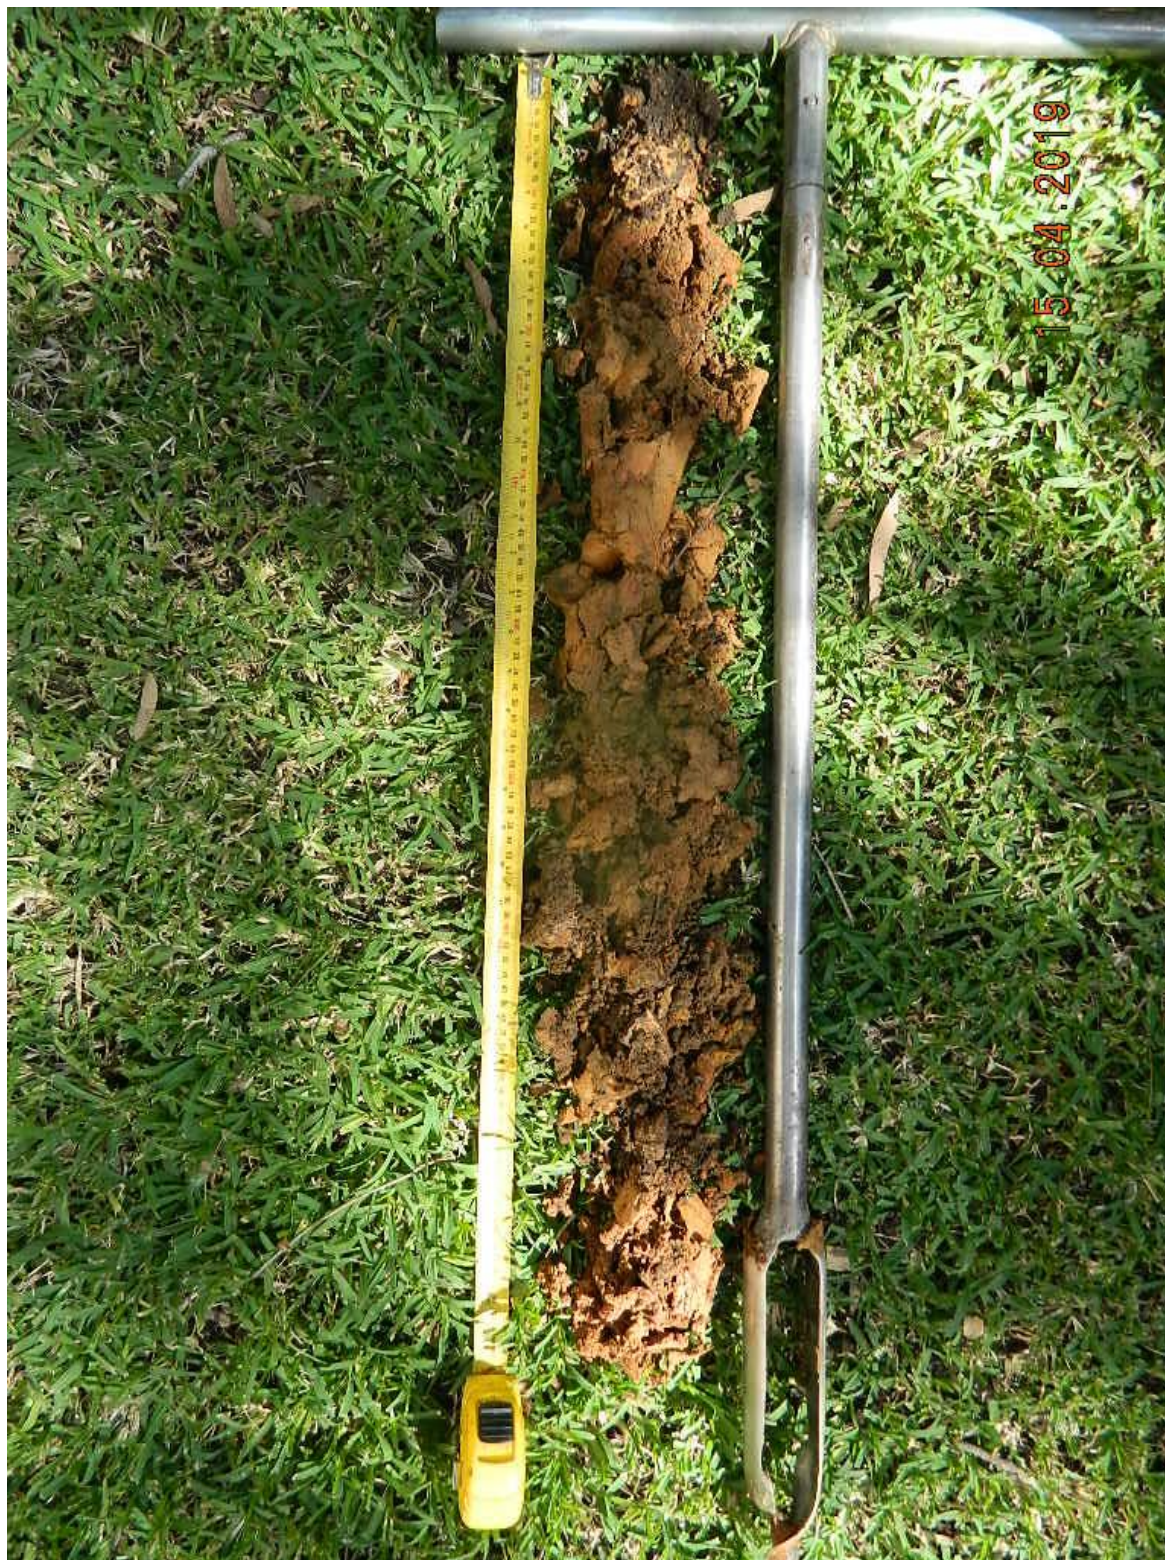
### AUGER HOLE 1 (~RL58.0) – AH1 (Photo 12)

Depth (m)	Material Encountered
0.0 to 0.1	<b>FILL</b> , disturbed sandy soil, brown, loose, roots, organic matter, fine to medium grained, dry.
0.1 to 0.5	<b>FILL</b> , disturbed sandy clay, orange/brown, firm, fine to medium grained, organic matter, dry.
0.5 to 0.9	<b>FILL</b> , disturbed sandy clay, orange with yellow mottling, fine to medium grained, roots, firm to stiff, rock fragments.

End of test @ 0.9m in disturbed sandy clay. No watertable encountered

Photo 12: Auger hole 1, top of hole at top of image.

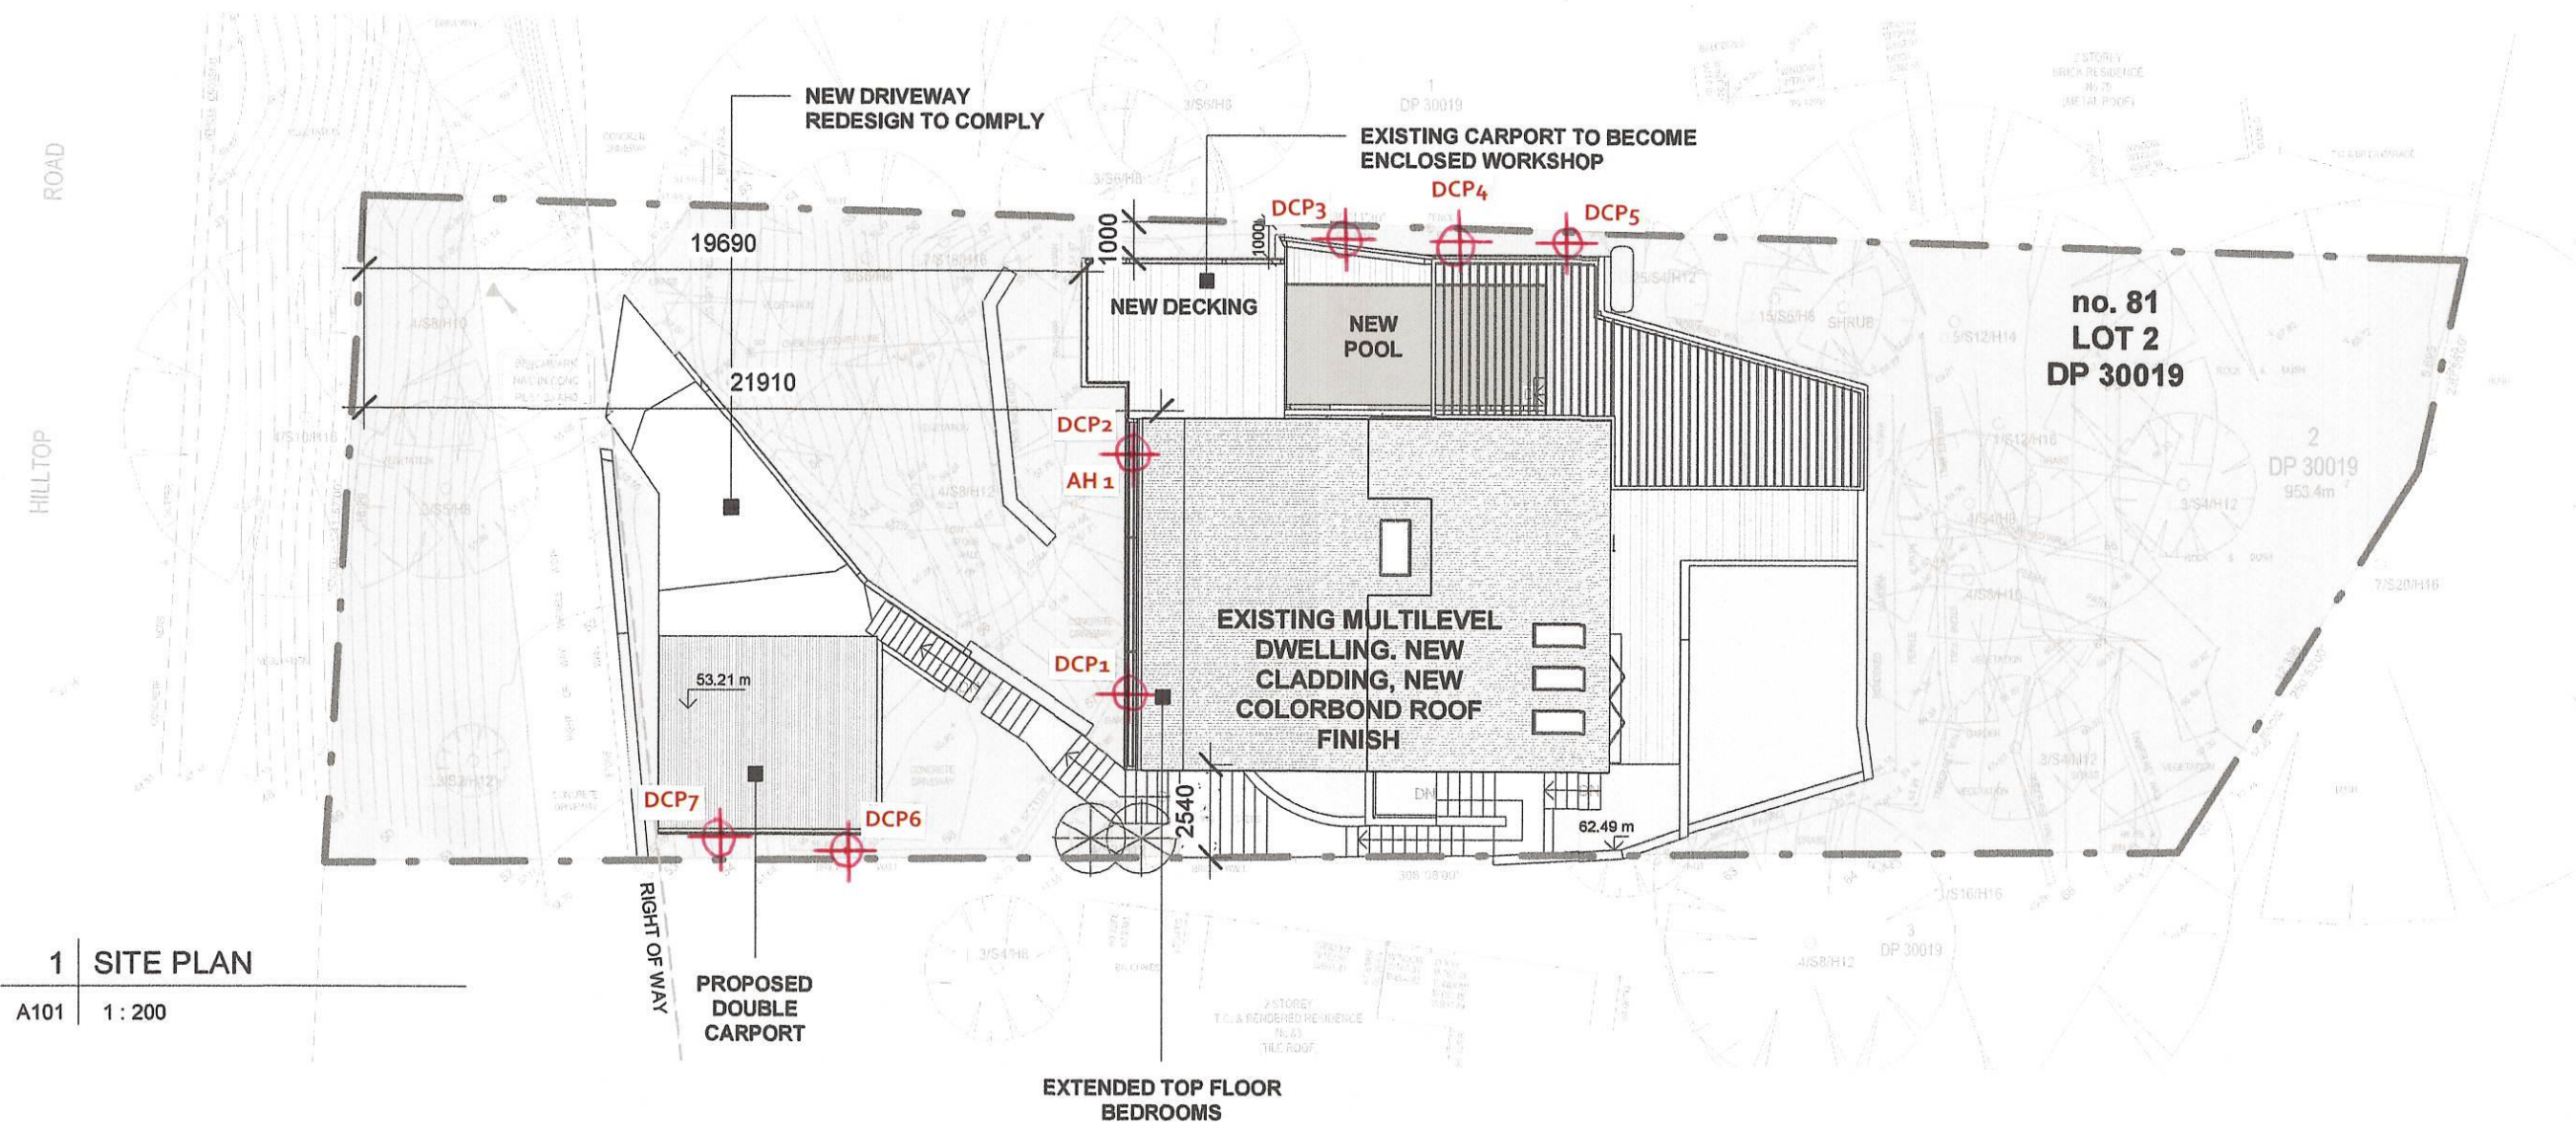
SITE PLAN – showing test locations

One Hand Auger Hole (AH) was put down to identify the ground materials. Seven Dynamic Cone Penetrometer (DCP) tests were put down to determine the relative density of the overlying soil and the depth to weathered rock. The locations of the tests are shown on the site plan. It should be noted that a level of caution should be applied when interpreting DCP test results. The test will not pass through hard buried objects so in some instances it can be difficult to determine whether refusal has occurred on an obstruction in the profile or on the natural rock surface. DCP4 likely refused on an obstruction in the profile. This is not expected to be an issue for the rest of the testing on this site and the results are as follows:

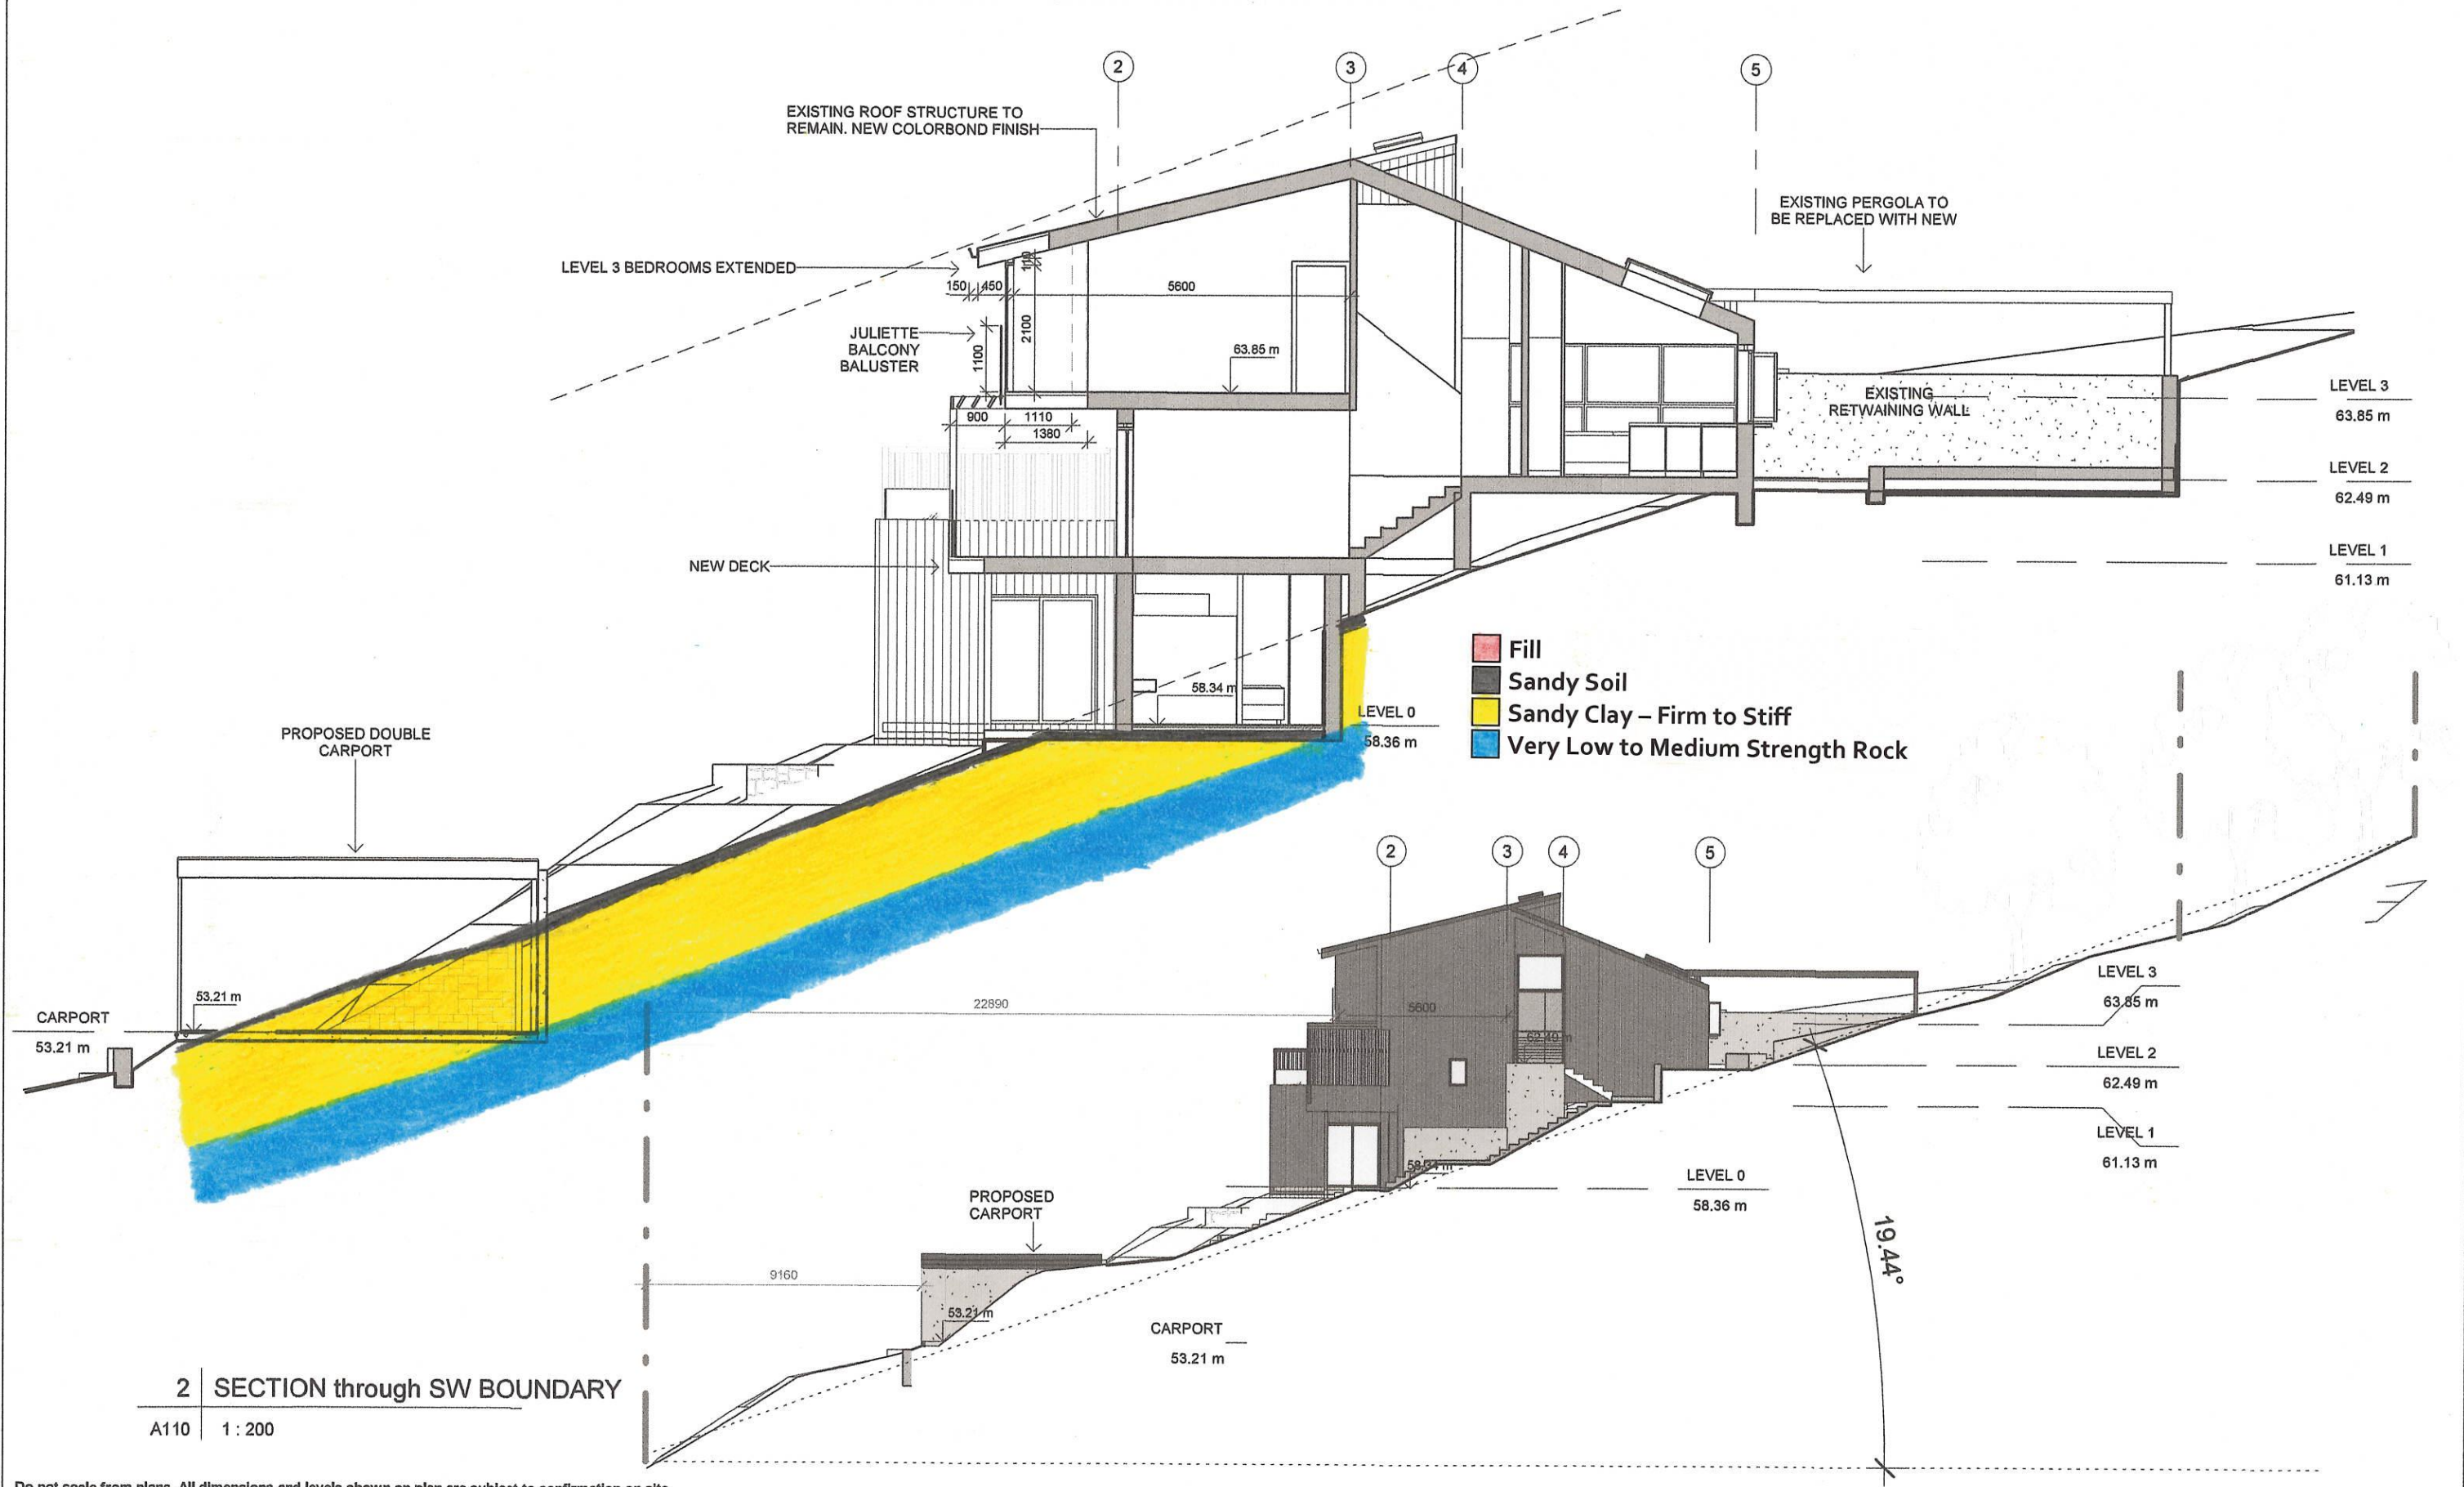
# TYPE SECTION – Diagrammatical Interpretation of expected Ground Materials

The slope materials are colluvial at the near surface and residual at depth. In the test locations, the natural ground materials consist of a thin sandy topsoil over firm to stiff sandy clay. The clay merges into the underlying weathered rock at an average depth of ~1.8m below the current ground surface. The property is cut by the contact between the Narrabeen Group Rocks and Hawksbury Sandstone. The outcropping Sandstone bedrock exposed across the upper portion of the property is indicative of a typical Hawksbury Sandstone derived slope. The tests were all taken through the lower half of the property and either bounced or thudded on refusal. This is indicative of stronger rock than what is typical in a shale-dominated profile and is likely beds of stronger rock or narrow sandstone bands that run through the shale profile on the lower portion of the property. We interpret the underlying rock to be in the range from Very Low Strength to Medium Strength. Filling to a maximum depth of ~1.0m was encountered on the downhill side of the house, pushed forward during the initial excavation and construction of the house. No other significant filling was observed or encountered on the property during the testing on the site. See Type Section attached for a diagrammatical representation of the expected ground materials.
