GEOTECHNICAL INVESTIGATION:

Proposed Pool and Alterations and Additions at **3 Capua Place, Avalon**

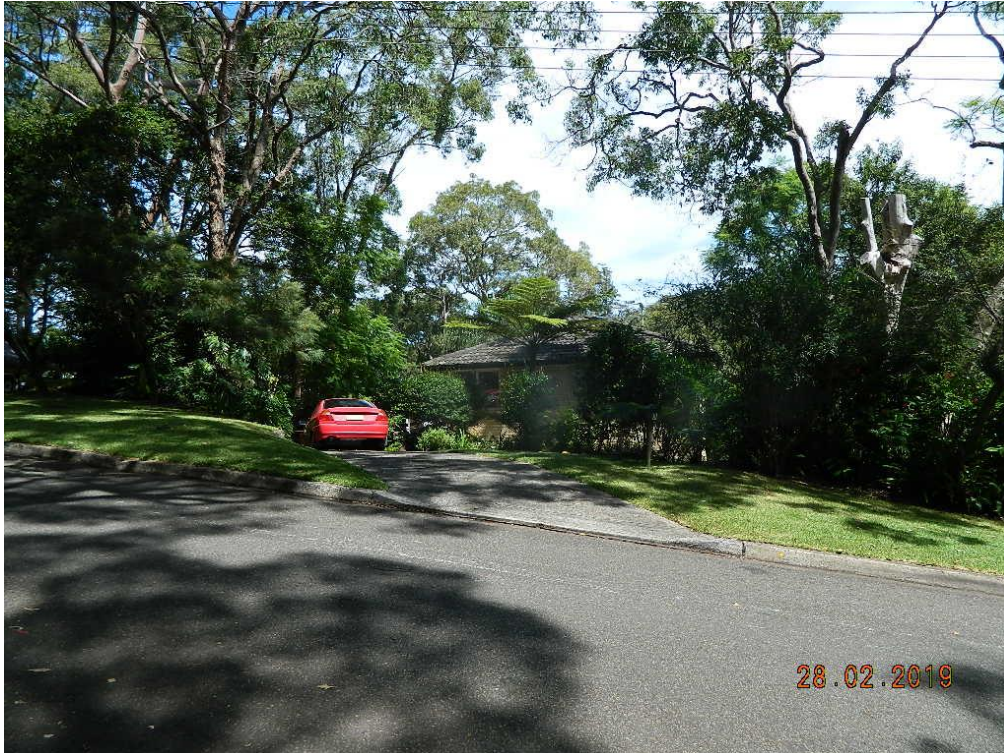
Photo 1

- 2.3** At the road frontage a concrete driveway runs down the slope to a garage under E side of the house (Photo 1 & 2). A series of low stable sandstone block retaining walls and a ~1.2m brick retaining wall terrace the slope above the house (Photo 3). The brick retaining wall displays cracking through the mortar (Photo 4). No significant deflection was observed in the wall and it is currently considered stable. A ~2.5m high excavation has been made to level an area for the house, the excavation runs along a portion of the E side of the driveway. The cut is supported by a brick

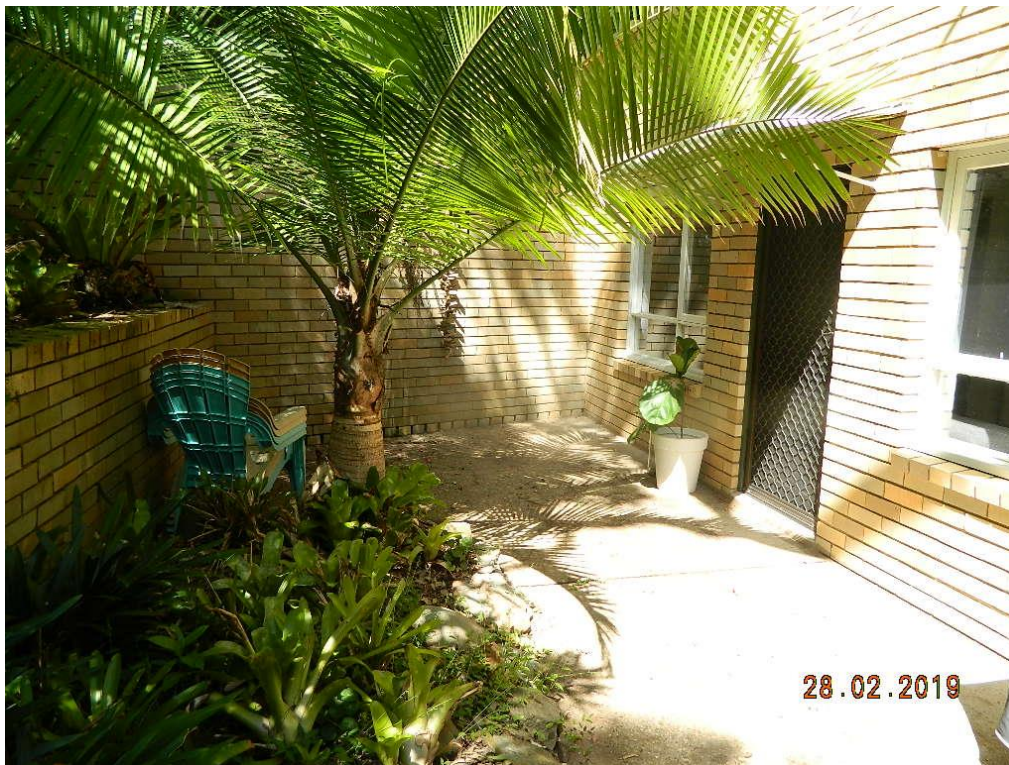
Photo 5

retaining wall (Photo 5). The cracked portion of the wall shows slight deflection downslope but this is limited to the top ~0.5m of the wall (Photo 6). The reason for cracking is unclear but it may have been due to the growth of shrub/tree that has since been removed. See recommendations in **Section 16** for advice. The two storey brick house is supported on brick walls (Photo 7). Cracking was observed in the external supporting walls of the house (Photos 8 & 9). Some of the cracking appears to be related to rusting window lintels. The majority of the cracking appears to be due to uneven settlement of the house. This type of settlement is common in houses with shallow or variable foundations on soil and surface clay. Brick paving and a level lawn area extend from the downhill side of the house (Photo 10). The ground surface around the paving and lawn has settled in places (Photo 11). Stable mortared sandstone block retaining walls reaching a maximum height of ~1.0m terrace the slope below the lawn and paved area (Photo 12). A gently sloping lawn continues from the walls to the lower common boundary (Photos 13 & 14).

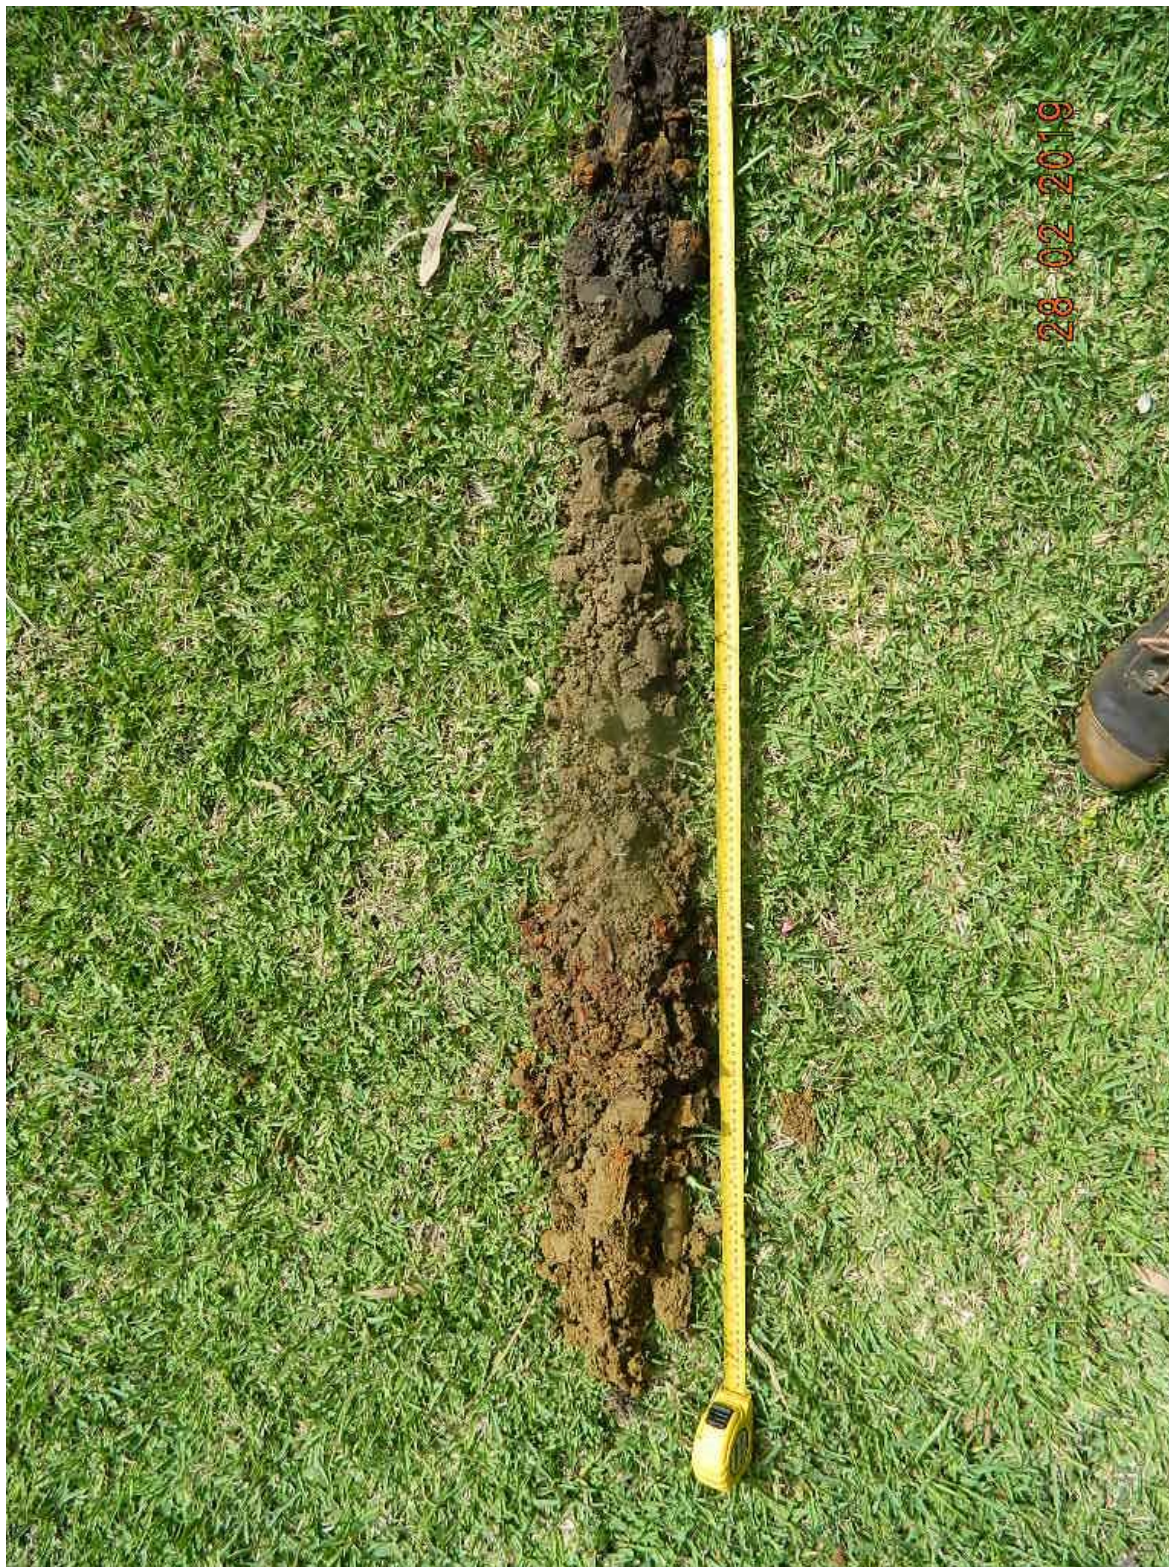
AUGER HOLE 1 (~RL 36.7) – AH1 (Photo 15)

Depth (m)	Material Encountered
0.0 to 0.05	SANDY SOIL , brown, loose, fine to medium grained, organic matter, roots, dry.
0.05 to 0.2	SANDY CLAY , orange and brown, firm, fine to medium grained, dry.
0.2 to 0.7	SILTY SAND , light brown to medium tan, loose, fine to medium grained, damp.
0.7 to 1.0	SANDY CLAY , light brown, orange mottling, firm, fine to medium grained, damp.
1.0 to 1.3	SANDY CLAY , orange and brown, firm, fine to medium grained, slightly damp.

End of Hole @ 1.3m in sandy clay. No watertable encountered

Photo 15: Auger Hole 1: Base of image is base of hole.
