# Geotechnical Assessment

**Project:** Alterations & Additions  
37 Lanford Avenue, Killarney Heights NSW

**Ref:** AG 25117  
24 March 2025

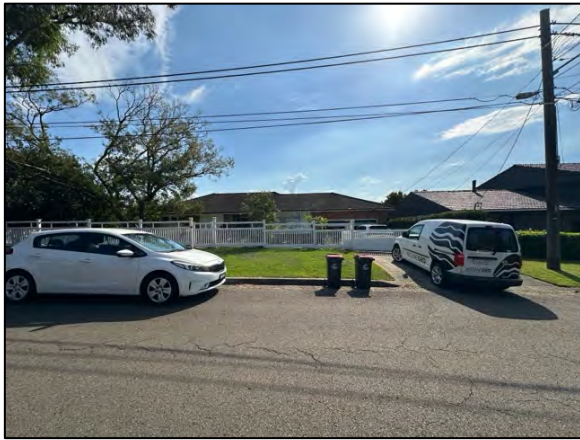
**Photo 1:** Site frontage, looking west.

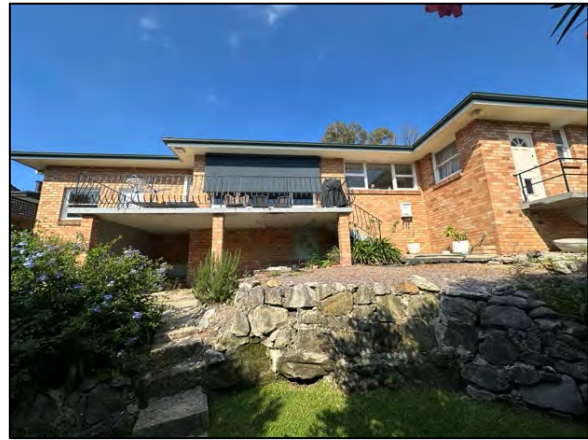
**Photo 2:** Photo taken from western (rear) boundary, looking east.

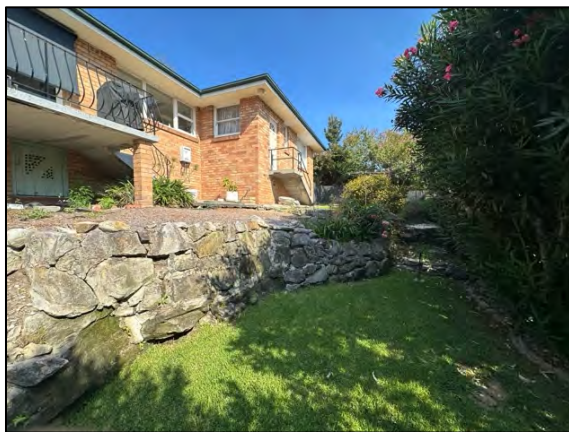
The existing building at the site is a single-storey brick dwelling with a grassed front yard and grassed terrace backyard area. Minor consolidation of uncontrolled topsoil material was observed in the vegetated area of the rear yard (See appendix D, Image 3). Neighbouring buildings are mostly single and double storey dwellings.

**Photo 3:** Photo taken from northwestern boundary, looking south.

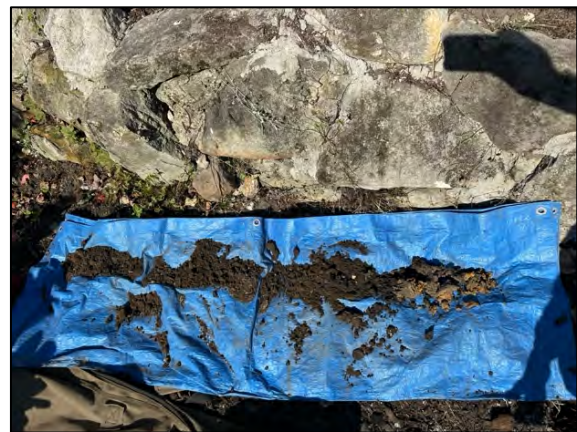
**Photo 4:** Subsurface soil profile of BH01.
