141 Riverview Road, Avalon

Comments on updates to Plans

GEOTECHNICAL INVESTIGATION:

New House at 141 Riverview Road, Avalon

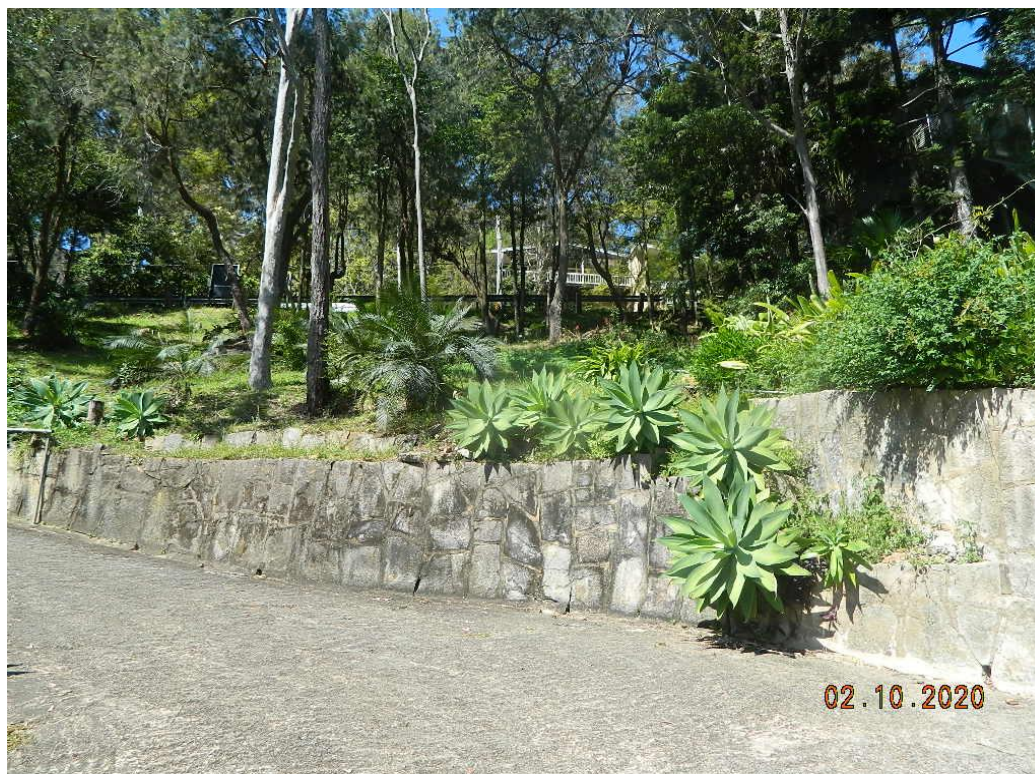
Photo 4

sandstone flagging retaining wall supports the cut batter for the neighbouring concrete driveway (photo 4). The surface of the slope is lawn covered and has a scattering of shrubs and mature gums. No significant signs of movement were observed on the block.

No geotechnical hazards were observed beside the property. The steeply graded land surface that falls across the property and continues above and below is a potential hazard (**Hazard One**). The proposed excavations are a potential hazard until retaining structures are in place (**Hazard Two**). The vibrations from the proposed excavations are a potential hazard (**Hazard Three**). The additional surcharge loads from the proposed house and terrace are a potential hazard to the existing sandstone flagging retaining wall (Photo 4) (**Hazard Four**).

Fill will be placed for landscaping purposes on the downhill side of the proposed house. The proposed fill is located above an existing sandstone flagging retaining supporting the cut for the right of carriageway below (Photo 4 in the original report). The sandstone flagging retaining wall is to be demolished from the top down prior to the filling commencing. The soil and clay immediately behind the wall is to be battered at 1.0 Vertical to 1.7 Horizontal (30°) as the wall is lowered and demolished.

The piers on the downhill edge of the house/terrace near the existing sandstone flagging retaining wall (Photo 4) are to be taken to beyond the zone of influence of the wall. Provided this occurs no additional loads will be transferred onto the existing retaining wall. In the instance the zone of influence is the area above a theoretical 45° line extending from the base of the wall towards the piered foundation.

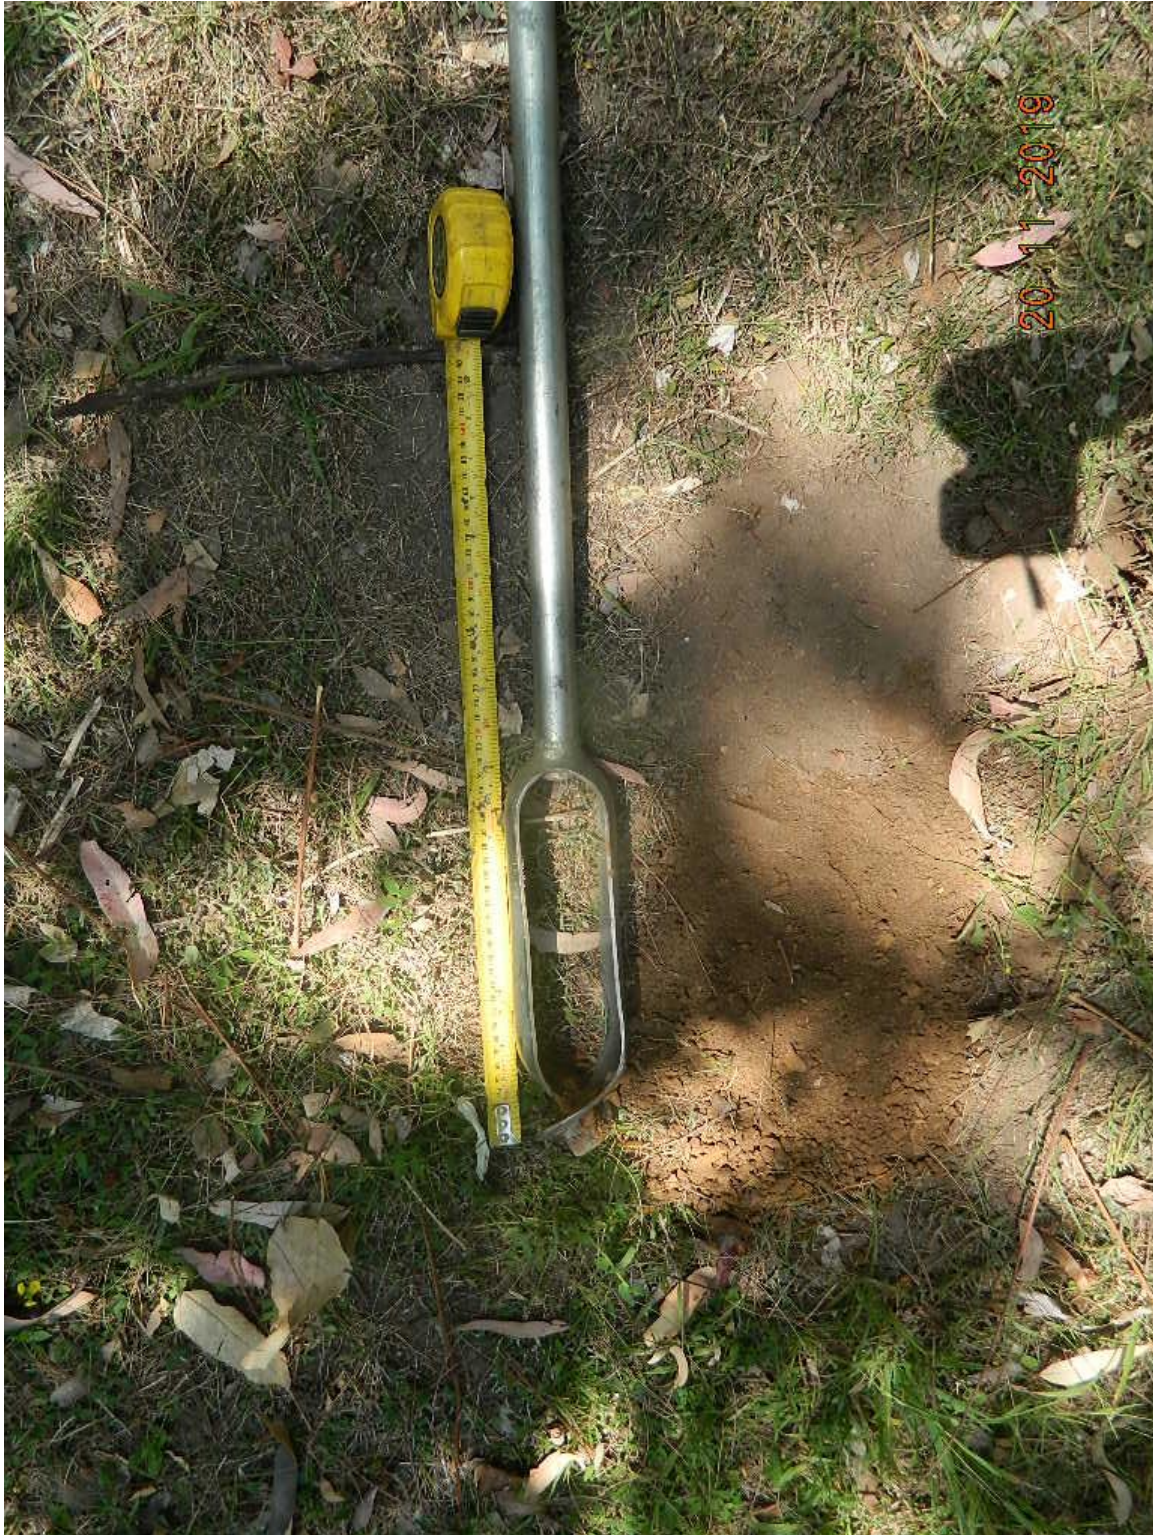
AUGER HOLE 1 (~RL35.8) – AH1 (photo 5)

Depth (m)	Material Encountered
0.0 to 0.2	SANDY SOIL , brown, fine to medium grained, dry.
0.2 to 0.5	SANDY CLAY , brown, firm, dry.

End of hole @ 0.5m in Sandy Clay. No water table encountered.

Photo 5: AH1 – Downhole is from top to bottom.

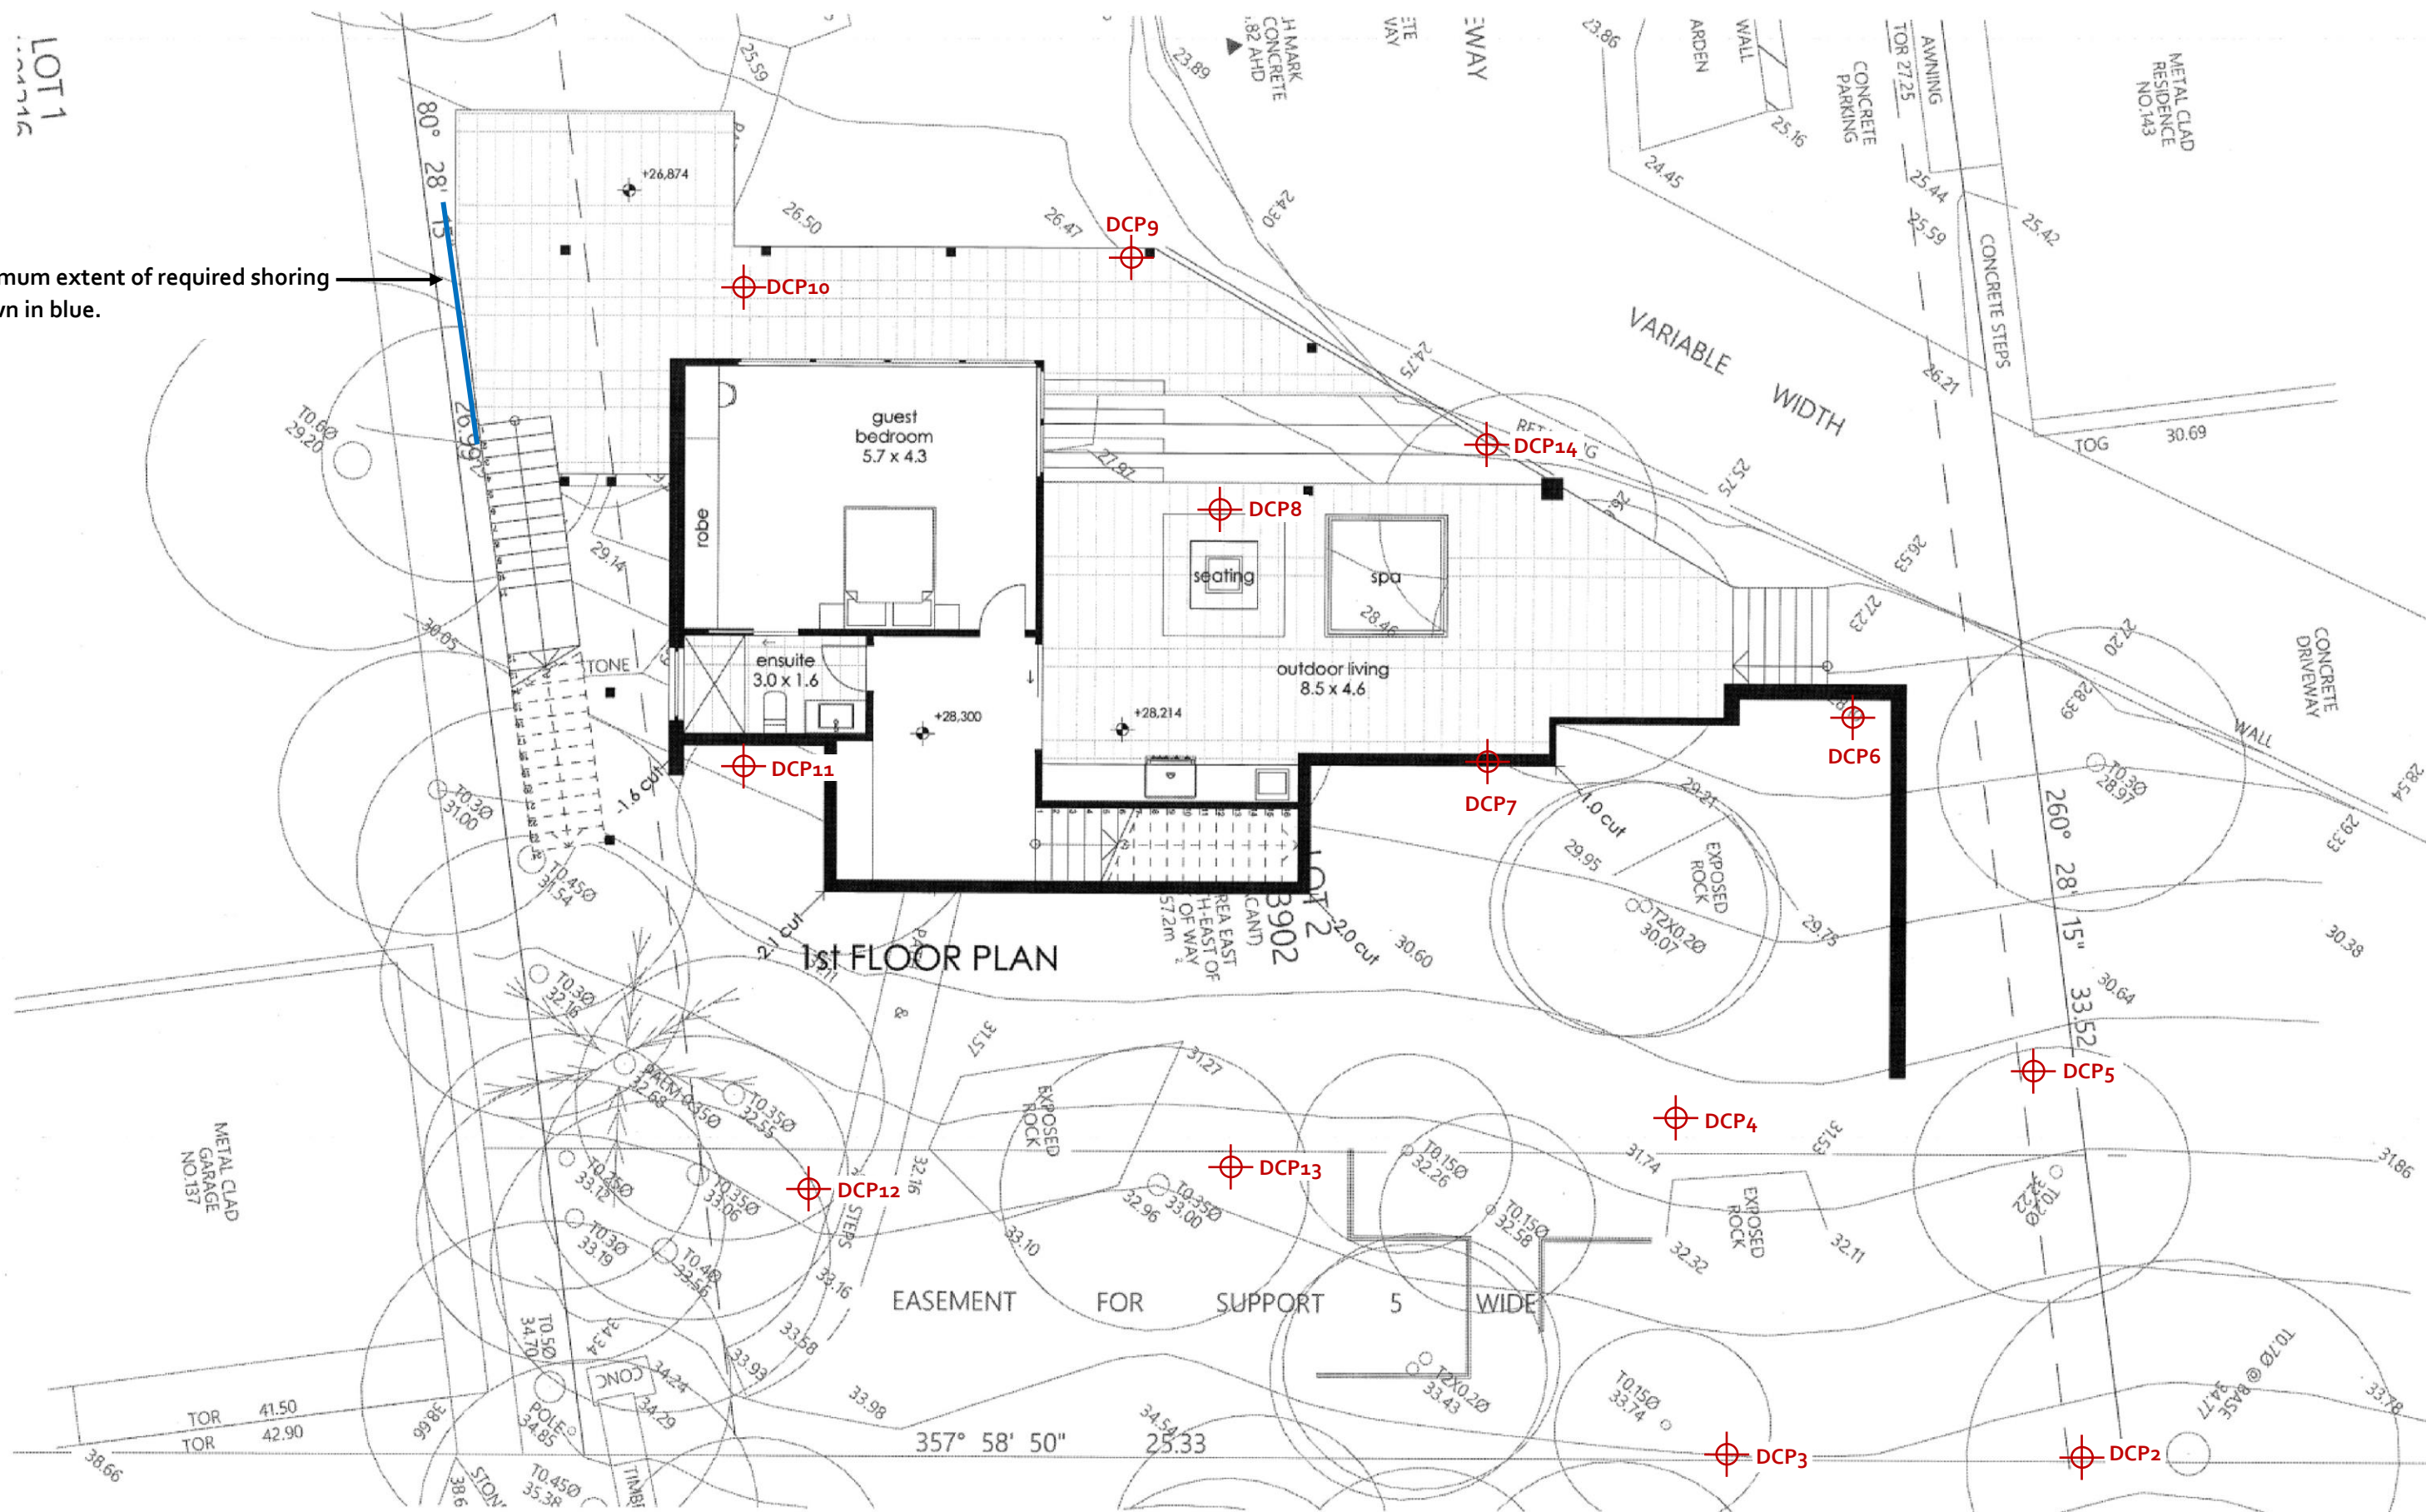
SITE PLAN – showing test locations

The S cut for the terrace excavation is to be permanently or temporarily supported before the excavation through Medium Strength Rock commences. The support is to be installed systematically as the excavation progresses to ensure the integrity of the neighbouring property. If the support is temporary, it is to remain in place until the retaining wall is built as a sacrificial-type system. See the site plan attached for the minimum required extent of the shoring shown in blue.

Minimum extent of required shoring shown in blue.

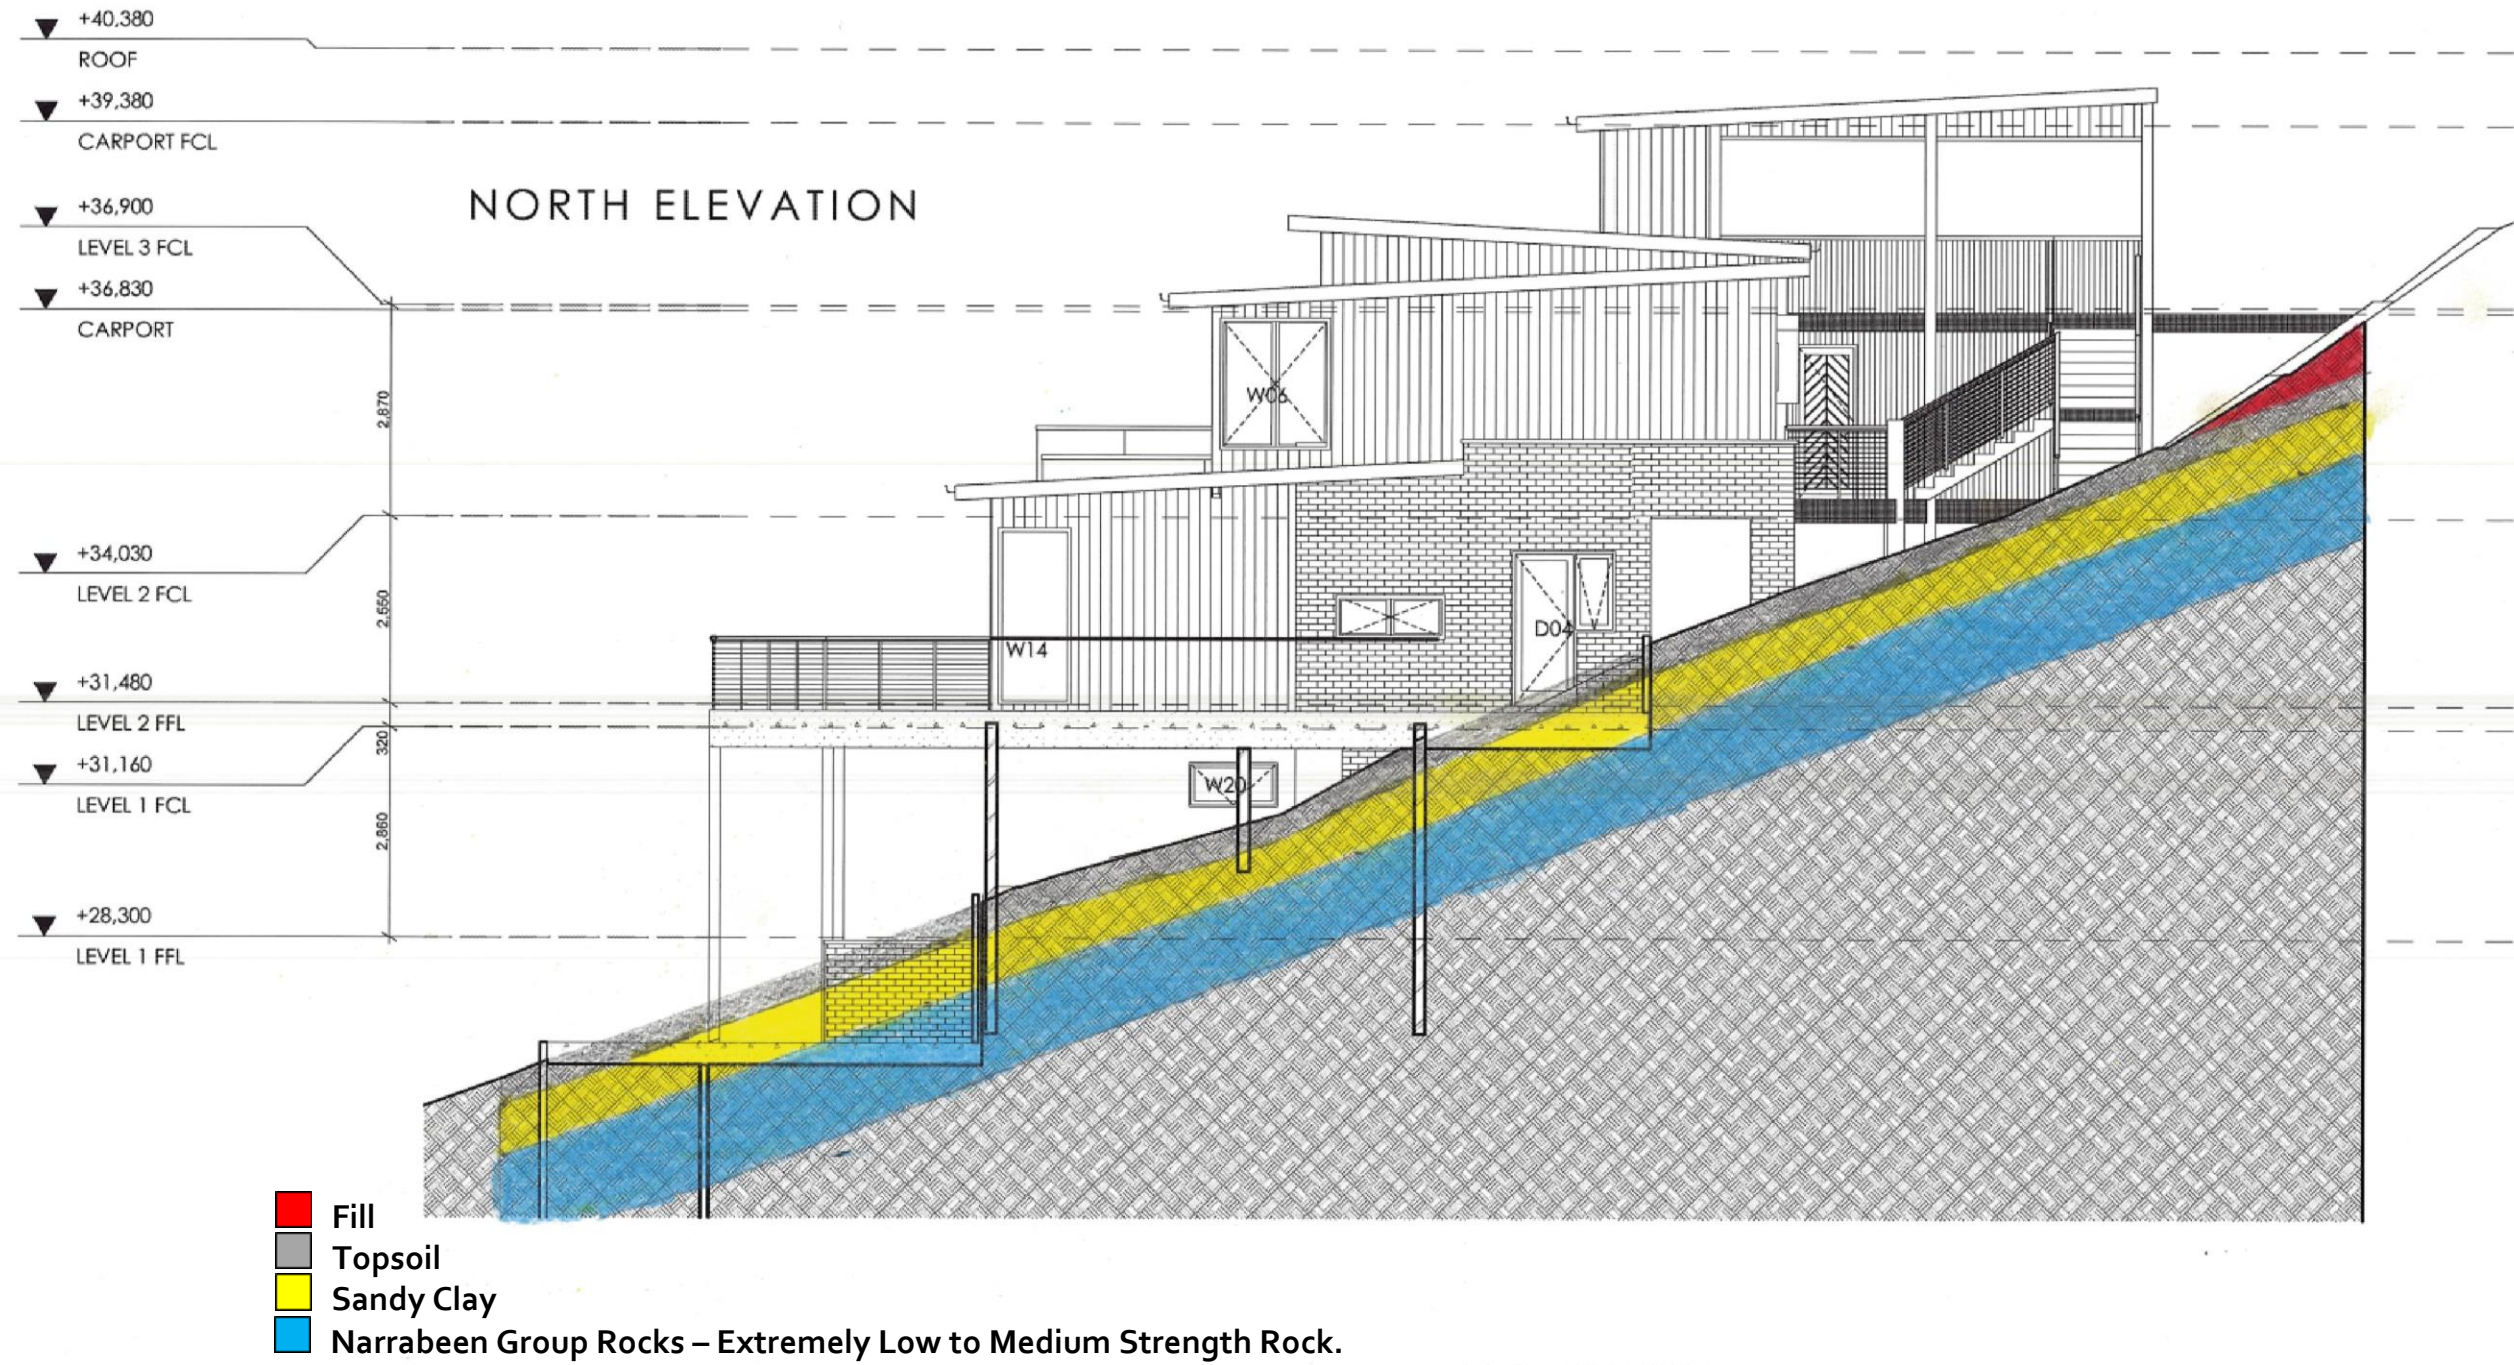
TYPE SECTION – Diagrammatic Interpretation of expected Ground Materials

The slope materials are colluvial at the near surface and residual at depth. In the test locations, the ground materials consist of a sandy topsoil over sandy clays. The clays merge into the underlying weathered rock at a maximum depth of ~1.7m below the current surface. The weathered rock is interpreted to be variable ranging from Extremely Low to Medium Strength Rock or better and it appears the majority of the proposed house will be underlain by sandstone and that shale is present from the uphill side of the proposed house to the street. The exact extent of the sandstone will only be known once the footing excavations are carried out. See Type Section attached for a diagrammatical representation of the expected ground materials.
