REPORT ON GEOTECHNICAL ASSESSMENT

PROPOSED SUBDIVISION and DEVELOPMENT

2 WYADRA AVENUE, CURL CURL

Project: 2020-229

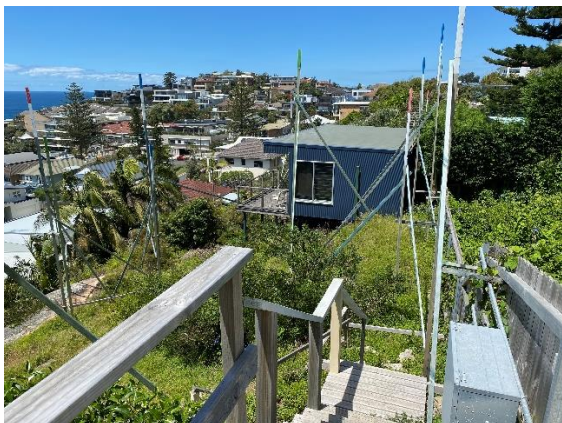
View of site (No. 2) from access driveway

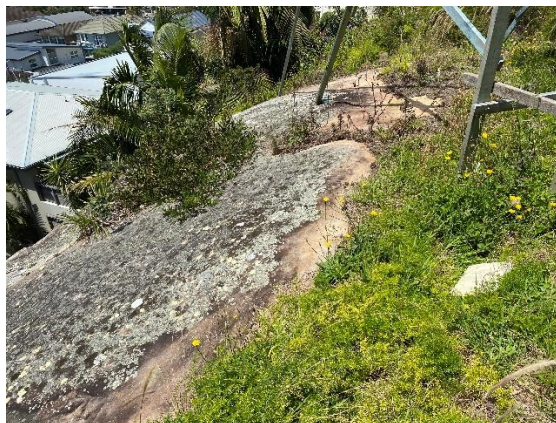
Outcrop along eastern side of block

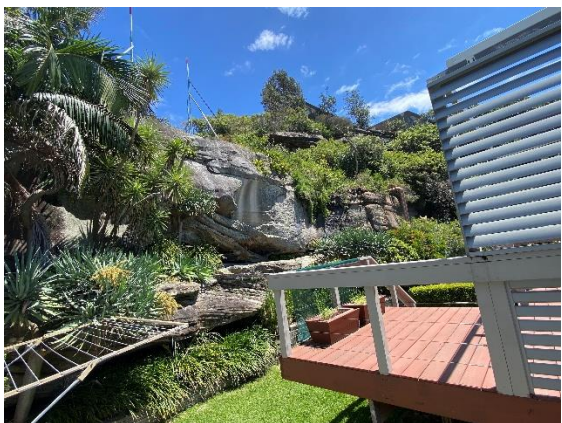
The cliff is up to 8.0m in height and formed through generally massive sandstone with few bedding or joint defects in the upper portion and with more bedding defects in the lower 3.0m. An undercut is formed at the base of the upper cliff, that extends up to 4.0m laterally into the cliff face towards the east. Some spalling at face of the cliff has also separated some small sections of rock.

Rear of No. 16 showing cliff line at rear of No. 2

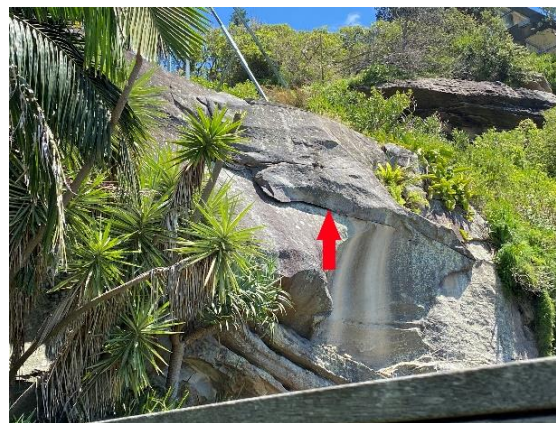
Spalling and fractured rock near cliff crest.

The spalling within the cliff crest adjacent to No. 16 has deteriorated since the previous inspection and it is now recommended that this section of rock be removed prior to its natural failure. This is likely to require rope access and should also be undertaken by an experienced contractor. It is recommended that the area below the spalled section of rock be cordoned off to prevent access until this section of rock is removed.

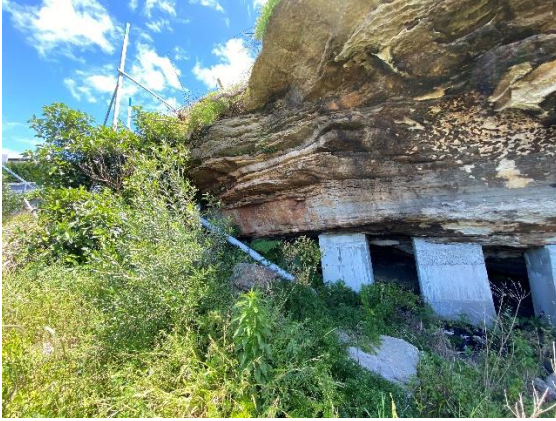
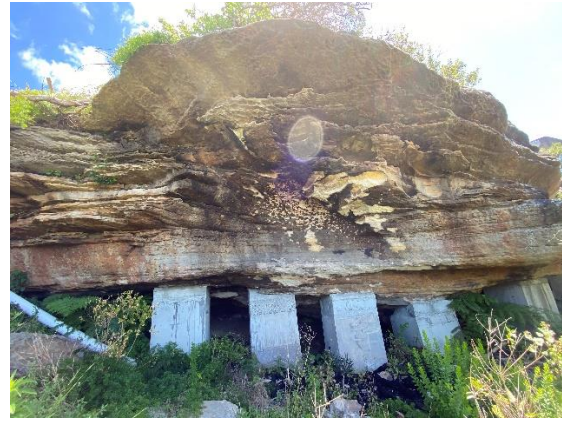
At the rear north-west corner of the property there is another 4.0 to 5.0m high cliff line that extends from the northern neighbouring property to the site's north-west corner. This cliff contains a large overhang in the corner of the site which has been previously underpinned via several large mass concrete underpinning

Outcrop cliff and underpinning at north-wets corner of No. 2

The outcrop to the north-west of the site has been underpinned where it is undercut and is considered stable. The large sandstone cliff that extends across the rear edge of the site and extends through No. 14 to the south appears generally stable. However, the depression as seen to the rear of the outcrop in No. 2 along with the increased undercut dimension as seen from No. 14 warrant the installation of support systems to ensure long term stability. This could be undertaken following a more detailed geotechnical inspection/investigation via the installation of a blade wall along the boundary alignment between No. 14 and No. 16 or via two separate underpinning blocks, as seen within the overhang in the north-west corner of the site. This work should be engineer designed and installed by an experienced contractor.

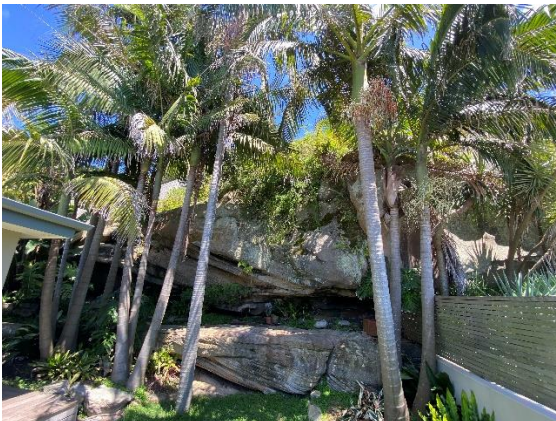
Cliff to rear of No. 14

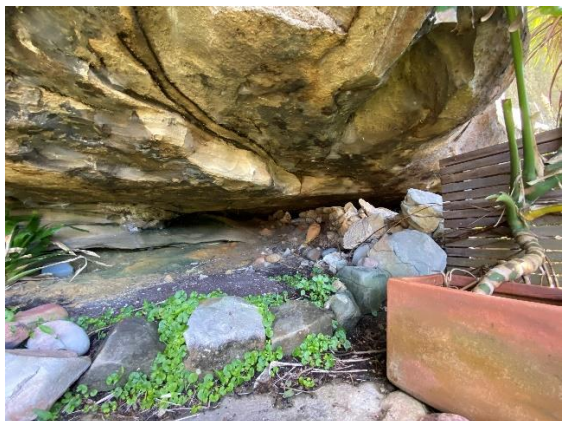
Undercut below cliff face as viewed from No. 14

Whilst the risk assessment identified some of the risk levels as being marginally 'Acceptable' when compared to the AGS criteria, it is recommended that an underpinning system be implemented to the overhang based on future detailed geotechnical inspection whilst the spalled section/s of rock on the cliff face adjacent to No. 16 should be removed as soon as possible. Provided this occurs and the excavation/construction inspections detailed within this report the risk from all hazards will be well within the 'Acceptable' risk level for the life span of the proposed development, taken as 100 years.
