## **Lot 1, 7 Trentwood Park, Avalon**

Comments on updates to Plans for House

## **GEOTECHNICAL INVESTIGATION:**

New Subdivision and Two New Houses at **7 Trentwood Park, Avalon.**

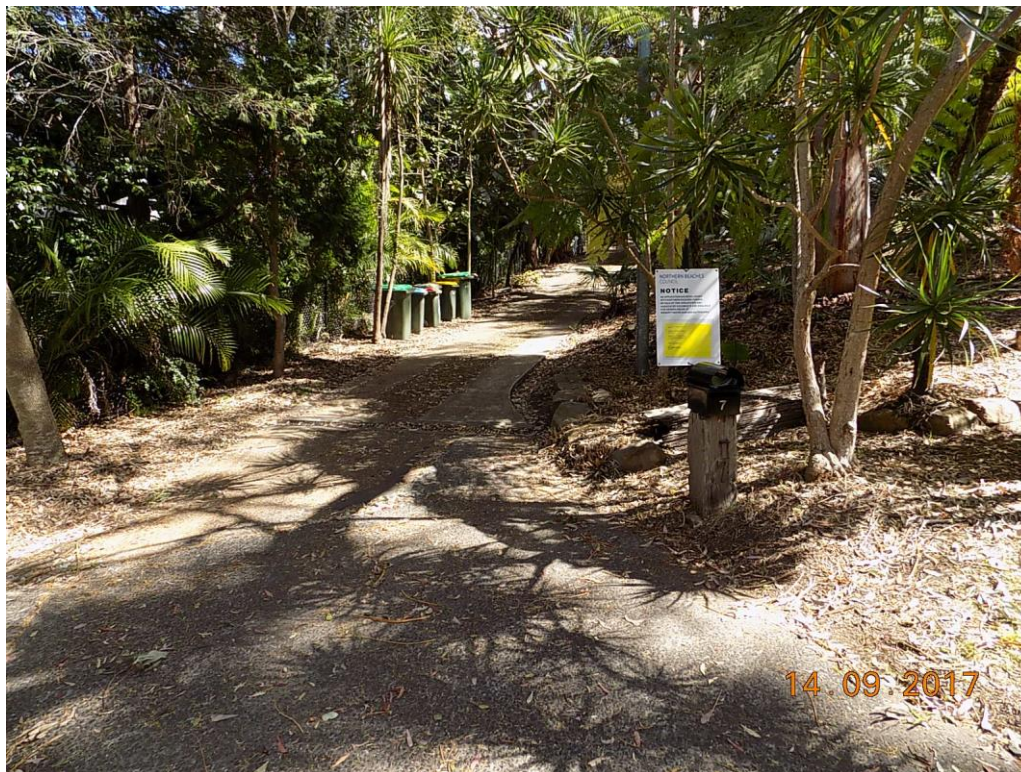
Photo 1

- 2.3** At the road frontage, a concrete driveway runs up the slope to a brick garage and brick-paved parking area on the S side of the house (Photos 1 & 2). The garage will be demolished as part of the proposed works. The driveway diverts to a lawn-covered parking area below the brick-paved parking area (Photo 3). The fill for the lawn-covered parking area is battered to stable angles and merges into the natural slope (Photo 4). Between the road frontage and the lawn-covered parking area, the slope is sparsely vegetated with native trees (Photo 5). The part two-storey timber framed and clad house will remain unchanged as part of the proposed works (Photo 6). An excavation has been made in the slope for the lower ground floor of the house. The cut was made through a

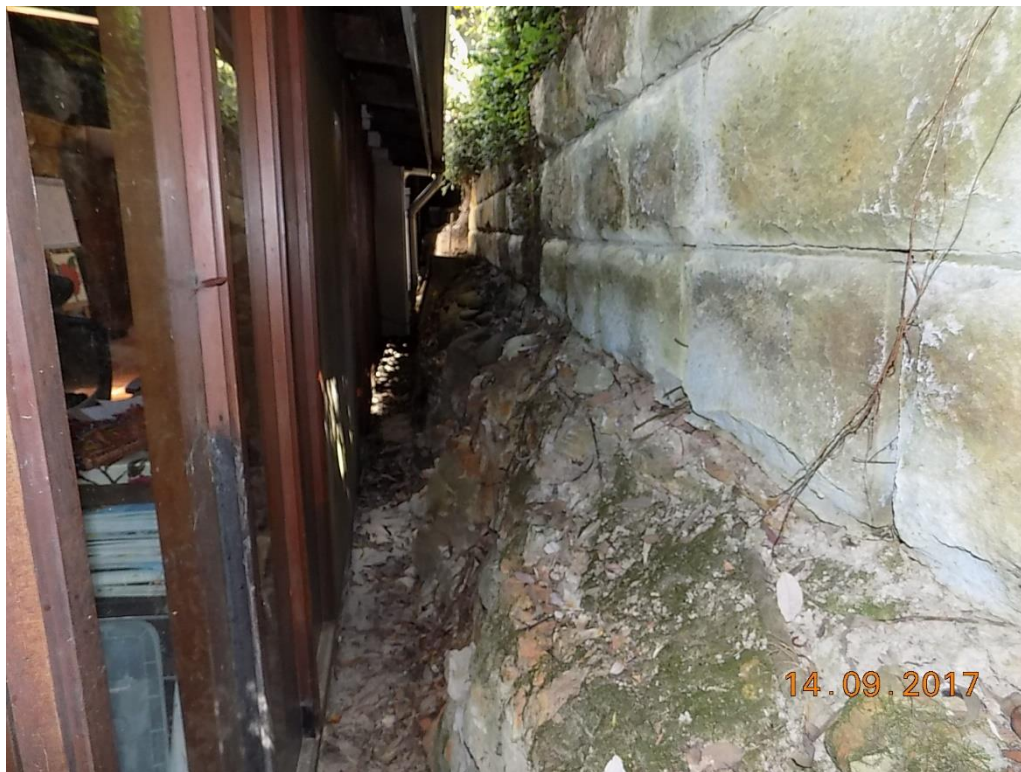
Photo 7

band of medium-strength sandstone (Photo 7). A fill has been placed on the slope above the cut for a level paved area. The fill is supported by a ~1.2m high stable sandstone block retaining wall that is supported directly off the exposed sandstone band. Another excavation has been made in the slope for the upper ground floor. The cut batter is well-vegetated and battered to stable angles. The slope that rises above the house to the upper boundary has been cleared of most of its vegetation (Photo 8).

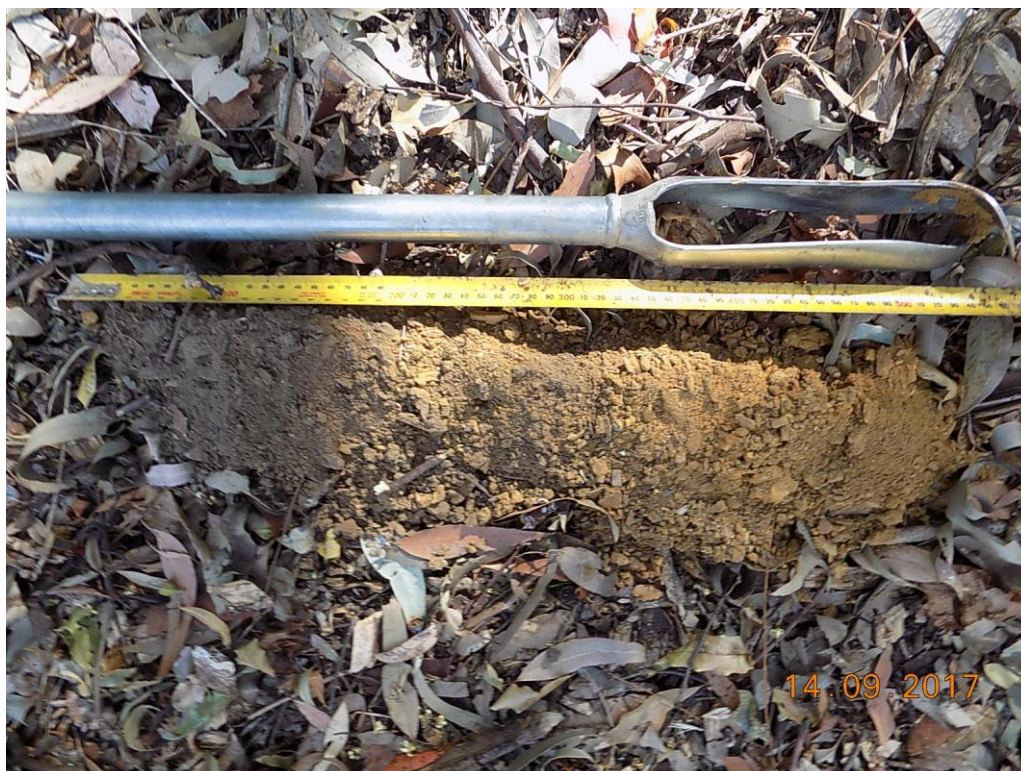
#### AUGER HOLE 1 (~RL46.1) – AH1 (Photo 9)

Depth (m)	Material Encountered
0.0 to 0.3	<b>TOPSOIL</b> , sandy soil, brown-grey, fine to medium grained with fine trace organic matter and trace silt.
0.3 to 0.6	<b>CLAY</b> , orange-brown, firm to stiff, fine grained.

End of hole @ 0.6m in firm to stiff clay. No watertable encountered.

Photo 9: AH1 – Downhole is from left to right.

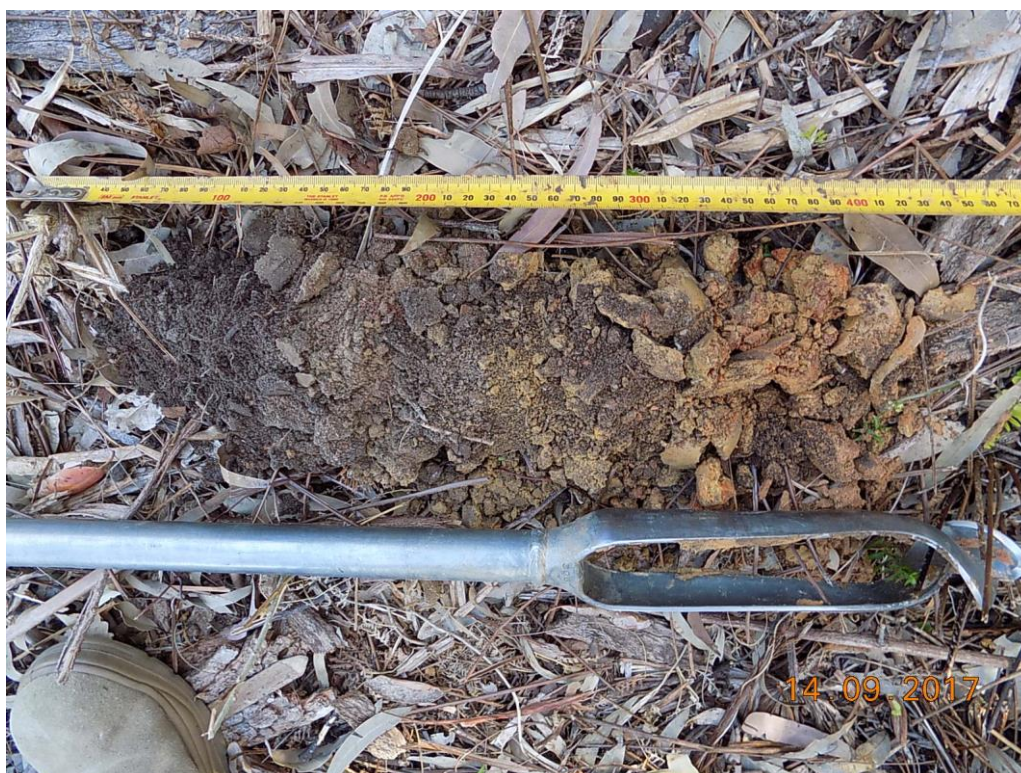
## AUGER HOLE 2 (~RL69.8) – AH2 (Photo 10)

Depth (m)	Material Encountered
0.0 to 0.2	<b>TOPSOIL</b> , sandy soil, brown to dark brown, fine to medium grained with fine trace organic matter.
0.2 to 0.5	<b>CLAY</b> , weathered shale, orange-brown with mottled maroon, stiff, fine grained.

End of hole @ 0.5m in weathered shale. No watertable encountered.

Photo 10: AH2 – Downhole is from left to right.
