## **GEOTECHNICAL INVESTIGATION:**

Alterations and Additions and New Pool at **34 Beatty Street, Balgowlah**

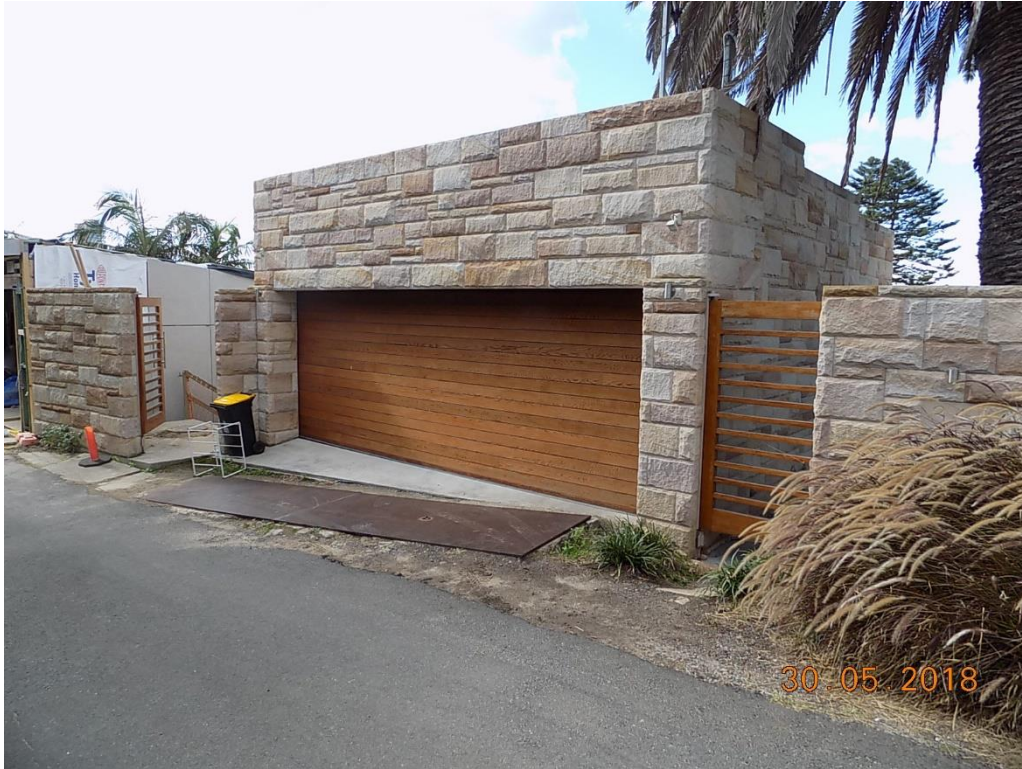
Photo 1

**2.3** The property is accessed by a Right of Carriageway (ROW) that diverts off Beatty Street. A stable brick and concrete block garage and studio extends off the ROW (Photo 1). The garage and studio are supported off vertical concrete piers. Some of the piers were observed to be supported directly onto outcropping competent Medium Strength Sandstone. A sandstone rock face ~3.1m high steps down the slope below the garage. The rock face is undercut to ~1.2m at its N end (Photo 2). The cantilever arm of the undercut rock does not show any jointing or cracking as viewed from above and below. Thus, the rock is currently considered stable. The slope under the garage and surrounding the rock face has been sealed/stabilised in the past with sprayed concrete (Photo 3). The moderate slope between the rock face and the uphill side of the house is well vegetated and terraced with a series of stack rock retaining walls that will be demolished as part of the proposed works (Photos 4 & 5). An excavation has been made on the uphill side of the house for a tile-paved patio area and for the inclined lift's lower stop (Photo 6). The excavation is supported by a stable sandstone block retaining wall reaching ~2.5m high. The two-storey brick house is supported on brick walls (Photo 7). No significant signs of movement were observed in its external supporting brick walls. A stone-paved patio area extends off the downhill side of the house to the lower boundary (Photo 8). Below the lower boundary is a gently sloping lawn reserve that falls to Forty Baskets Beach (Photo 9). A concrete-lined stormwater easement runs down the S boundary of the property and then into the ground at the beach reserve (Photo 10).

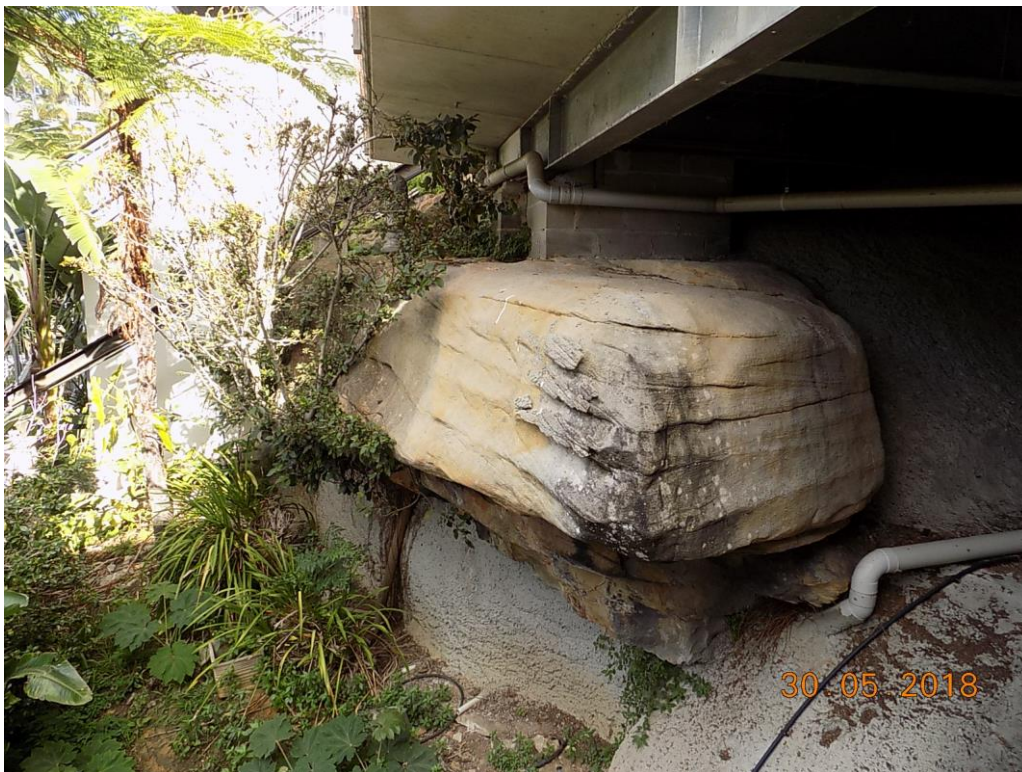
Photo 2

The excavation for the proposed lift and lift access will be taken above and through an undercut outcrop of Medium Strength Sandstone (Photo 2). The undercut portions of the outcrop will remain on either side of the excavation. Thus, prior to the excavation commencing, the remaining undercut portions of rock are to be supported with blade walls or a similar suitable support designed by the structural engineer in consultation with the geotechnical consultant.
