GEOTECHNICAL RISK MANAGEMENT POLICY FOR PITTWATER
FORM NO. 1 – To be submitted with Development Application

Address of site 4 Forest Road, Warriewood NSW 2102

Willows Engineering Drawings No. 2122010-SK1 (plan), SK2 (section) and SK3 (hazards)

Project:	Geotechnical Report for Proposed Residential Subdivision	Drawing No. 2122010-SK2
Location:	4 Forest Road, Warriewood NSW 2102	Date: 9/12/2022
Client:	BMN Properties Pty Ltd	Report No. 2122010-R1 (Rev 01)

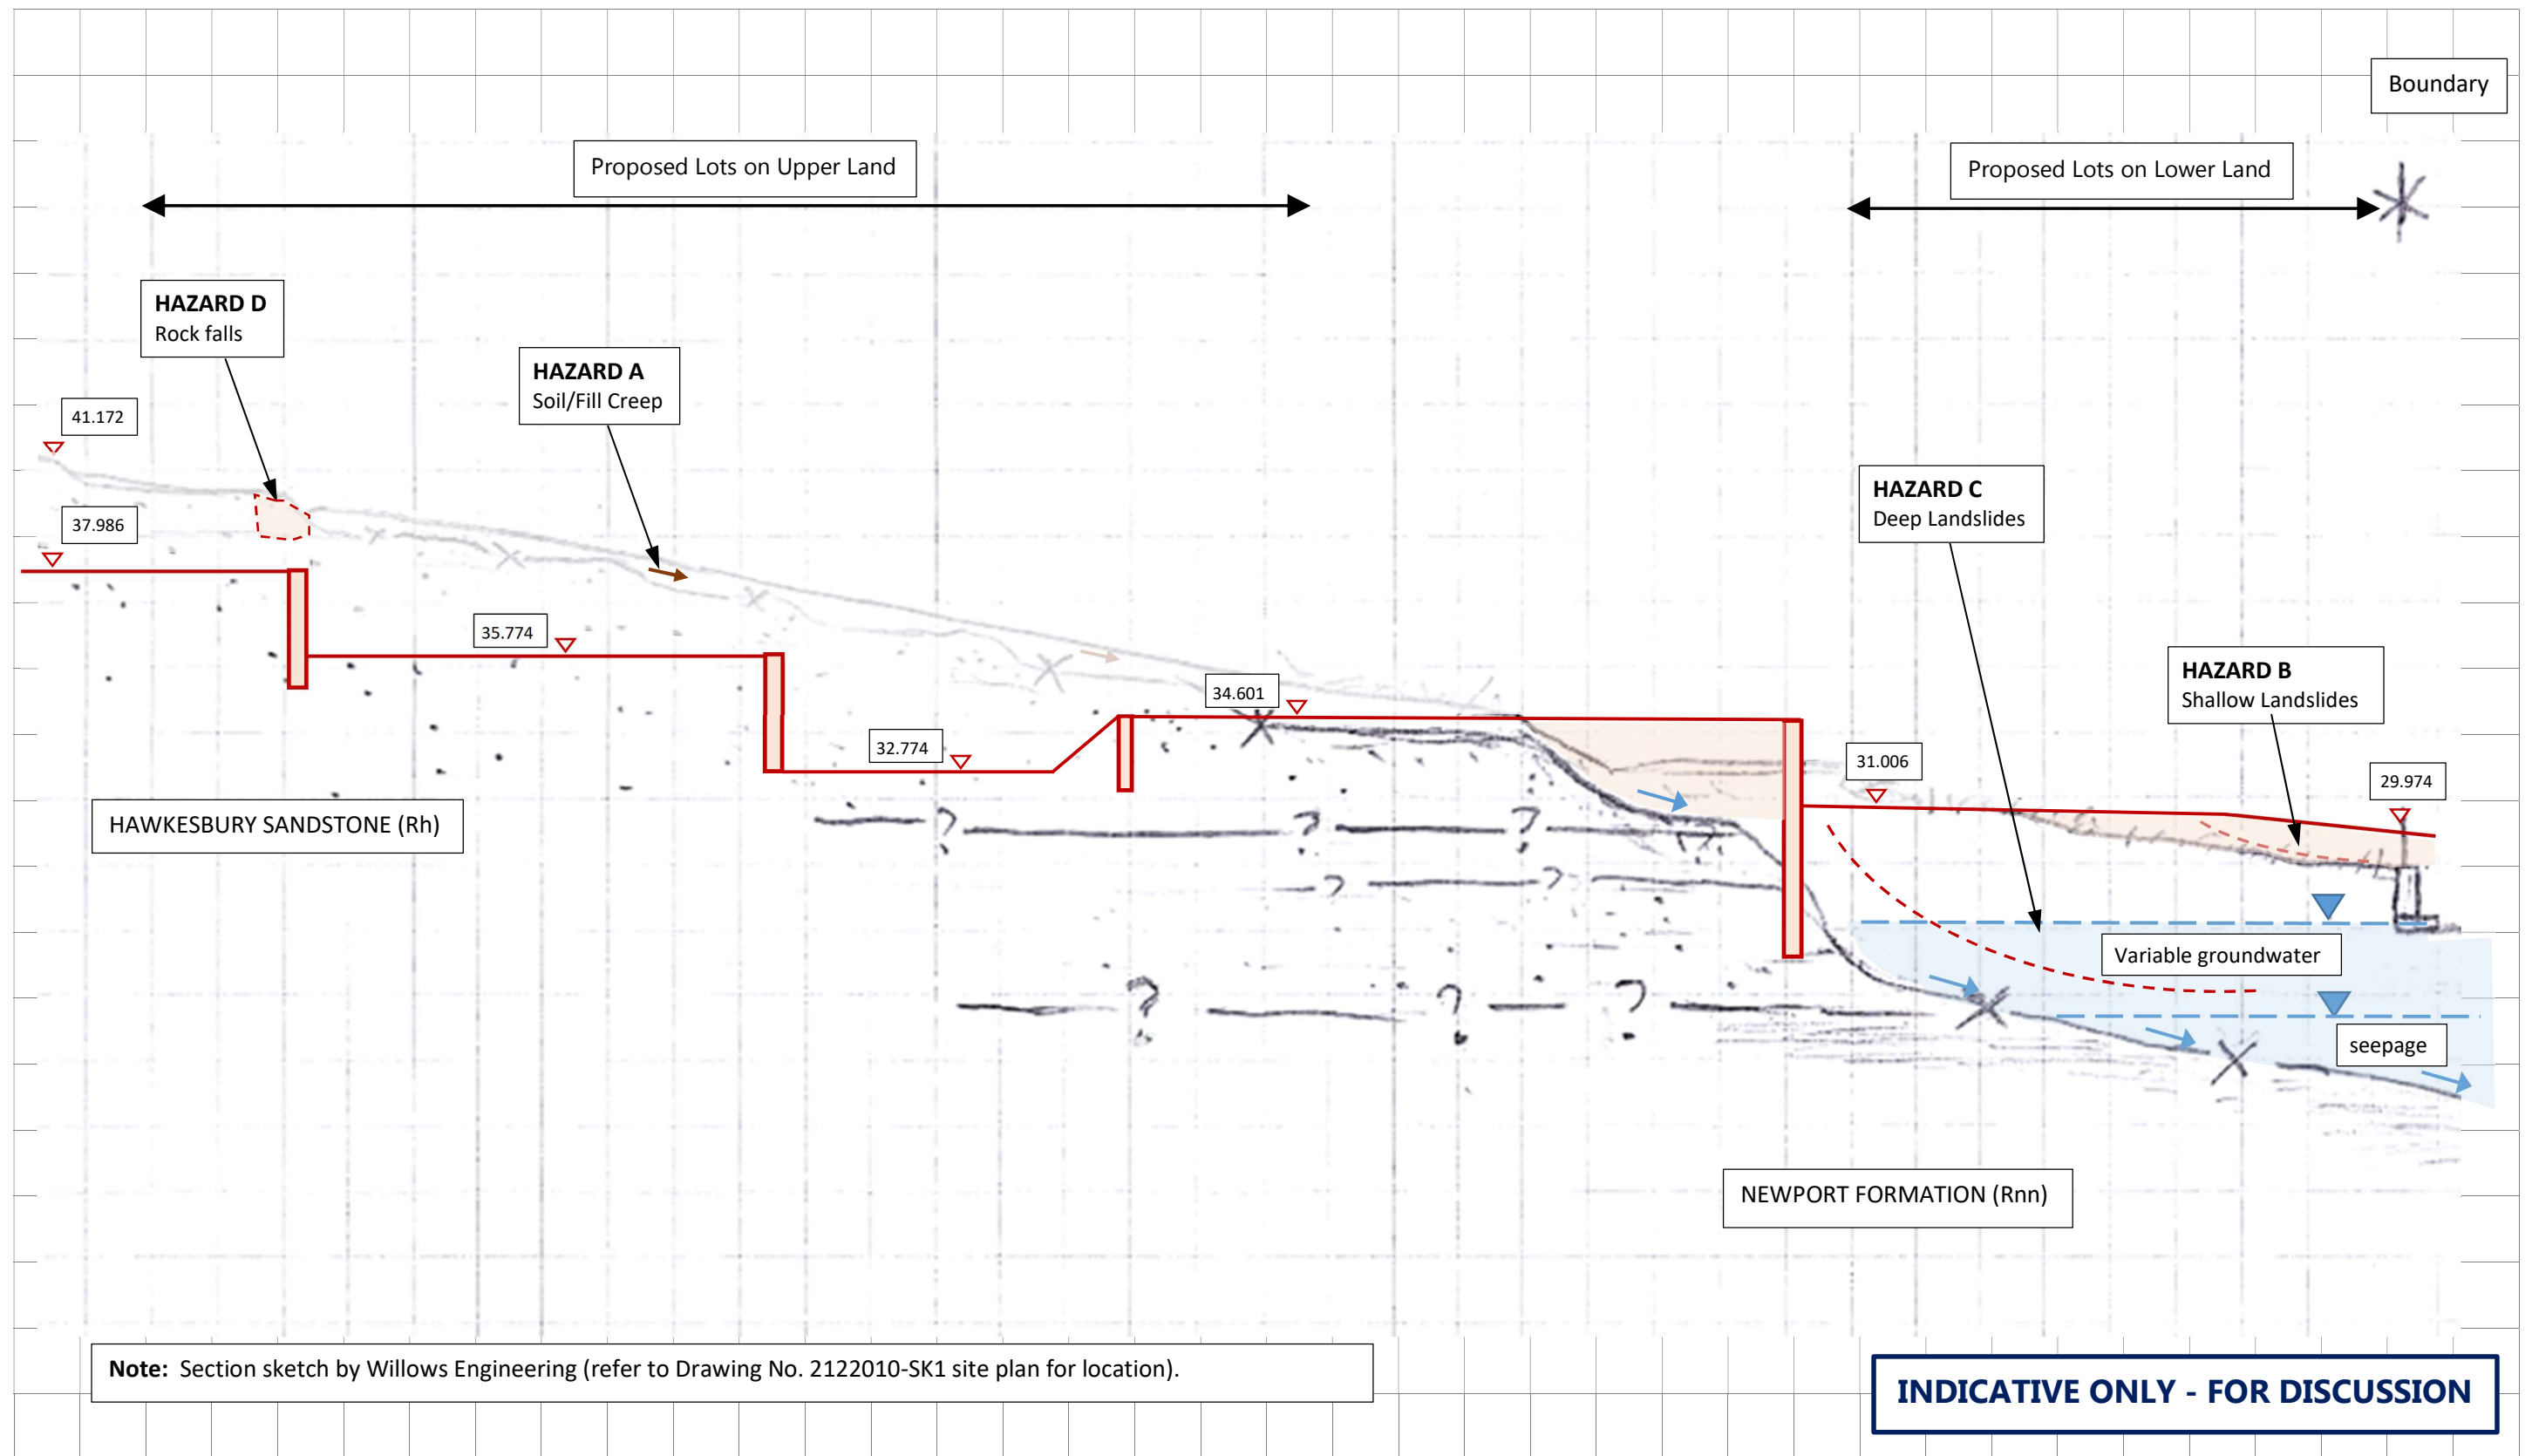
Section 1 – Geotechnical Hazards for Proposed Development

Drawing No. 2122010-SK3 is annotated to indicate the geotechnical hazards identified on the site and considered in the landslide risk assessment for the residential subdivision development. The hazards are described as follows:

- Hazard A Soil creep (fill and surface soils)
- Hazard B Landslides (small scale, near surface soils)
- Hazard C Landslides (large scale, deeper soil and weathered bedrock)
- Hazard D Rock falls or boulder movement

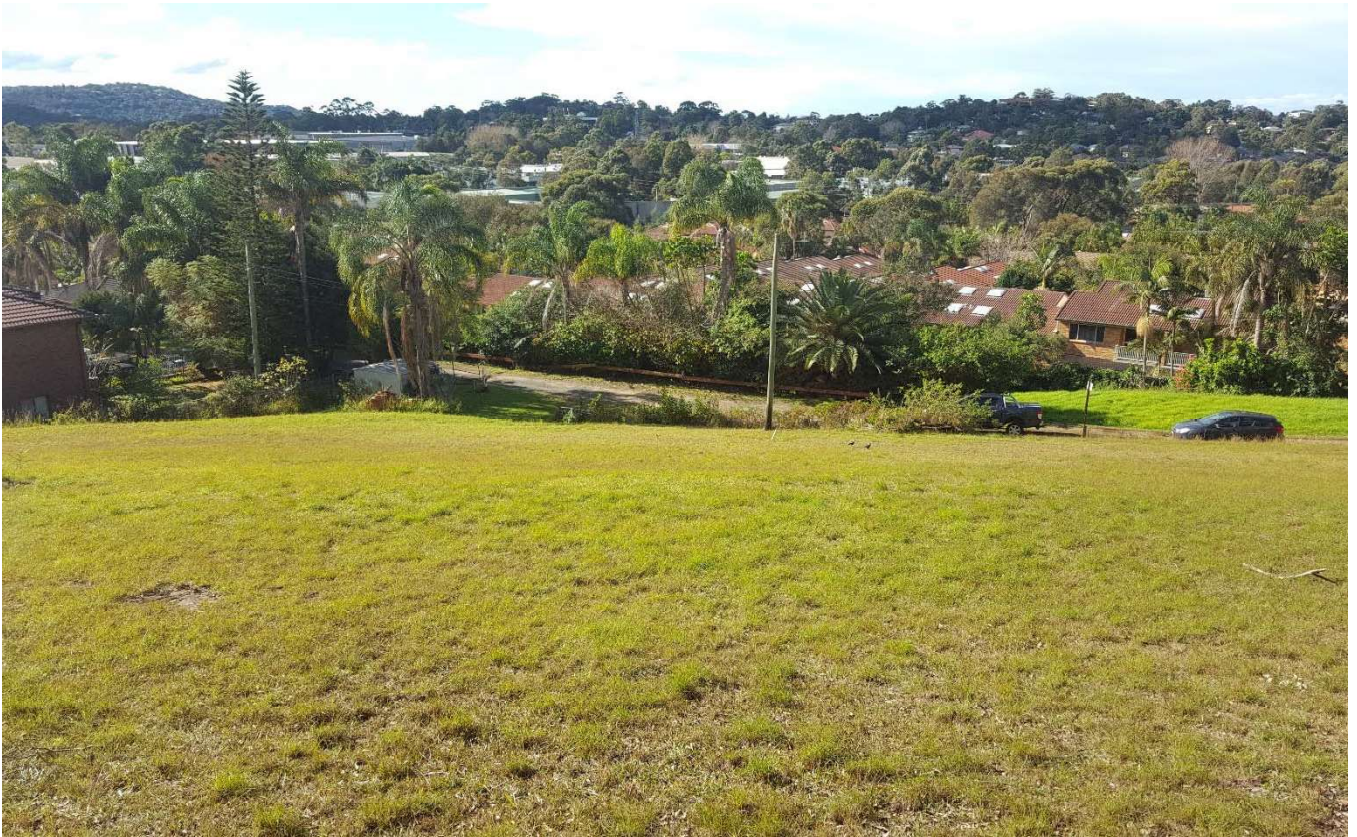
Figure 2 – Upper south-western portion of the land, looking north-east.
Note: Inferred Hawkesbury Sandstone bedrock underlying approx. 14° slope.

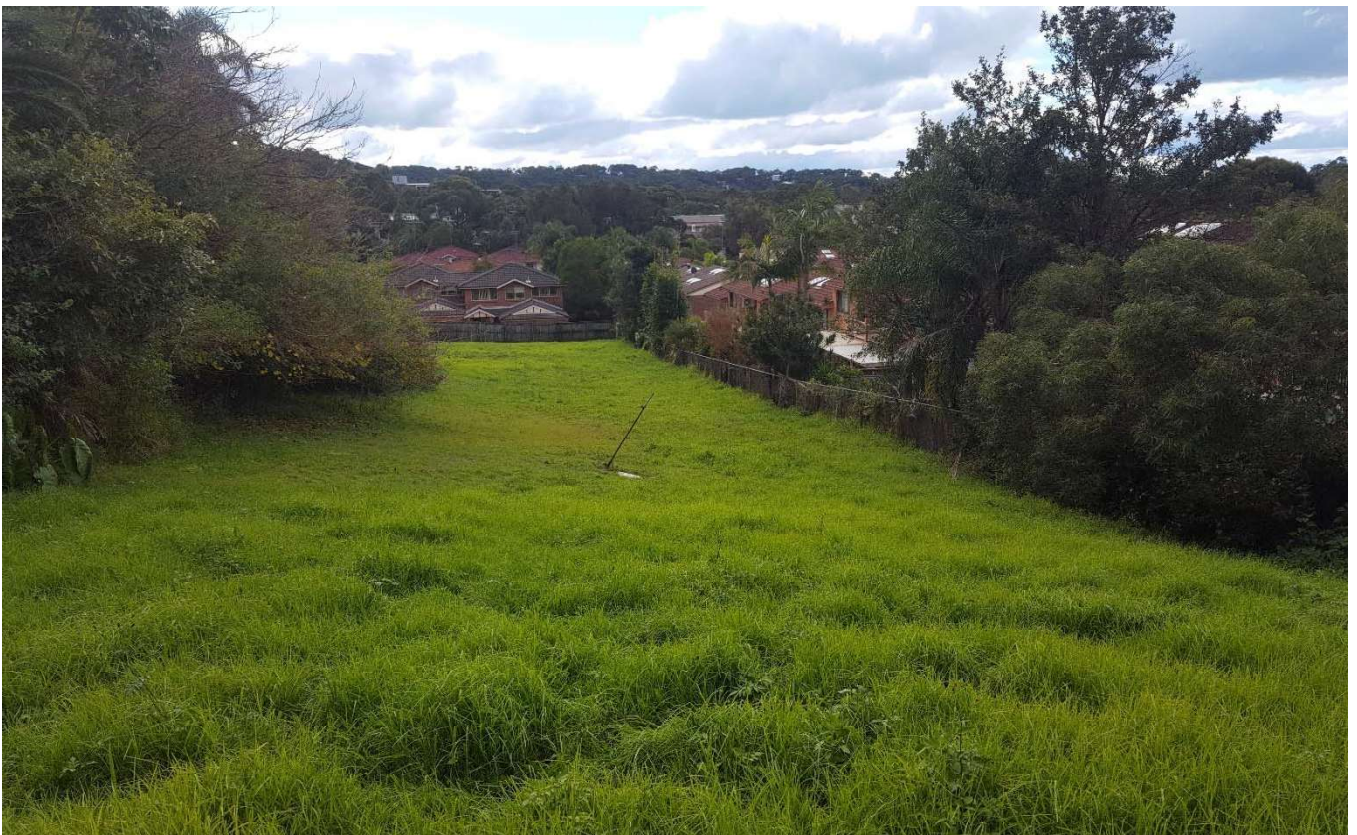
Figure 3 – Lower north-eastern portion of the land, looking north.
Note: Inferred Newport Formation (interbedded sandstone and siltstone bedrock) underlying approx. 10° slope. Existing houses on adjoining properties to the north and north-east.

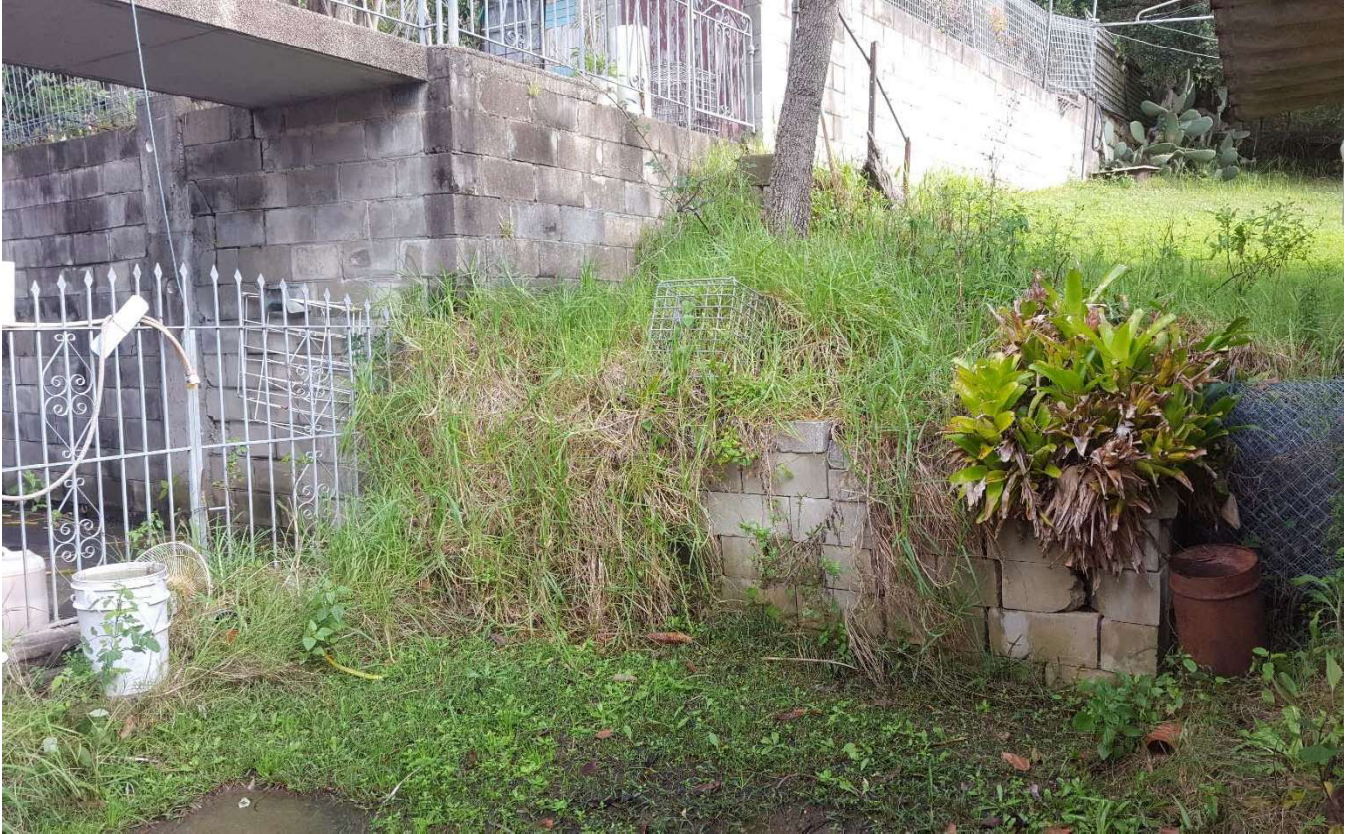
Figure 4 – Retaining walls, structures and slope behind existing house –central portion of land.
Note: Ponding of water on the ground, seepage through the wall joints, movement of wall blocks.

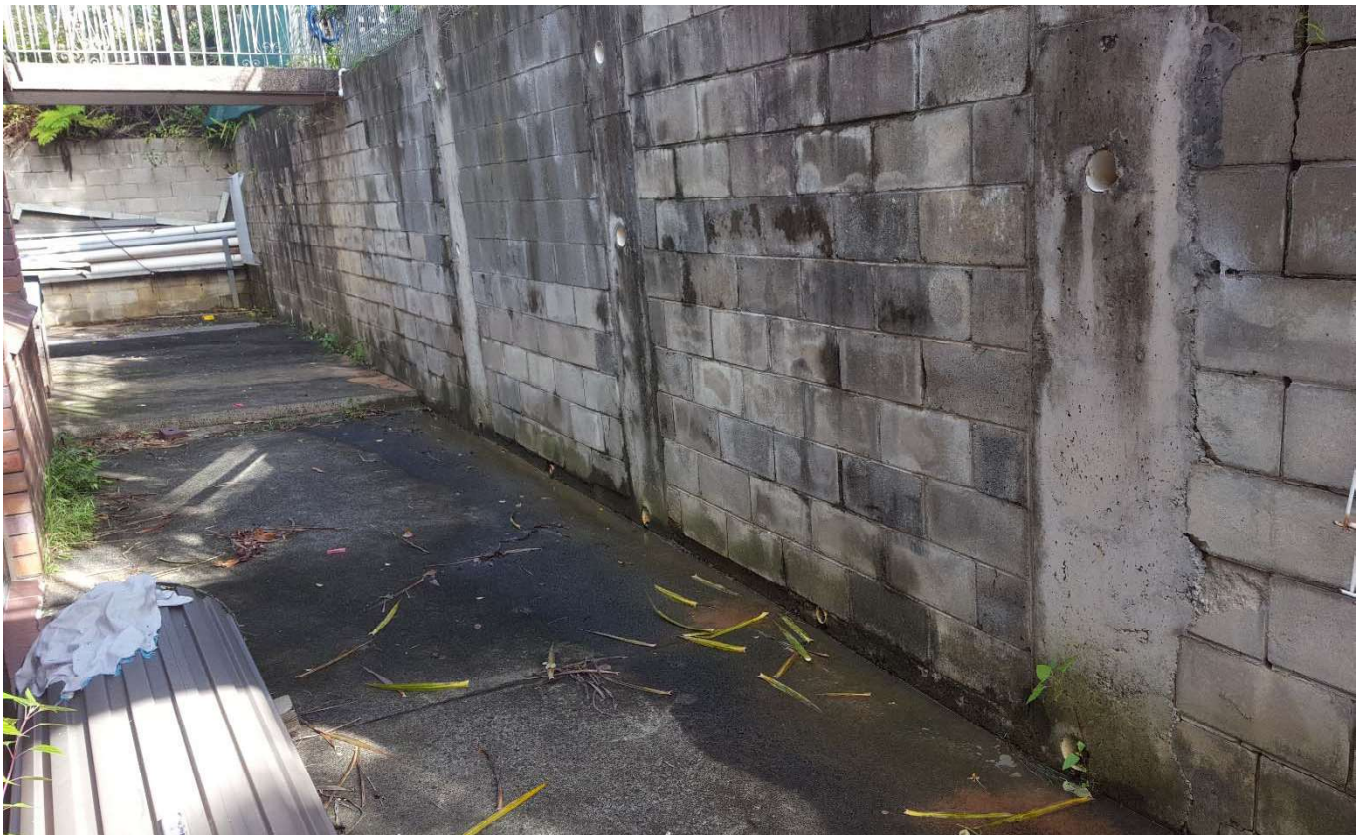
Figure 5 – Retaining wall and water ponding / seepage behind the existing house.
Note: Seepage through wall joints. The high volume of seepage suggests that the excavation is close to the geological interface between Hawkesbury Sandstone and Newport Formation.

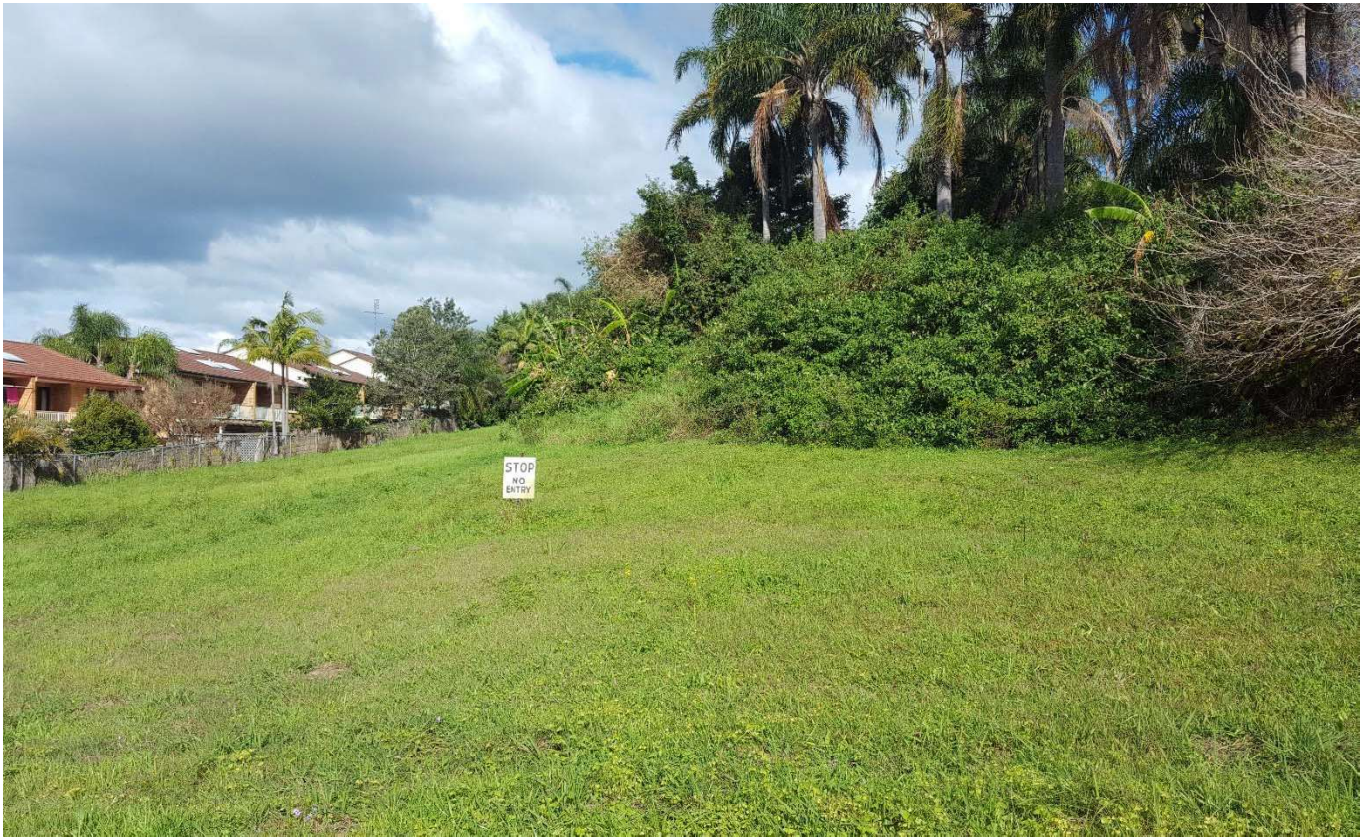
Figure 6 – Fill slope below the existing house and access driveway, looking south.

Note: The slope angle of the fill varies between approx. 24° and 31° . Substantial growth of vegetation on the fill slope and green grass cover suggests groundwater seepage.

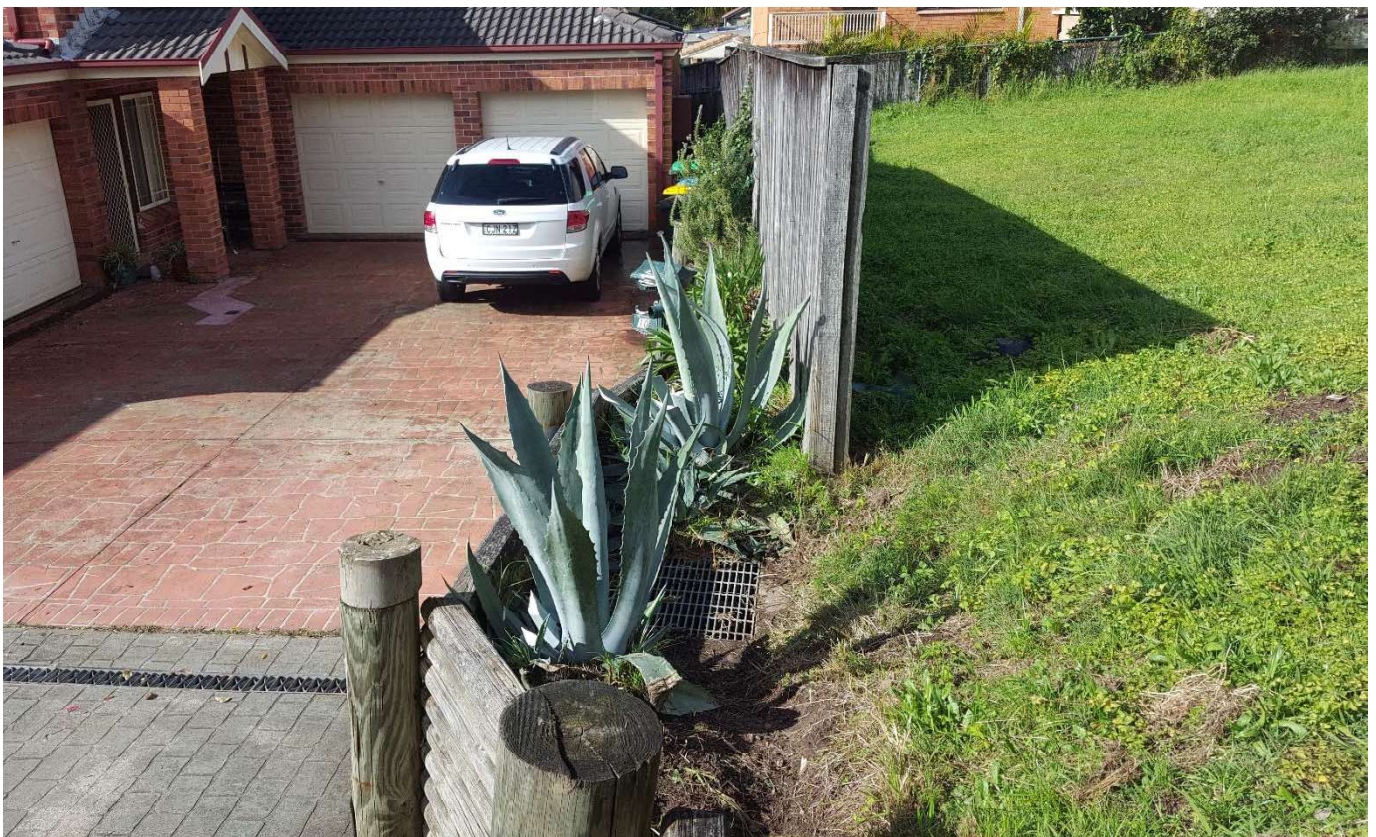
Figure 7 – Stormwater pit at the corner of Hillview Crescent and Bert Close, looking east.

Note: The development concept includes an on-site stormwater basin in the lower portion of the land for the subdivision construction, which is to be drained to this Council stormwater pit.
