REPORT ON GEOTECHNICAL SITE INVESTIGATION

PROPOSED NEW RESIDENTIAL DEVELOPMENT

**No.75-No.77 FOAMCREST AVENUE, NEWPORT,
NSW**

Project No.: 2020-202

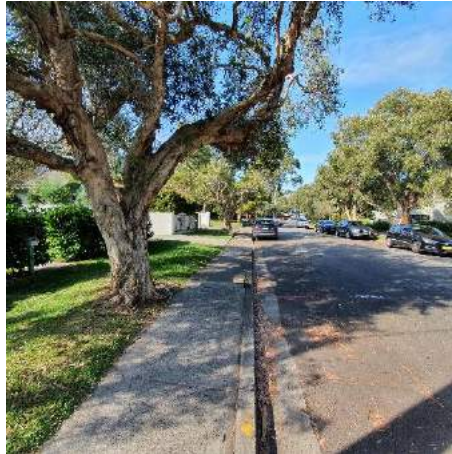
The site is located on the low east side of Foamcrest Avenue within gently east dipping topography. Foamcrest Avenue is formed with a gently south dipping bitumen pavement where it passes the site, with low concrete gutter and kerbs, a concrete pathway, grass lawn and two trees (up to $\leq 10.0\text{m}$ height). The road pavement and road reserve appeared in good condition, there were no signs of significant undulations, deformations or underlying geotechnical issues.

Photograph-7: Foamcrest Avenue road reserve. View looking south.

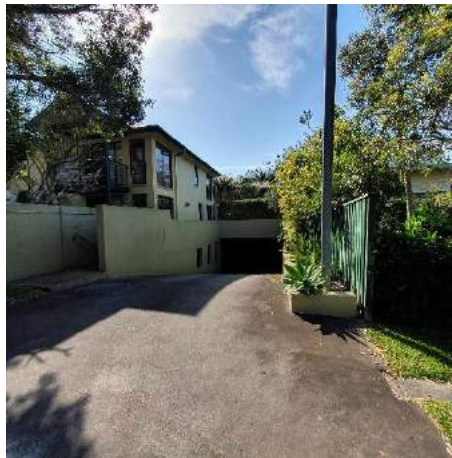
The neighbouring property to the north (No.79-83 Foamcrest Avenue) contains two separated two storey rendered unit buildings (within the west and east side of the property) that extend south to within approximately 4.50m to 7.00m from the common boundary at similar GSL to the site. The south-west corner of the property contains a concrete driveway ramp (Photograph-8), that leads down east to a basement carpark at a level approximately 3.0m below the site's GSL. The neighbouring dwellings, driveway and observed structures appeared in good condition, significant deformation or cracking or underlying geotechnical issues were not observed within the neighbouring property.

Photograph-8: No.79-No.83 Foamcrest's front driveway, directly to the north of the site. View looking east.

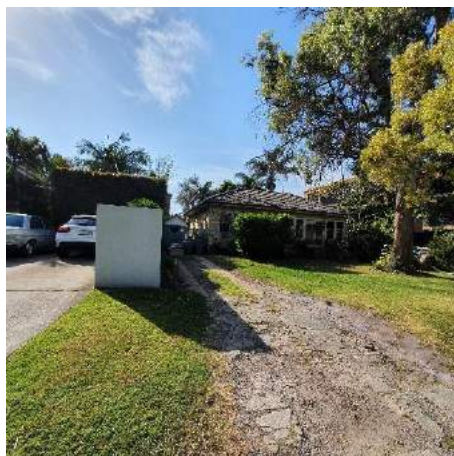
The neighbouring property to the south (No.73 Foamcrest Avenue) contains a single storey clad house with a detached fibro shed to the north east, front and rear grass lawns with a front strip driveway (Photograph-9) at the north-west corner of the property. The fibro shed is adjacent to the common boundary, whilst the dwelling extends north to approximately 2.50m from the common boundary. The front driveway and fibro shed, and rear grass lawn contain a similar GSL to the site. The property dwelling appeared in a relatively old condition, however significant deformation, cracking or underlying geotechnical issues were not observed within the neighbouring property.

Photograph-9: No.73 front driveway, directly to the south of the site. View looking east.

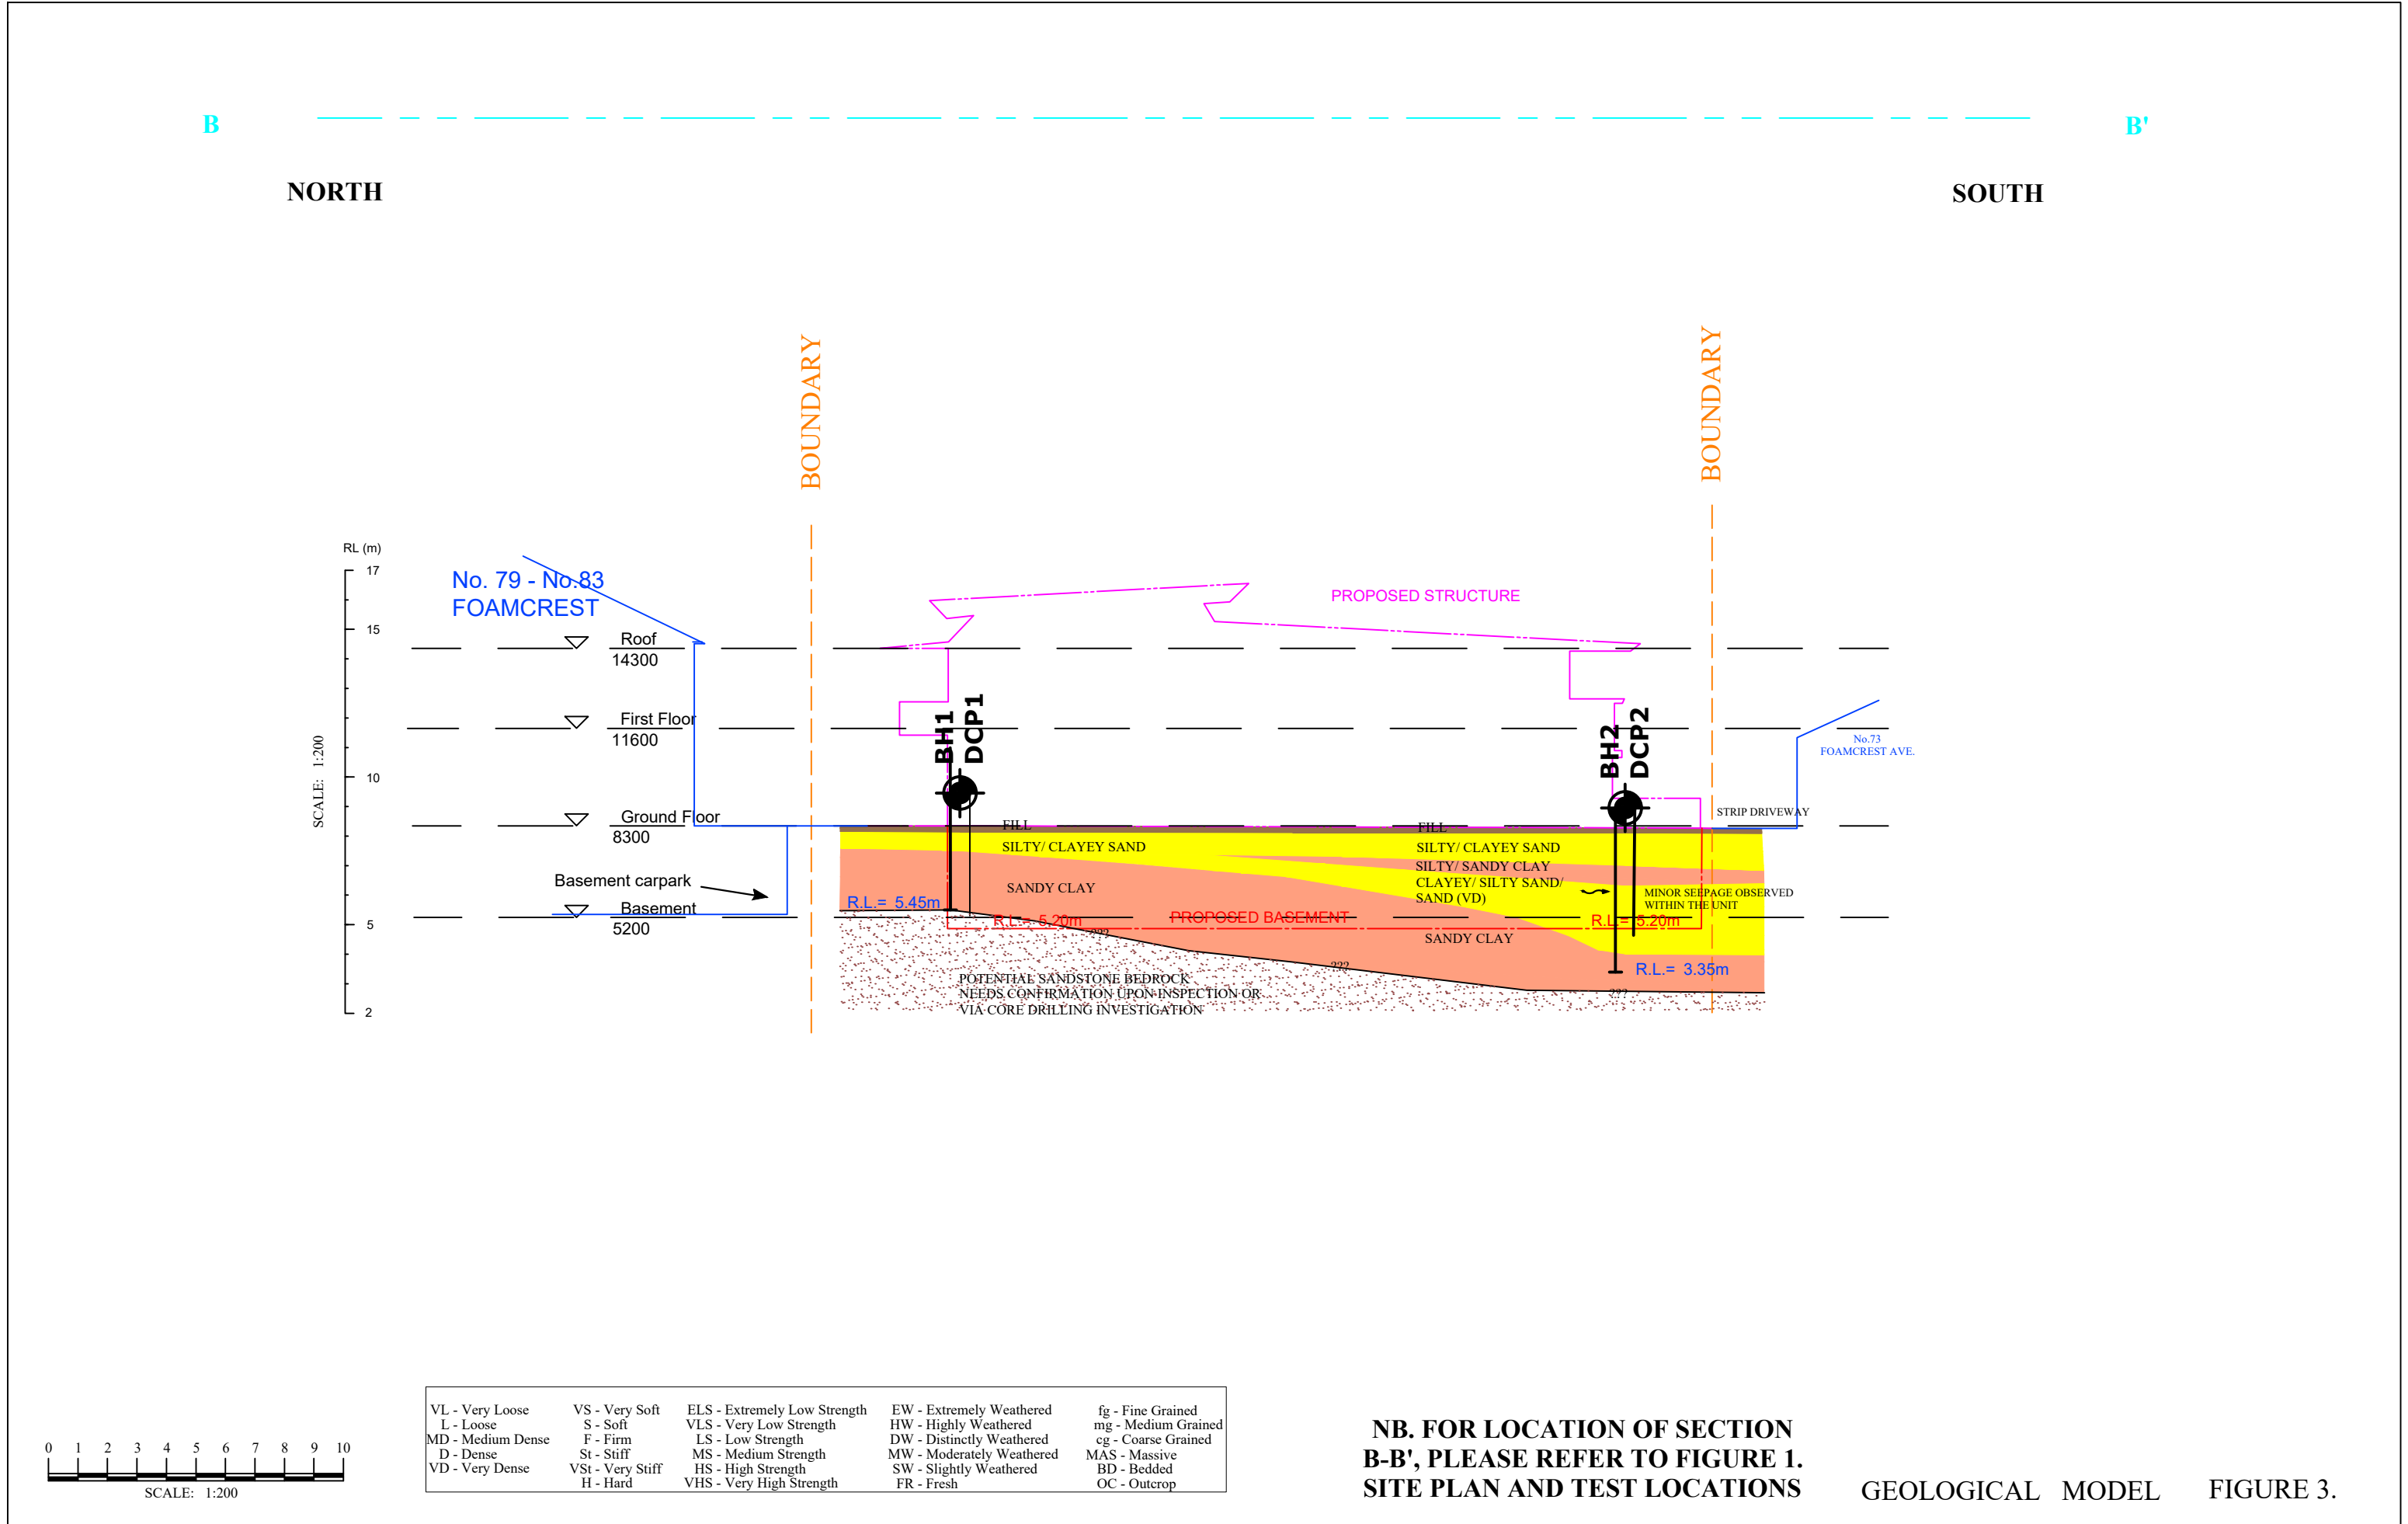
GEOLOGICAL MODEL FIGURE 3.

Within the western portion of the site, the site investigation identified the presence of silty sandy topsoil/ fill to a maximum depth of 0.80m, overlying a silty clayey sand unit to 1.40m depth (R.L.= 7.45m) and to 4.40m depth (R.L.= 3.95m) within BH1 and BH2, respectively. Increase in moisture was encountered within the clayey/ silty sand layer to 2.60m depth. Underlying the silty/ clayey sand unit, sandy clay (residual) was encountered to potentially interpreted bedrock within BH1 (3.40m depth, R.L.= 5.45m) and to the maximum drilled depth of 5.00m within BH2 (R.L.= 3.35m).

No groundwater or seepage were observed in the BHs and seepage was only observed from 3.0m depth upon retrieval of DCP2a. DCP effective refusal was encountered at 1.18m depth (DCP3) and 3.45m depth (DCP4a, R.L.= 5.15m) within the interpreted hard sandy clay/ clayey unit.
