# **GEOTECHNICAL INVESTIGATION:**

New Residence at 2 Lincoln Avenue, Collaroy

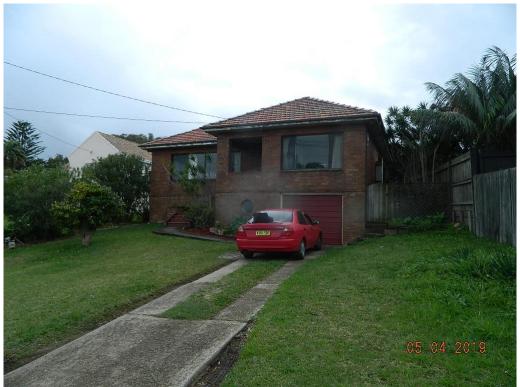
Photo 1

- 2.3 At the road frontage a concrete driveway runs up the slope to a garage under the house (Photo 1). A gently sloping lawn rises from the road frontage to the downhill side of the house (Photo 2). The single storey brick house will be demolished as part of the proposed works (Photo 3). Another gently sloping lawn rises from the uphill side of the house to the uphill boundary (Photo 4). No significant signs of movement were observed on the property. No geotechnical hazards that could impact on the subject property were observed on the neighbouring properties as seen from the subject property and the road.

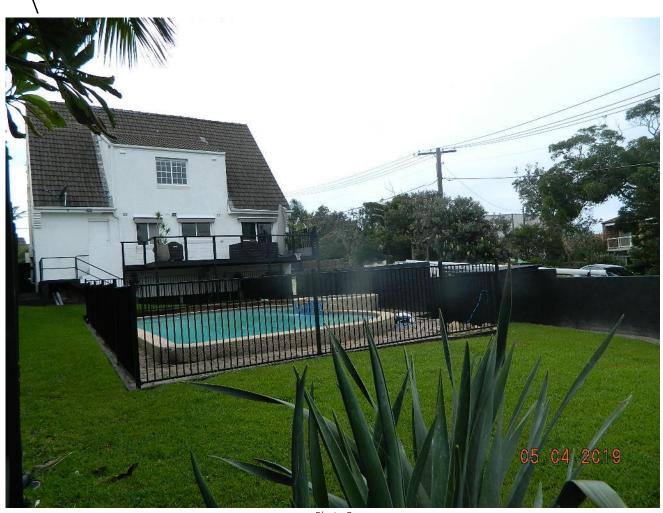
Photo 5

HAZARDS	Hazard One	Hazard Two		
ТҮРЕ	The vibrations produced during the proposed excavations impacting on the neighbouring houses and pool to the E (Photo 5).	The proposed garage level excavation for the house collapsing onto the work site before retaining walls are in place.		
LIKELIHOOD	'Possible' (10 <sup>-3</sup> )	'Possible' (10 <sup>-2</sup> )		
CONSEQUENCES TO PROPERTY	'Minor' (9%)	'Medium' (20%)		
RISK TO PROPERTY	'Moderate' (5 x 10 <sup>-5</sup> )	'Moderate' (2 x 10 <sup>-4</sup> )		
RISK TO LIFE 2.1 x 10 <sup>-7</sup> /annum		6.7 x 10 <sup>-4</sup> /annum		
COMMENTS	'This level of risk to property is  'UNACCEPTABLE'. To move risk to  'ACCEPTABLE' levels the recommendations in Section 13 are to be followed.	This level of risk to life and property is 'UNACCEPTABLE'. To move risk to 'ACCEPTABLE' levels the recommendations in Section 13 are to be followed.

houses to the E and W (Photo 5). The neighbouring pool will be as close ~6.6m from the edge

of the excavation and the E and W neighbouring houses ~9.0m. Close controls by the

contractor over rock excavation are recommended so excessive vibrations are not generated.

Excavation methods are to be used that limit peak particle velocity to 10mm/sec at the

property boundaries. Vibration monitoring will be required to verify this is achieved.

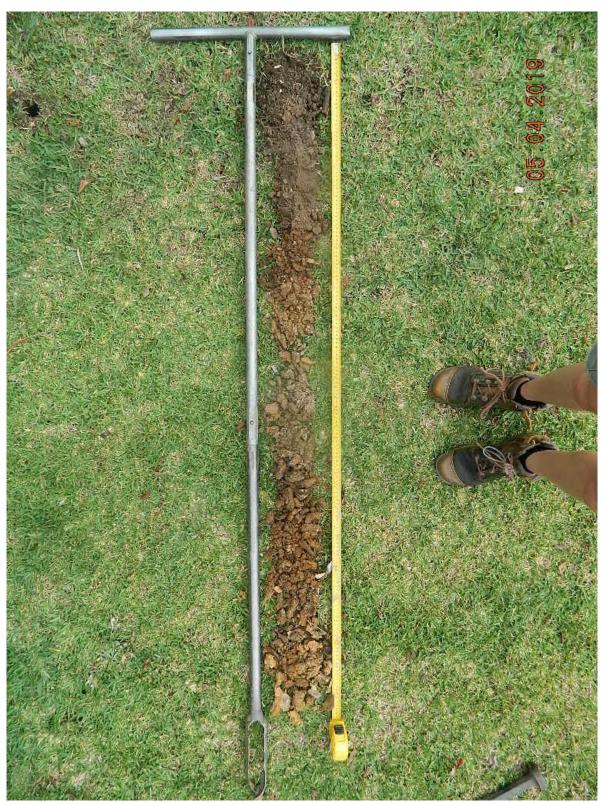
**AUGER HOLE 1** (~RL 65.7) – AH1 (Photo 6)

Depth (m)	Material Encountered
0.0 to 0.1	<b>TOPSOIL,</b> loamy soil, brown, loose, roots, organic matter, fine grained, damp.
0.1 to 0.4	<b>SANDY SOIL,</b> light brown, loose, rock fragments, roots, fine to medium grained, dry.
0.4 to 0.6	CLAY, reddish brown, stiff, fine grained, rock fragments, dry.
0.6 to 1.0	<b>CLAY,</b> reddish brown with white mottling, stiff, rock fragments, fine grained, dry.
1.0 to 1.6	<b>CLAY,</b> reddish brown with orange mottling, stiff, rock fragments, fine trace charcoal, fine grained, dry.
1.6 to 1.7	<b>CLAY,</b> brownish yellow with orange mottling, firm to stiff, fine grained, rock fragments, red mottling, dry.

Refusal @ 1.7m, grinding on rock. No watertable encountered

Photo 6: Auger Hole 1: Base of hole at base of image
