Report Title: Geotechnical Report 39 Chisholm Avenue, Avalon  
Report Date: 7/3/24  
Author: BEN WHITE  
Author's Company/Organisation: WHITE GEOTECHNICAL GROUP PTY LTD

## **39 Chisholm Avenue, Avalon**

### **Minor Works Assessment**

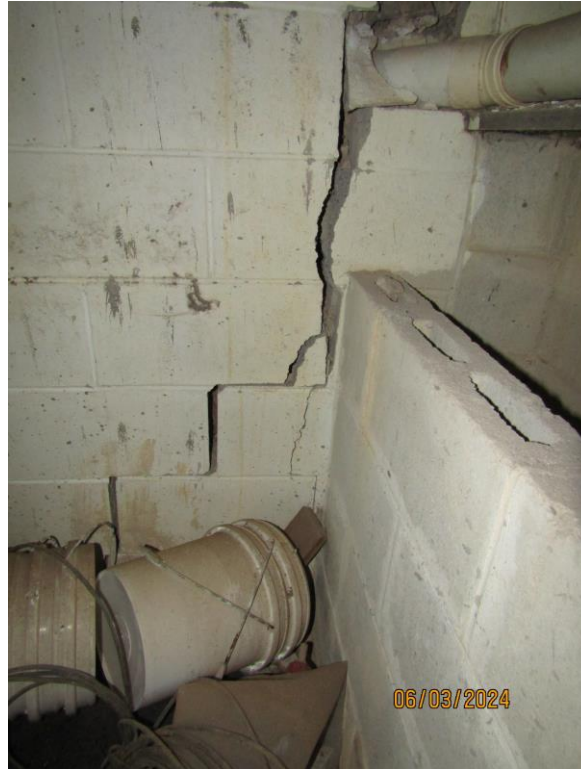
Photo 1

The cracked concrete block wall (Photos 1 to 2), tilting timber posts (Photos 3 to 5) and tilting retaining walls across the site (Photos 6 to 8) are to be monitored by the owners on an annual basis or after heavy and prolonged rainfall events, whichever occurs first. A photographic record of these inspections is to be kept. Should further movement occur the walls or posts are to be remediated or replaced so that they meet current engineering standards. We can carry out these inspections upon request.
