## **REPORT ON GEOTECHNICAL INVESTIGATION**

### **PROPOSED ALTERATION AND ADDITIONS**

**7 PACIFIC ROAD, PALM BEACH, NSW**

**Project No.: 2024-155**

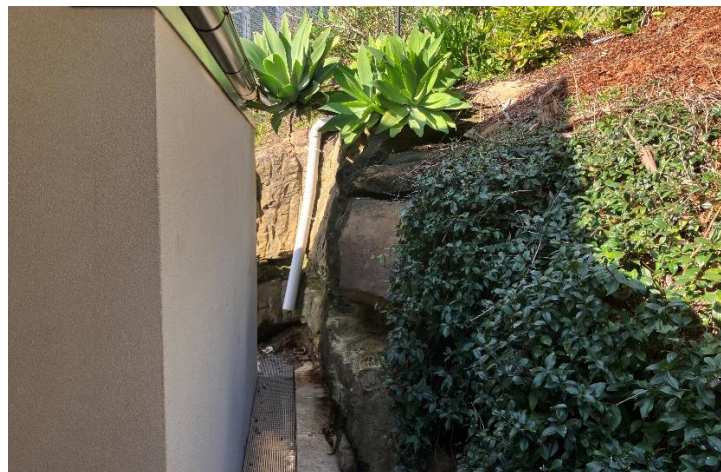
A pathway extends further down into the site and provides access to a small courtyard area adjacent to the main site dwelling. The courtyard area appeared to be excavated below pre-development ground levels with visibly excavated sandstone bedrock observed in numerous locations adjacent to the courtyard. Photograph 2 below provides a view of one of the exposures.

*Photograph 2: View of the exposed sandstone adjacent to the front of the dwelling, looking broadly south*

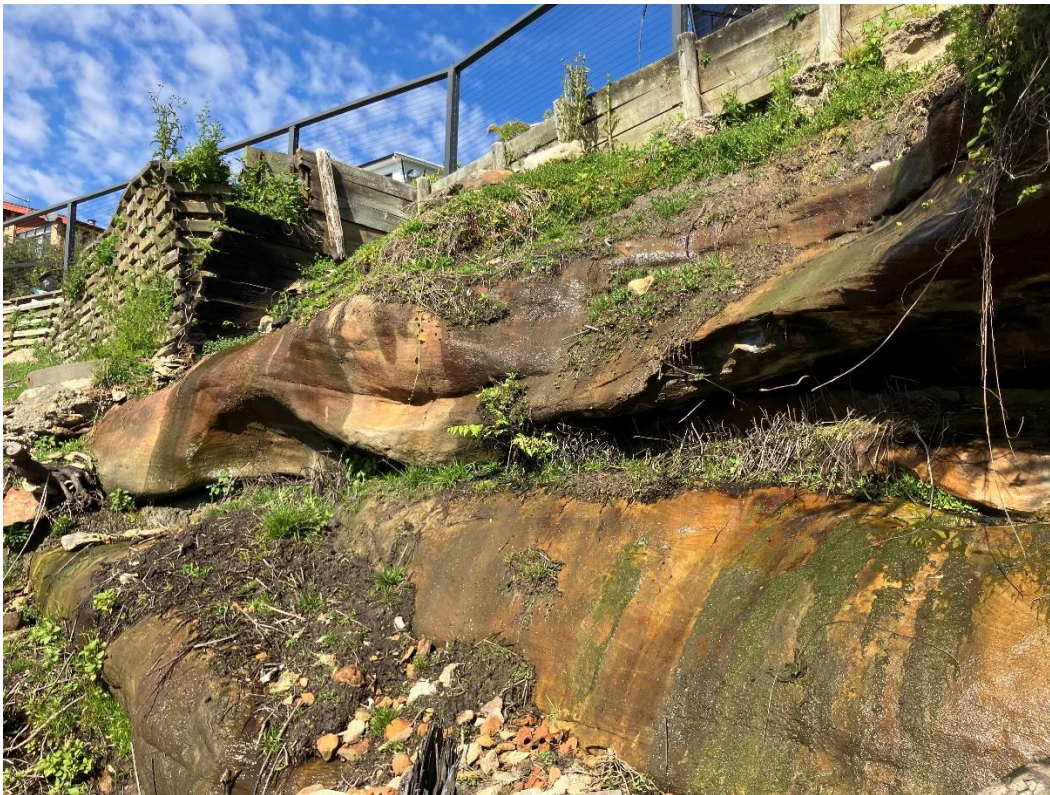
Gently east dipping pathways extend around either side of the dwelling structure and provide access to the rear garden area. The rear garden initially comprises a gently east dipping lawn area that is retained along its eastern edge by a timber wall of maximum height  $\approx 2.50\text{m}$ . The timber crib wall exhibited signs of significant deterioration and deflection near its crest and is collapsing.

*Photograph 3: View of the exposed sandstone bedrock within the rear garden, looking broadly south west, also showing deterioration in the timber retaining wall*

The deteriorated timber crib wall within the rear garden area exhibited significant signs of deflection and, as such, presents an inherent risk of collapse, likely triggering a minor landslip/earth slide of the pre-existing retained soils. As such, it is recommended that this wall be replaced in the near future.

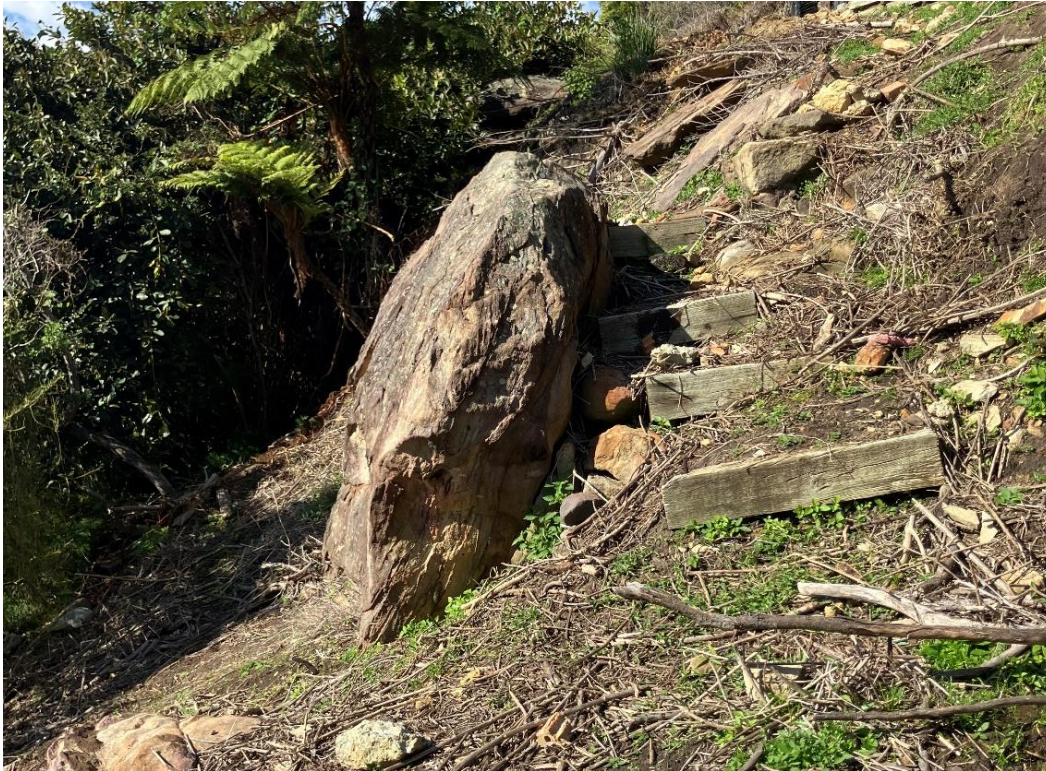
Beyond the timber retaining wall the site transitions to a steep to very steep east dipping slope featuring multiple sandstone outcrops interpreted as both bedrock and detached boulders. The bedrock portion (shown below in photograph 3) is situated towards the northern site boundary and features a minor overhang ( $< 1.0\text{m}$ ). The detached boulder (shown below in Photograph 4) is approximately  $10\text{m}^3$  in overall size and appears to have rotated up to  $90^\circ$  from its estimated original position. The boulder is considered relatively stable in-situ.

*Photograph 4: View of the detached sandstone boulder within the rear garden, looking broadly south*

At the time of the investigation the boulders within the site and immediate surrounds were all considered to be relatively stable with no impending instability identified provided site conditions do not significantly change. The rotated boulder within the lower portion of the site, although considered relatively stable during the investigation, may present a significant risk of movement if site stormwater is not adequately diverted. It is imperative that, if this boulder is to be left in position, that stormwater is not discharged into the ground in the vicinity as the associated erosion may undermine the boulder. Alternatively, the risk could be entirely mitigated via removal of the boulder.
