Arboricultural Impact Assessment

Site Address
3 BAKERS ROAD
CHURCH POINT NSW 2105

June 2021

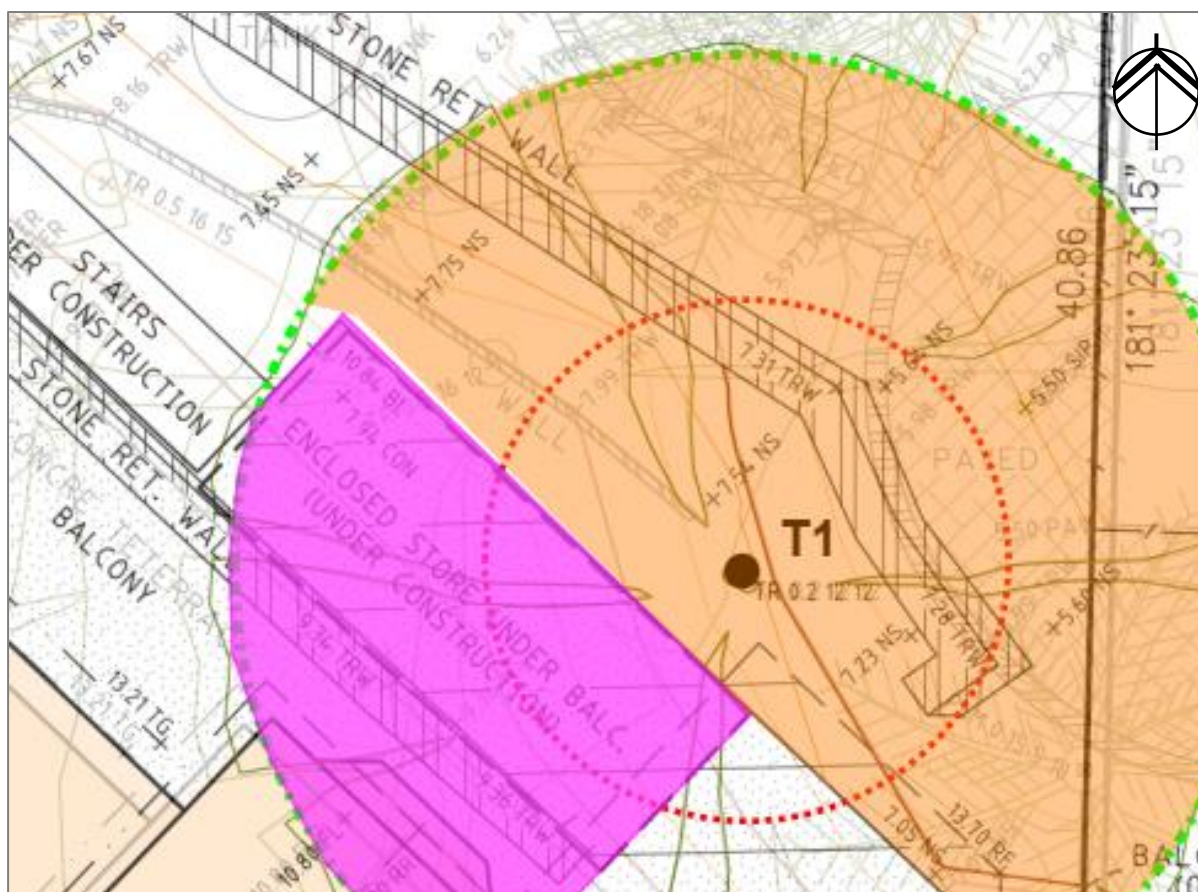
- An estimated TPZ encroachment of 82.4m² or 87% has been calculated in relation to the new works, this falls well within the *major* level of encroachment under AS4970 (see Figure 1 below/next page).

Figure 1 – Tree 1 – Survey Plan dated 12/9/2019 by Waterview Surveying Services overlaid with Design Plan by Northern beaches Designs Drawing no. C4.55-2. Red dotted circle indicates SRZ whilst TPZ is denoted by green hashing. Pink shading indicates area of potential excavation whilst orange shading notes likely fill within the TPZ. Marked up by C.Hughes. NOT TO SCALE.

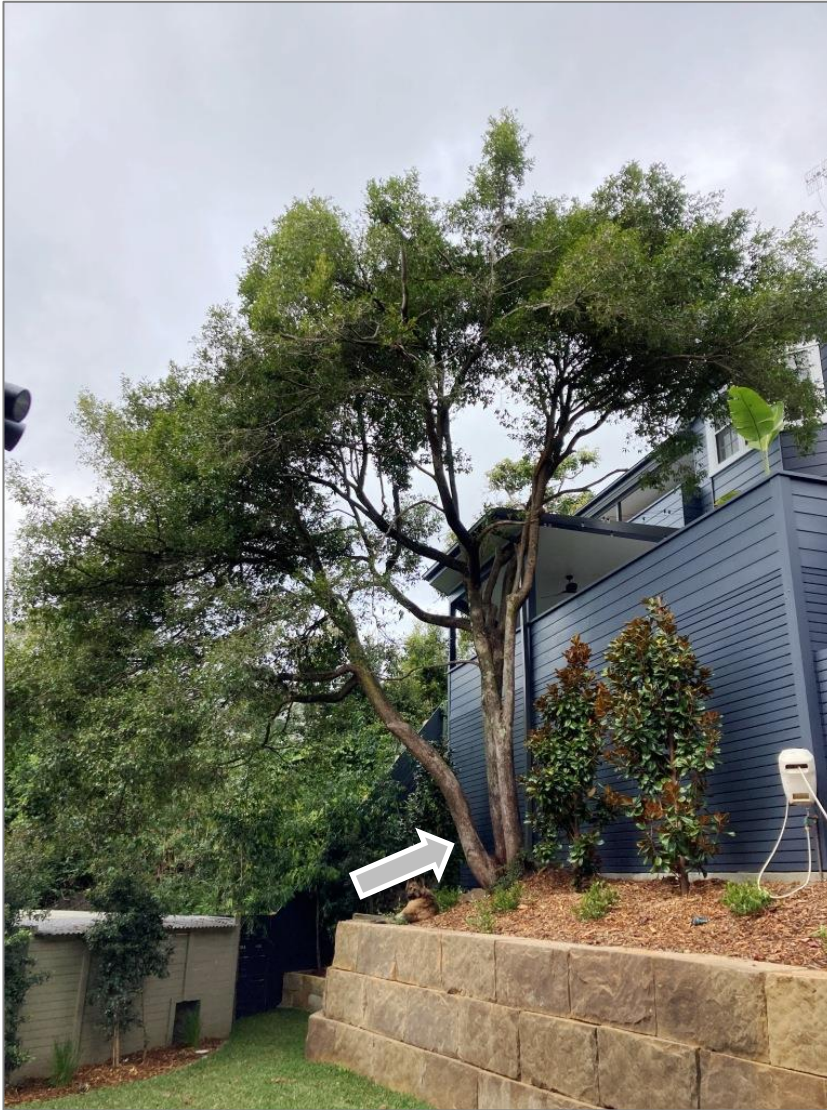
Plate 1 – Tree 1. Arrow notes subject tree.

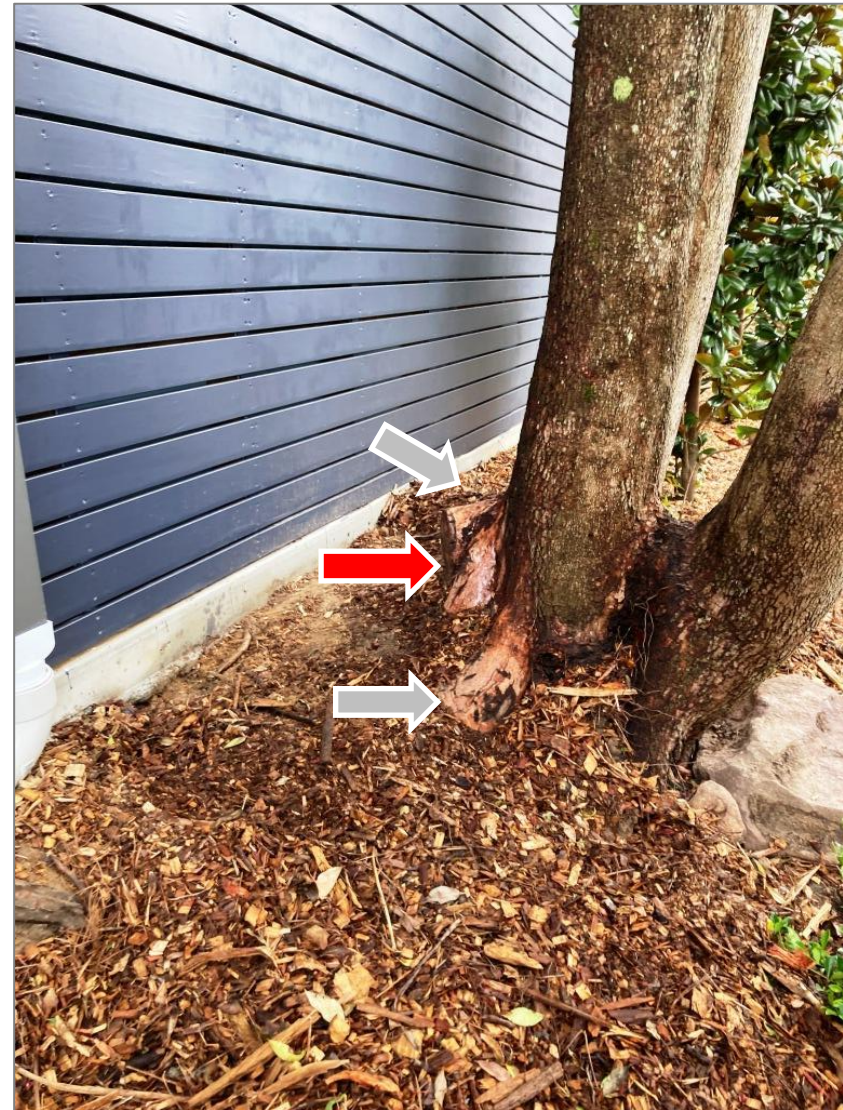
- A concrete slab was laid, and new retaining wall built within the calculated SRZ of this specimen. Both placement of fill and excavation has occurred within this zone.

- Evidence of root severance has occurred for the concrete slab construction (see Plates 2 & 4) with one (1) 190mm diameter exposed root severed cleanly at the root crown to the south-west of the tree stem. Tension side roots on a steep slope are generally known to be more important for tree stability.

Plate 2 – Tree 1 – Photo notes location of new slab in relation to base of stem Pinkish areas at base of stem (noted with grey arrow) are indicators of soil removal against stem. Red arrow notes severed large diameter root.

Root mapping along the slab has been recommended. This will hopefully determine if further roots were severed and what roots remain.

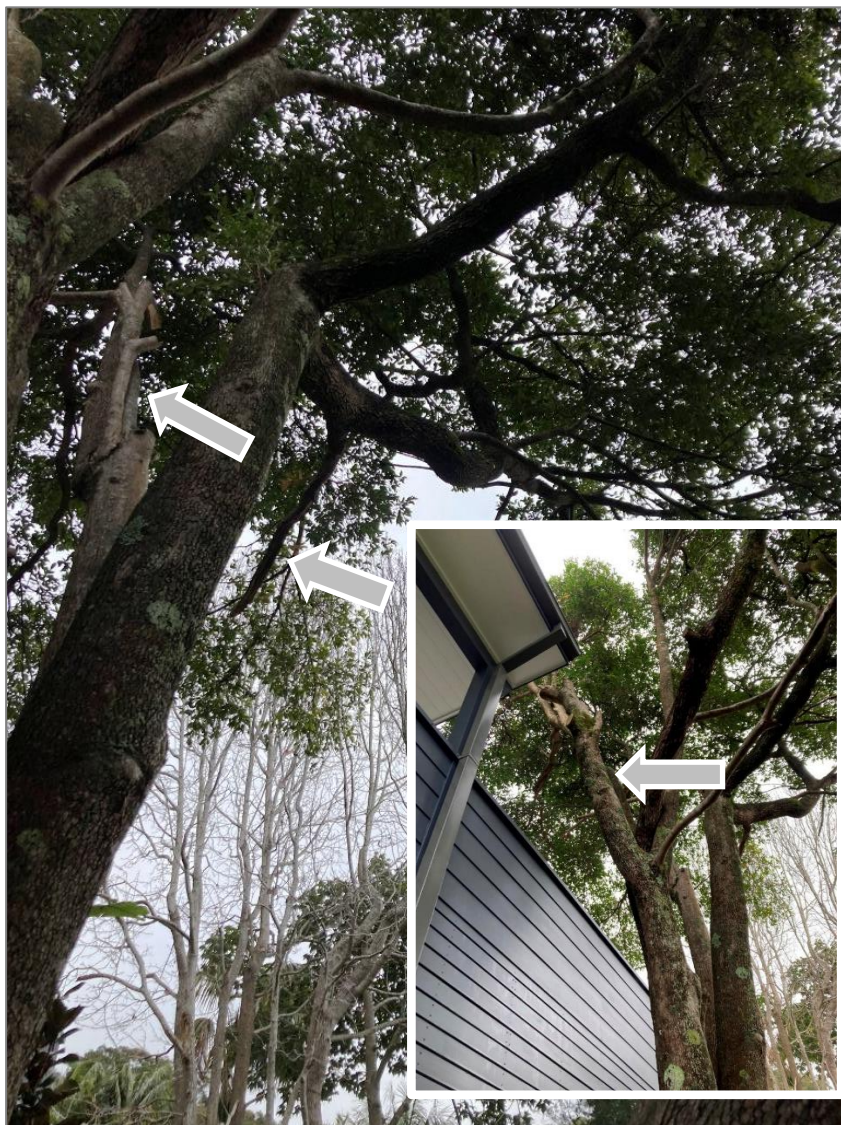
- Significant pruning has been carried out on this specimen, works contrary to the standards set within AS4373 -2007 Pruning of Amenity Tree were completed. Large diameter stubs were noted during assessment for pruning carried out to provide clearances for the new decking/storage structure. An estimated 15-20% is likely to have been removed but without prior knowledge or photography of the tree it is hard to determine, a higher percentage may have been removed.
- However, despite the previous pruning the remaining foliage is likely to be sufficient to fuel the tree in the medium term. Epicormic growth was noted at the time of assessment and tree vigor appeared adequate.

Plate 3 – Tree 1 – Arrow note smaller diameter stubs requiring clean up should tree be found stable.

Inset Plate – Arrow notes 200mm diameter stub.

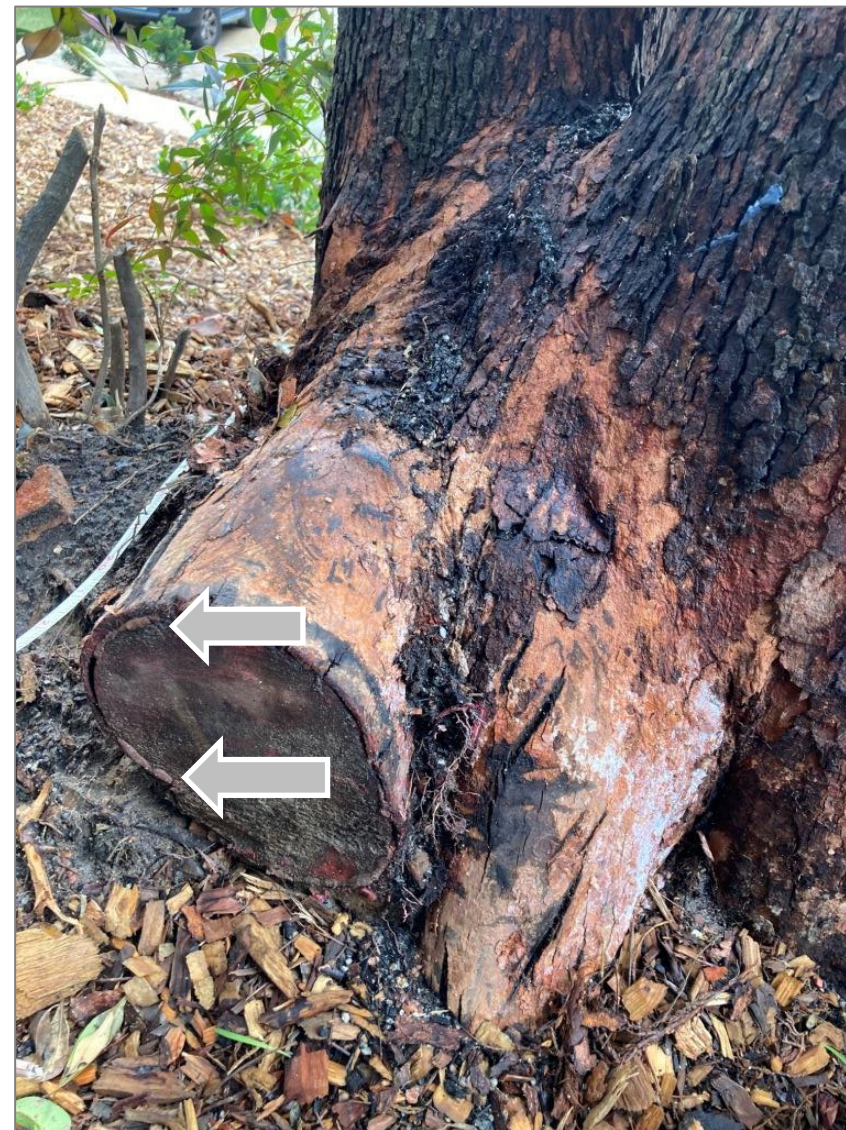
One (1) severed large diameter root was noted during site inspection. This was severed cleanly and is displaying very early signs of wound tissue starting to grow over the wound site. It is unknown if further roots were severed for the concrete slab construction.

Plate 4 – Tree 1 – Close up of severed root. Arrows note where root starting to try and occlude.
