## **Geotechnical Assessment**

**Project:** Two-lot Subdivision  
76 Herbert Avenue, Newport, NSW.

**REF: AG 18161**  
4<sup>th</sup> December, 2018

For Proposed Two-Lot Subdivision at  
76 Herbert Avenue, Newport, NSW

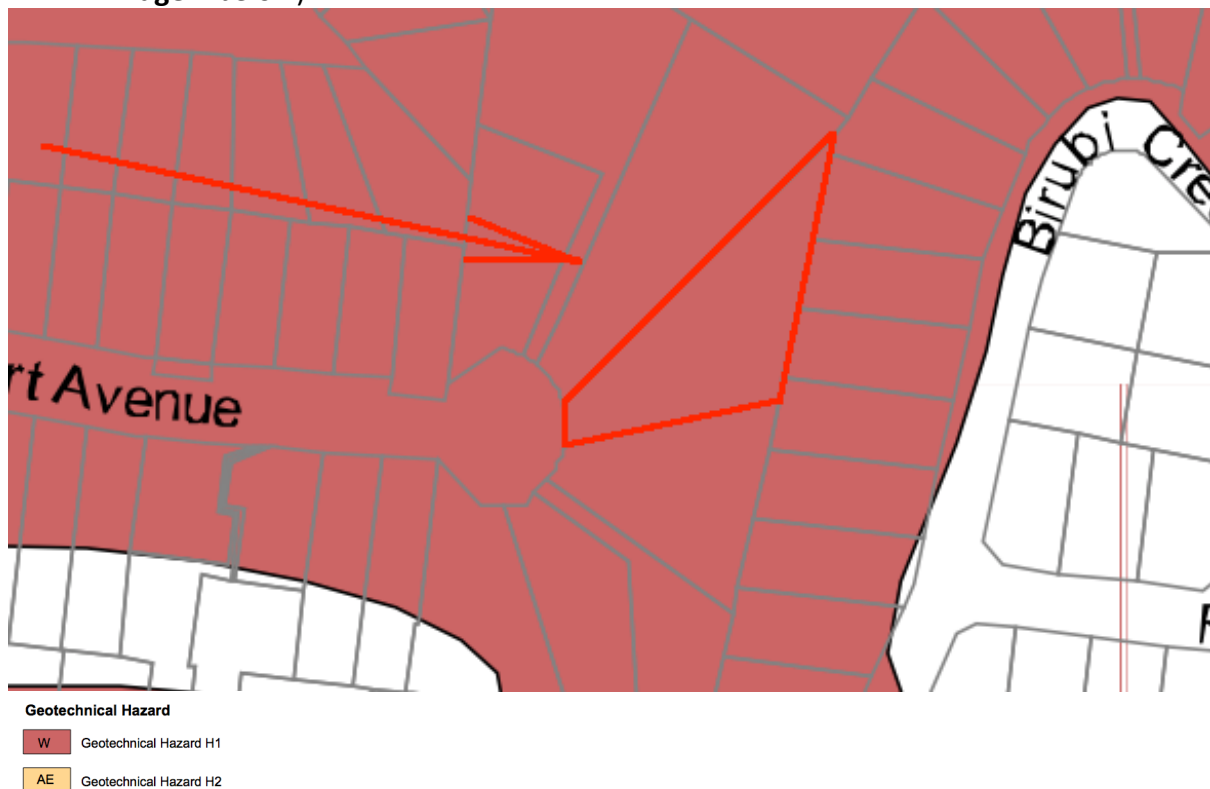
- The slope of the Site rises to the south-east at approximate average angles of 30 degrees. No evidence of significant soil creep, tension cracks or other indicators of slope instability were identified at the time of our inspection,
- Medium to large detached sandstone joint blocks and floaters appeared to be in stable positions on and in the slope,
- Established trees on Site stood vertically with no evidence of significant leaning which may be an indicator of slope destabilisation,
- No evidence of significant ground water ponding exfiltration or channelling was identified at the time of our visual assessment,

- The existing structures including retaining walls displayed no evidence of significant cracking or settlement that could be attributed to slope instability,
- The property is classified '**Geotechnical Hazard H1**' in Northern Beaches Council PLEP Geotechnical Hazard Map Sheet GTH\_017 (PLEP Geotechnical Hazard Map **Image 2** below).
