# Geotechnical Investigation Report Landslip Remediation

32A Nareen Parade, North Narrabeen, NSW

Project No.: 210083

Date: 13 November 2022

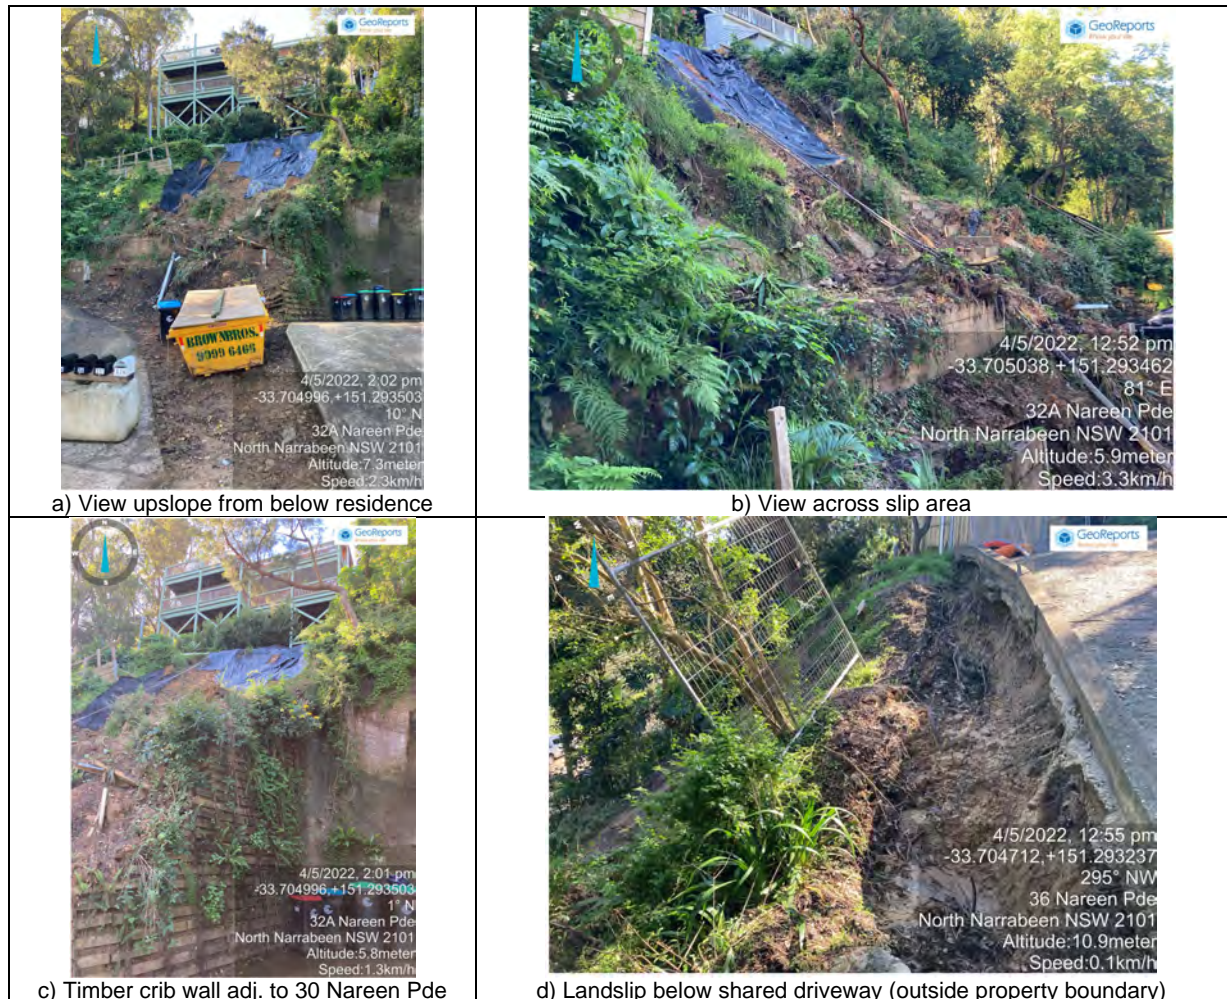
Figure 2 – Typical Site Images

- Extensive cracking, movement and in places undercutting of the shared concrete driveway due to multiple landslips and erosion above and below the driveway.
- A 150-250m<sup>3</sup> landslip immediately above Nareen Parade in the adjoining blocks of 34 and 36 Nareen Parade which partly affects the shared driveway serving #32A.
- Damage and erosion of post and panel, mid-level retaining structures supporting paved areas at 30 Nareen Parade, including some evidence that water flows have crossed from that site into the slip area at the subject site.
- Deteriorating condition of the timber crib wall along the common boundary at the low car parking bay between #30 & #32A Nareen Parade. This old gravel-filled timber crib wall is up to about 5m high and is near the end of its service life, with loose / detached rib elements, bulging and decaying timbers.

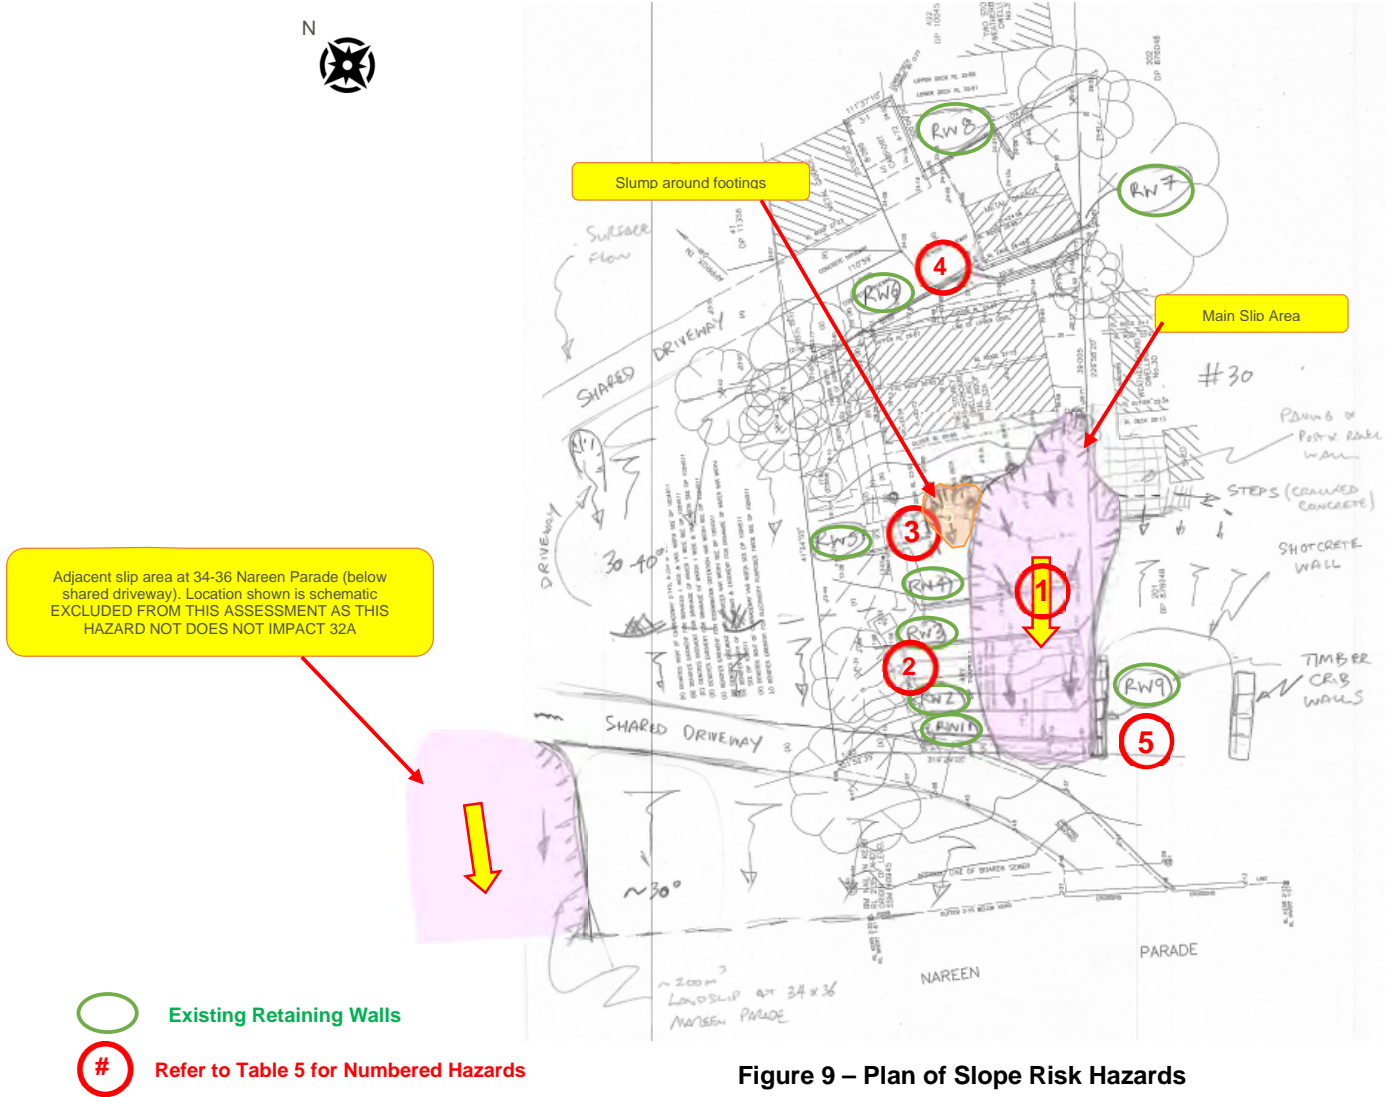
Figure 9 – Plan of Slope Risk Hazards

The itemised geotechnical hazards referred to in Table 5 are located as shown in Figures 9 & 10 overleaf.

Based on Appendix the AGS LRM Guideline, 'Low' risk to property is defined as '*Usually acceptable to regulators*'. Ongoing inspection and visual monitoring of slope and retaining wall performance is required as part of routine maintenance. Additional general recommendations for good construction practice on sloping sites is provided in Appendix D.

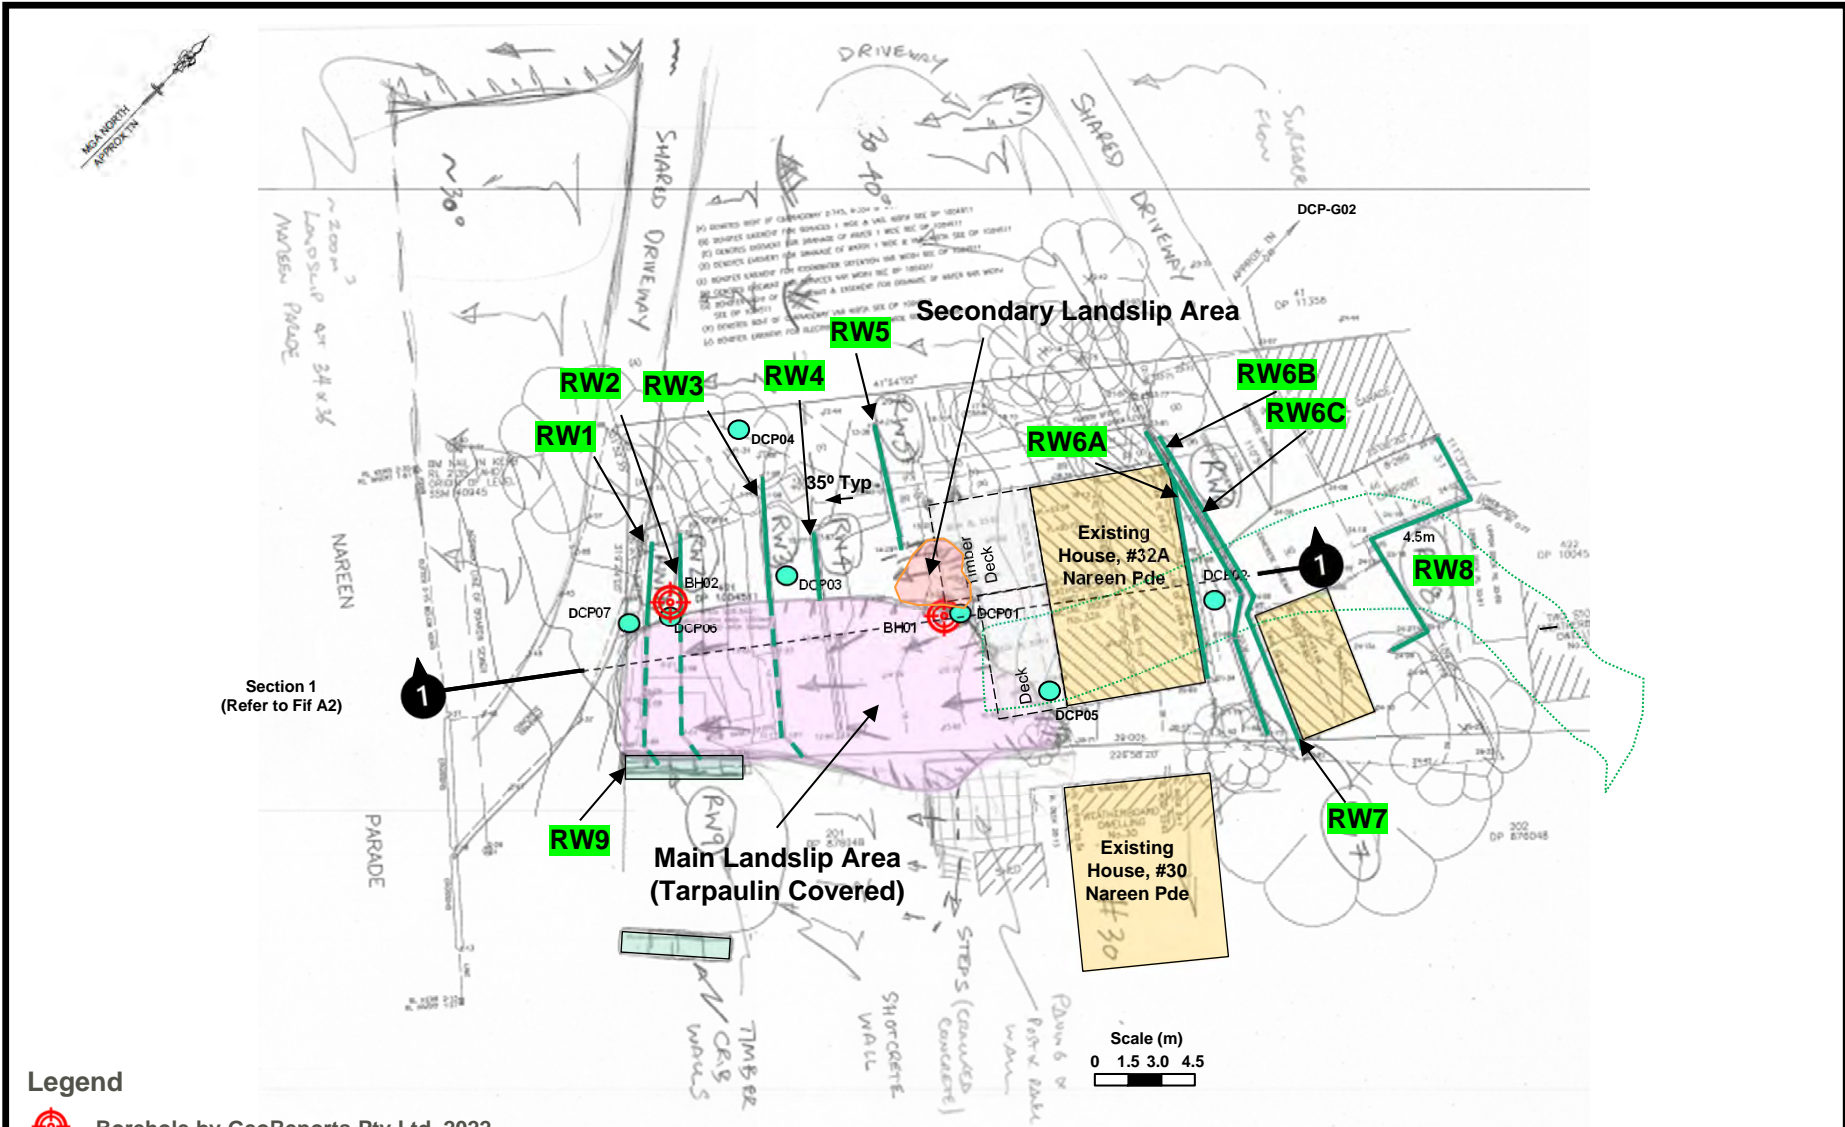
CLIENT		PROJECT		FIGURE
	Silver Wolf Projects Pty Ltd		32A Nareen Parade, Narrabeen		
	DRAWN	PD	DATE	TITLE	
	CHECKED	HD	DATE	Plan Showing Key Features	
SCALE	As shown (1:350)		PROJECT No	Reference	FIGURE
			2200103	2200103-001 2100103-001	A1

The landslide has an estimated volume of about 80-100m<sup>3</sup> and has resulted in removal of the uppermost 0.5m to 1.5m of topsoil across the landslide footprint. Extensive damage has occurred to multiple retaining walls as fluidised debris flows (inferred to be mainly re-worked colluvium) cascaded down the slope. The majority of the slip mass and broken wall materials have been removed off-site.

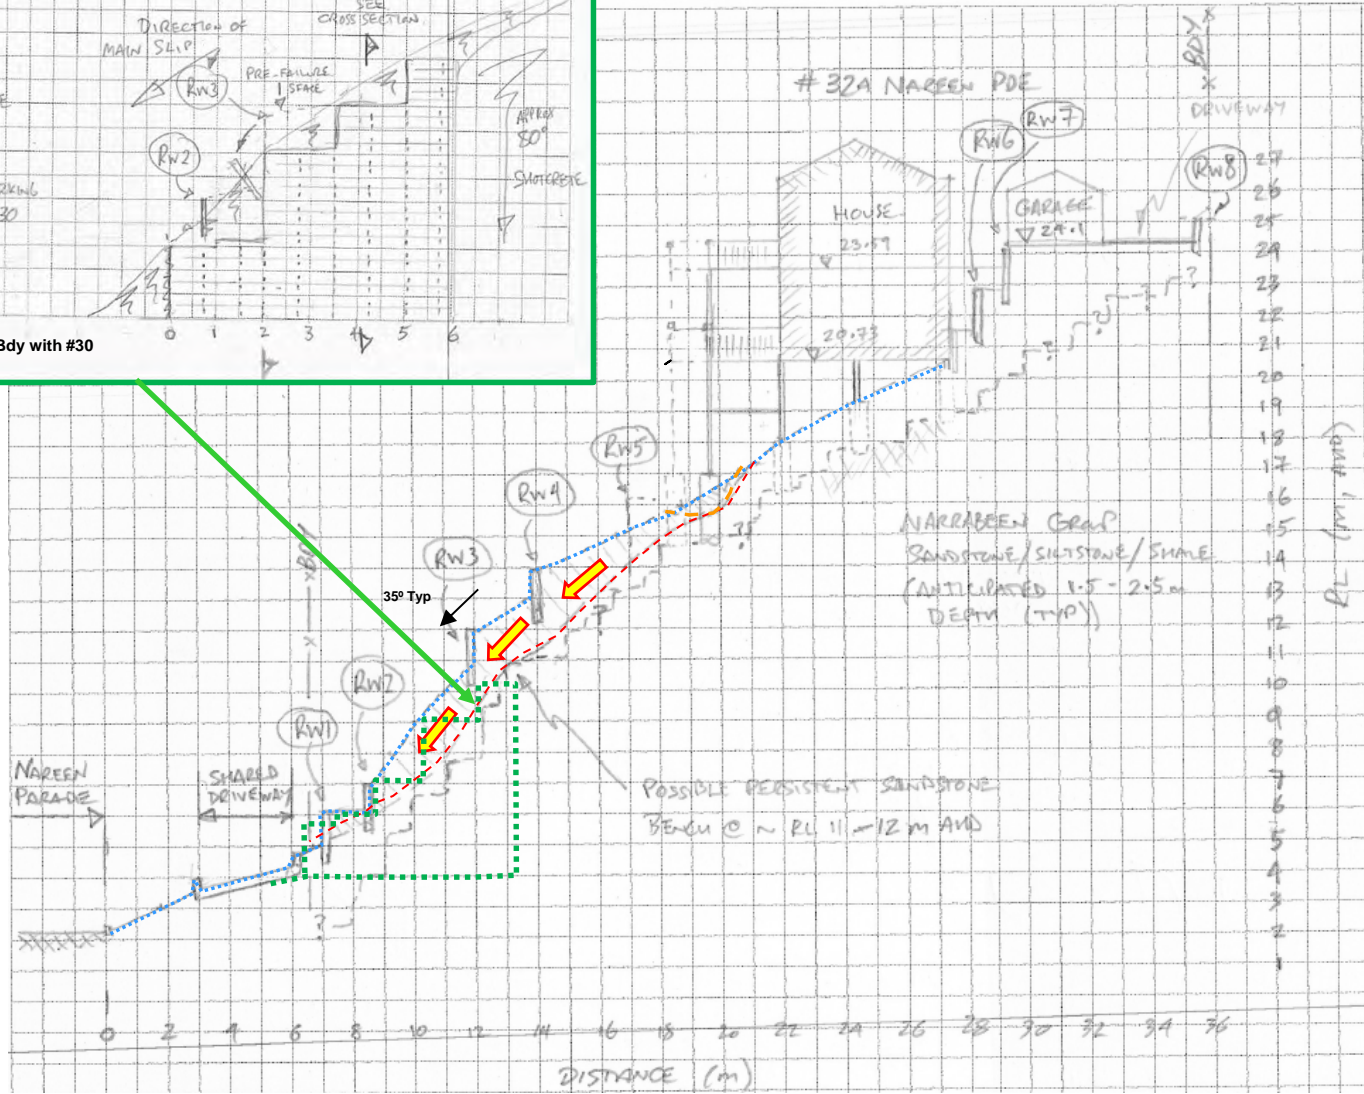
CLIENT Silver Wolf Projects Pty Ltd	PROJECT 32A Nareen Parade, Narrabeen	A4
DRAWN PD	DATE 06/10/2022	TITLE Cross Section 1 – Overall Site		
CHECKED HD	DATE 07/10/2022			
SCALE As shown	PROJECT No 2200103	Reference 2200103-001	FIGURE A2

Based on the observed subsurface observations and inferred consistency of materials identified during investigations and calibrated through back-analysis of the failed slope, the geotechnical design parameters shown in Table 1 are considered appropriate. Refer to Cross Sections in Figures A2 and A4 for the interpreted distribution of these materials.
