5 Kooloorra Avenue, Freshwater

Foundation Inspection: House Foundations

The site was inspected on the 27th June, 2024.

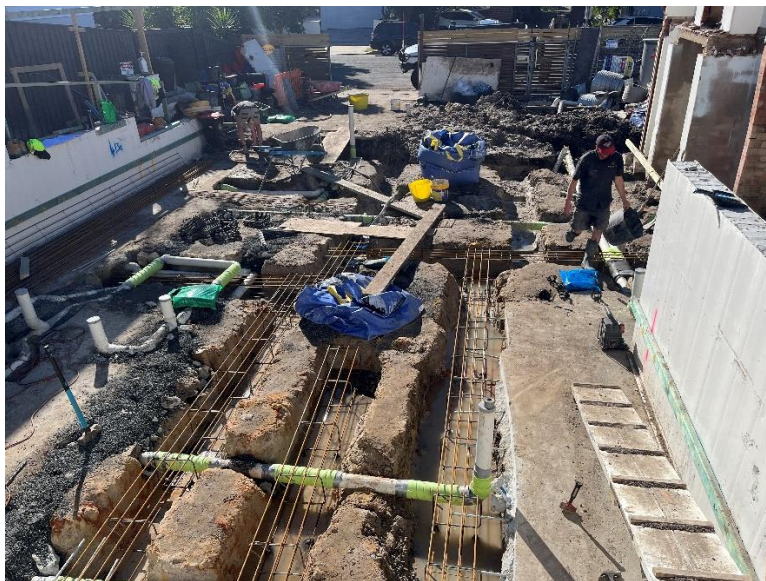
Photo 1

At the time of the inspection, the strip footings on the uphill side were complete and the shallow pier and beam footings on the downhill side were almost complete with a few more piers to be done. The as completed piers were taken to 0.3 to 0.6m below the strip footing. The piers were added to the downhill side to keep the bearing material more uniform across the sloping site.

Water was sitting on the foundation surfaces. As discussed with the Forman, as the bearing pressure of clay/clayey rock reduces significantly when it is saturated, just prior to the pour the soft wet layer of clay is to be scraped from the footing surface. If this is not feasible due to timing issues of the pour, a blinding layer of concrete can be added immediately after the soft clays have been scraped off the footing surface to seal it.

Provided the above recommendations are carried out the foundation material is considered adequate to support the likely loads from the house.
