REPORT TO
MELINE NAZLOOMIAN

ON
GEOTECHNICAL ASSESSMENT

FOR
PROPOSED ALTERATIONS AND ADDITIONS

AT
5 BARRABOOKA STREET, CLONTARF, NSW

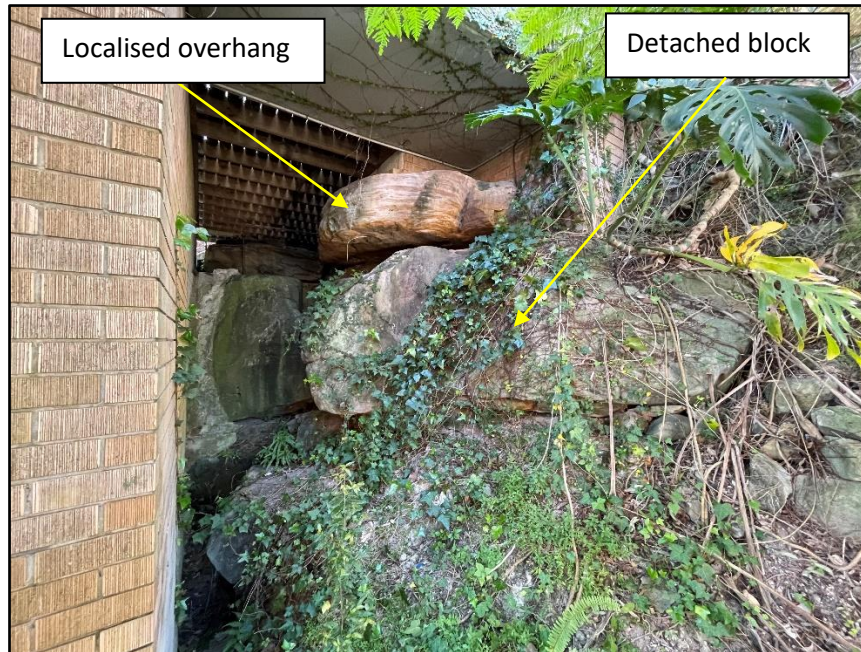
The sandstone cliff line within the subject site was located below the aforementioned timber deck and was orientated in an approximately north-south direction. The sandstone cliff line was up to a maximum height of approximately 3.5m beside the south-eastern corner of the house. In this area, the sandstone cliff face exposed several near horizontal bedding partings and sub-vertical joints orientated (i.e. striking) to the north-east and south-east at approximately 022° and 126°, respectively. The identified discontinuities had formed a localised overhang that was a maximum horizontal depth of approximately 1.4m and isolated several detached blocks which were between 0.5m and 1.8m thick. One of the detached blocks had shifted between approximately 0.2m and 0.5m away from the cliff line in a south-westerly direction; see Plate 1 below. Observations were somewhat limited due to the existing vegetation surrounding the southern end of the cliff line.

Plate 1: Overhang and detached block located beside the south-eastern corner of the house

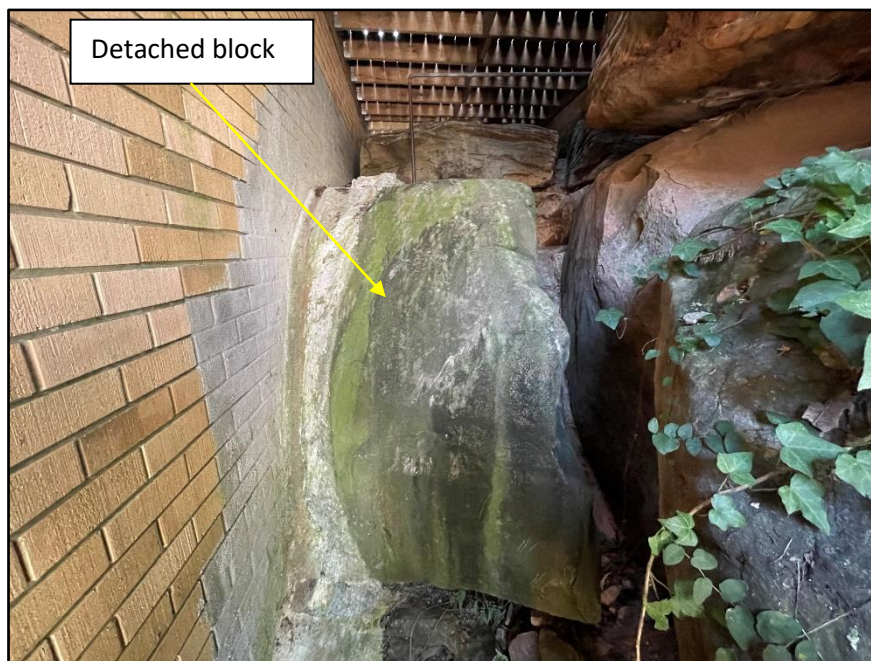
It is possible that a portion of the eastern brick wall of the house had been founded on a large detached block within the cliff line, although this could not be confirmed due to an existing drainage channel and previous waterproofing of the wall; see Plate 2 below.

Plate 2: Detached block located against (or possible below) the eastern brick wall of the house

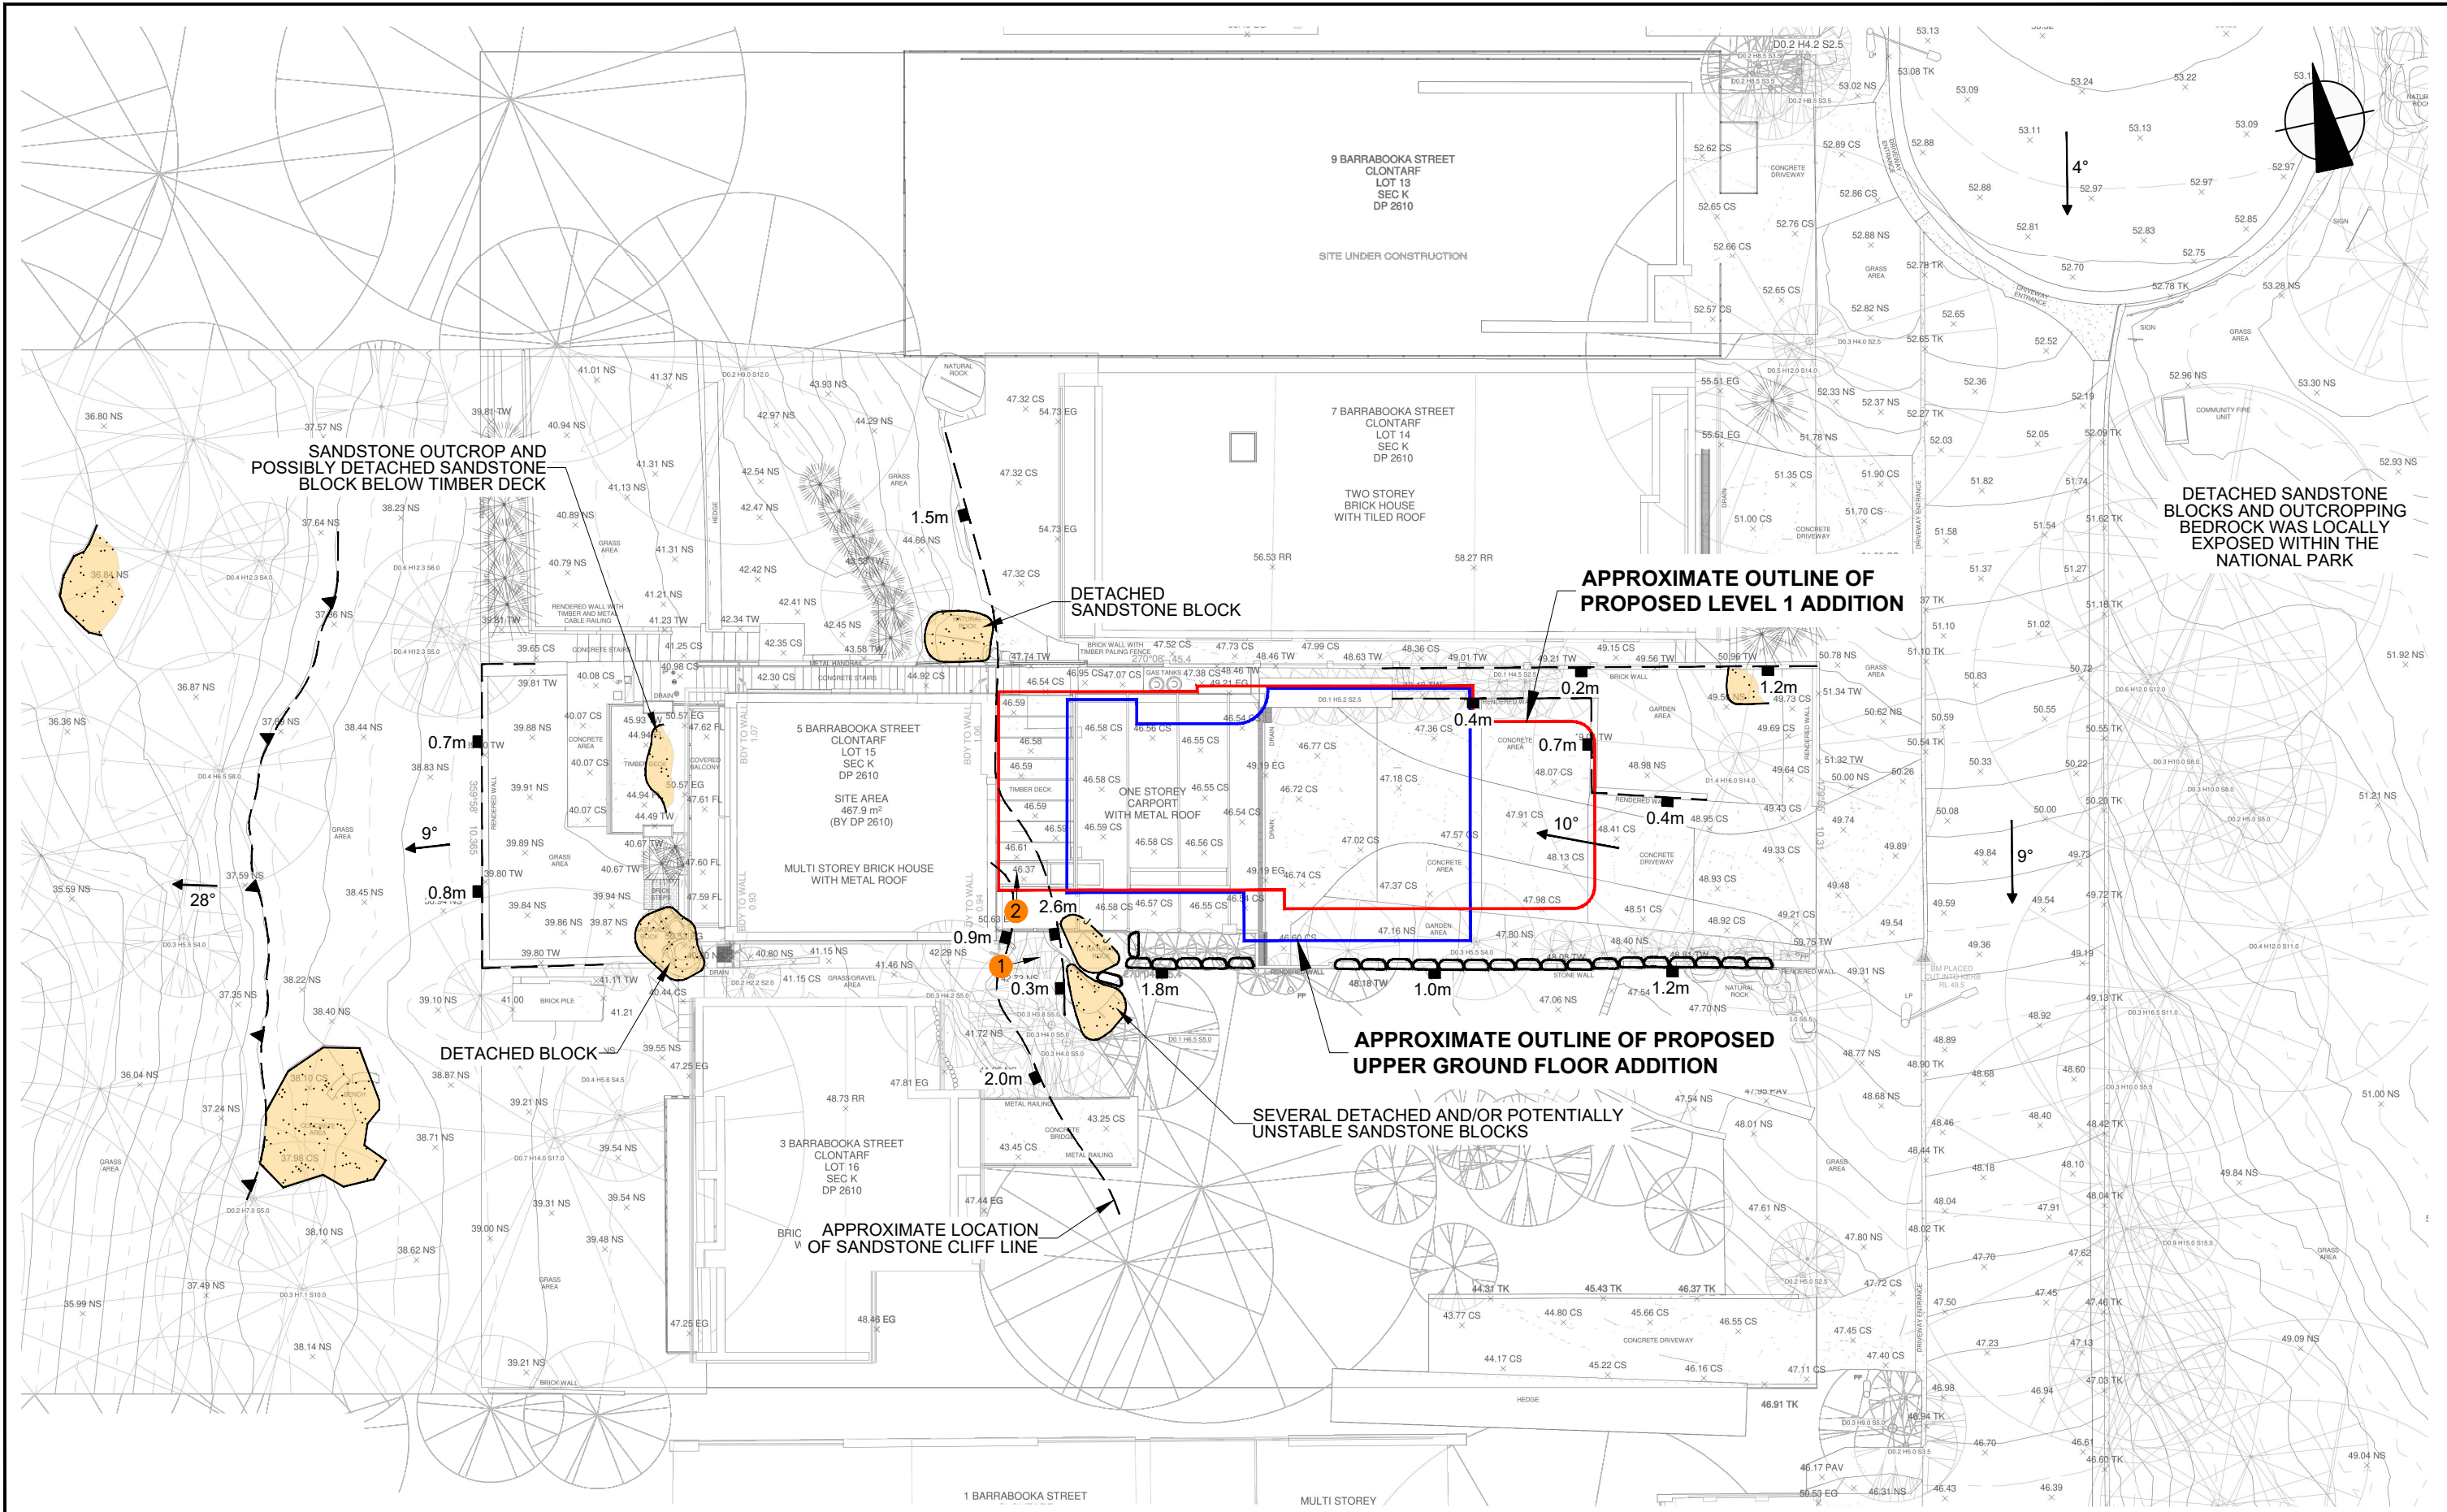
The attached Figure 2 presents a geotechnical site plan with the various features identified on site during our walkover assessment. These features were measured by hand held clinometer and tape measure techniques and hence are only approximate. Should any of these features be critical to the proposed development, we recommend they be located more accurately using instrument survey techniques. Figure 2 is based on the survey plan prepared C & A Surveyors NSW Pty Ltd (Reference No. 30921-23, dated 3 November 2023) and Figure 3 defines the mapping symbols used.
