J2915. 20<sup>th</sup> November, 2020. Page 1.

# **GEOTECHNICAL INVESTIGATION:**

## Alterations and Additions at **114 Whale Beach Road, Whale Beach**

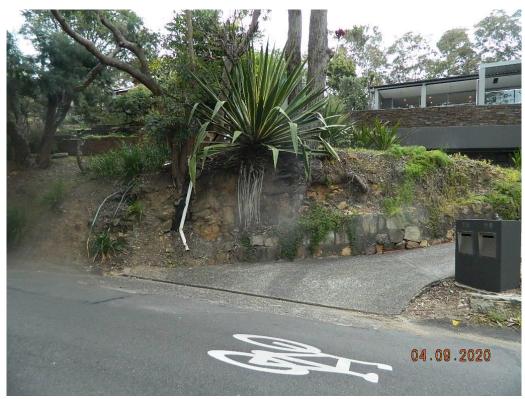
Photo 1

**2.3** The property is accessed by a concrete right of carriageway (ROW) (Photos 1 & 2). The upper portion of the cut for the driveway is unsupported and the lower portion of the cut is supported by a low sandstone flagging retaining wall in poor condition. A portion of the wall has partially collapsed but the wall will be replaced as

(Hazard One). The proposed fill is a potential hazard until retaining walls are in place (Hazard Two). The proposed excavation is a potential hazard until retaining walls are in place (Hazard Three). The proposed excavation undercutting the tree above the existing driveway (Photos 1 & 3) is a potential hazard (Hazard Four).

HAZARDS	Hazard Three	Hazard Four	
ТҮРЕ	The proposed excavation collapsing onto the worksite during the excavation process.	The proposed excavation undercutting the tree above the existing driveway causing failure (Photos 1 & 3).	
LIKELIHOOD	'Possible' (10 <sup>-3</sup> )	'Possible' (10⁻³)	
CONSEQUENCES TO PROPERTY	'Medium' (15%)	'Minor' (8%)	
RISK TO PROPERTY	'Moderate' (2 x 10 <sup>-4</sup> )	'Moderate' (5 x 10 <sup>-5</sup> )	
RISK TO LIFE	8.3 x 10 <sup>-6</sup> /annum	5.3 x 10 <sup>-3</sup> /annum	
COMMENTS	This level of risk to life and property is 'UNACCEPTABLE'. To move the risk to 'ACCEPTABLE' levels, the recommendations in <b>Section 13</b> are to be followed.	This level of risk to life and property is 'UNACCEPTABLE'. To move risk to 'ACCEPTABLE' levels, the recommendations in <b>Section 13</b> are to be followed.

An excavation to a maximum depth of ~1.5m will be required to extend the driveway. The excavation will come close to a tree above the existing driveway (Photos 1 & 3). For safety reasons and to ensure the ongoing durability of the proposed retaining wall for the driveway, the tree is to be removed prior to the excavation commencing.

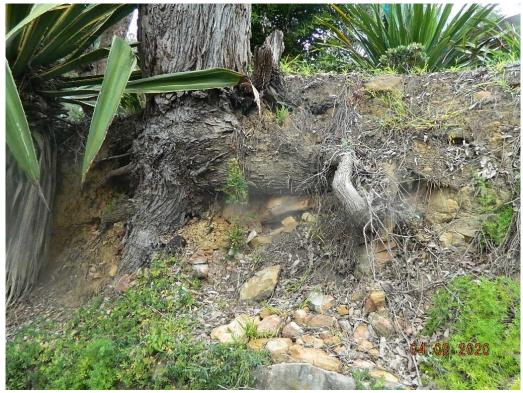
Photo 3

part of the proposed works. A large tree is located directly above the cut. Parts of the tree's roots are exposed near the base of the tree. Clay and weathered sandstone is visible below and beside the exposed roots (Photo 3). This material shows signs of minor erosion and has reeled back slightly over time. The proposed retaining wall will support this portion of the cut.

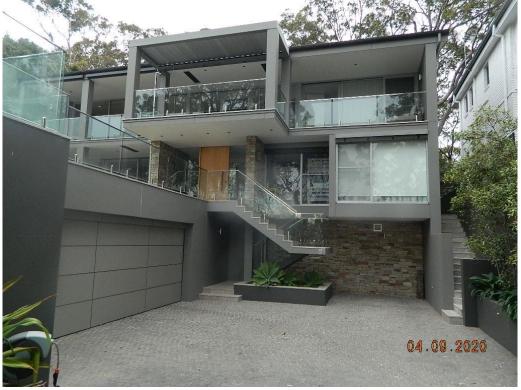
Photo 4

The driveway runs to a paved parking area and garage (Photo 4). The cut for the parking area is supported by a rendered retaining wall up to ~3m high in good condition (Photo 5). Next to the parking area is an above ground pool and terrace/lawn area in good condition (Photo 6). The garage is located below the terrace. The part three storey house is supported by rendered walls and stone dressed concrete walls (Photos 4 & 7). The external supporting walls show no significant signs of movement. Fill provides level lawn and garden areas on the SW side of the property (Photos 8 to 10). The fill is supported by low timber retaining walls and a stable ~1.6m high concrete block retaining wall. Overall the slope across the property is considered stable. The adjoining neighbouring properties pose no risk of instability to the subject property as seen from the street and subject property.

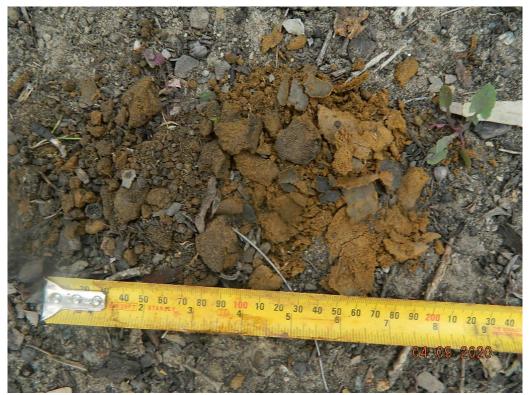
AUGER HOLE 1 (~RL55.1) - AH1 (photo 11)

Depth (m)	Material Encountered
0.0 to 0.1	<b>TOPSOIL</b> , sandy soil, brown, dry, fine to medium grained.
0.1 to 0.2	<b>SANDY CLAY</b> , orange brown, stiff to very stiff, dry.

Refusal @ 0.2m in stiff to very stiff clay. No watertable encountered.

Photo 11: AH1 – Downhole is from left to right.

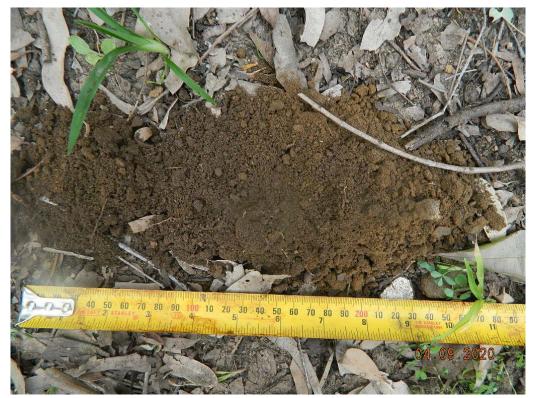
## AUGER HOLE 1 (~RL55.4) - AH1 (photo 12)

Depth (m)	Material Encountered	
0.0 to 0.1	<b>TOPSOIL</b> , sandy soil, brown, dry, fine to medium grained.	
0.1 to 0.2	SANDY CLAY, orange brown, stiff to very stiff, dry.

Refusal @ 0.2m in stiff to very stiff clay. No watertable encountered.

Photo 12: AH2 – Downhole is from left to right.
