Geotechnical Assessment

Project: Alterations & Additions
21 Park Street, Collaroy NSW

Ref: AG 24195
10 July 2024

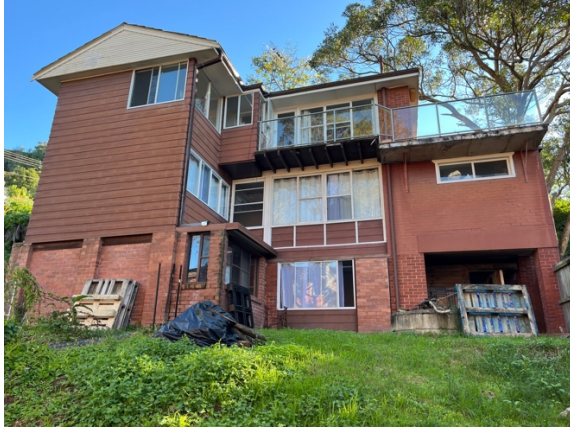
Photo 1: Eastern side of residence

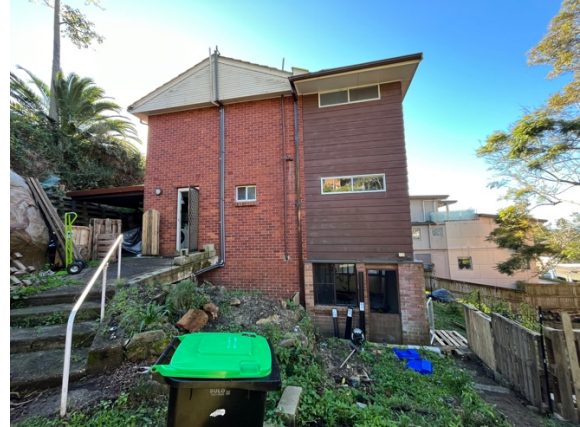
Photo 2: Southern side of residence

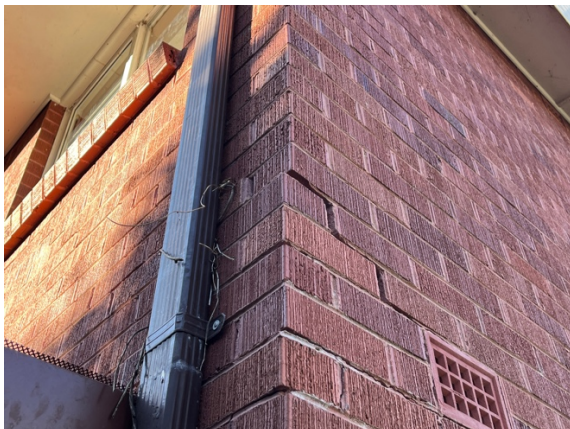
The existing building at the site is a three-storey house which is in dilapidated condition and shows signs of differential settlement, particularly at the southwestern corner where the brickwork has cracked and rotated (Photo 4). The pool and surrounding area is in poor condition, with a significant crack observed in the concrete wall upslope of the western side of the pool (Photo 7).

- The damage observed in the existing structure (photo 4) is attributed to inadequate and inconsistent foundation materials, potentially in combination with point loads from the boulder shown in Photo 6 which is in direct contact with the brickwork, as opposed to slope instability more generally.
- The property is classified as **Area D & E** with reference to Northern Beaches Council WLEP – Warringah Landslip Risk Map (**Image 2**).

Photo 4: Cracking and rotation of brickwork in south-western corner of the residence

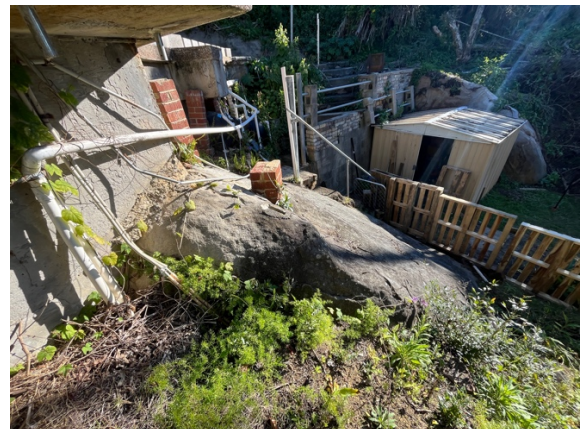
Photo 5: Sandstone boulder under pool

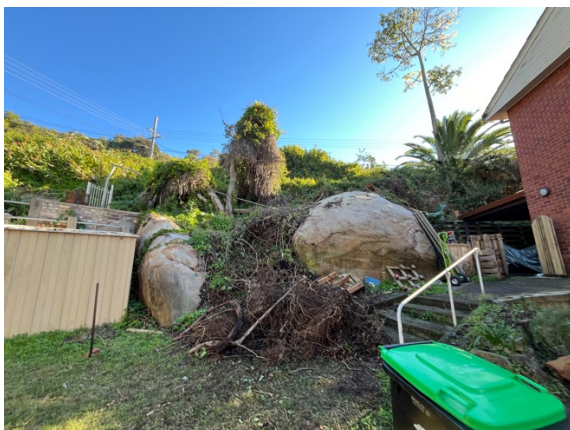
There are three very large sandstone boulders are present within the southern portion of the site (Photos 5 & 6). The pool has been founded partly on the boulder of Photo 6. The boulders are embedded within the soil profile and are likely to have originated from the Hawkesbury Sandstone unit represented in the current escarpment of Collaroy Plateau in an historical (>1000 year) rock fall event. A fourth boulder is present at the south-western corner of the house, under the concrete slab and where the brickwork of the existing house has been cut to fit, the boulder sits upon uncontrolled fill, sandy materials and brick pieces and is indirect contact with the brickwork (Photo 7). Bedrock was not outcropping on the subject site.

Photo 5: Two large sandstone boulders to the south west of the residence

<p>Sandstone Boulder Excavation / Removal</p>	<p>AscentGeo should be contacted once the specific details of the proposed sandstone boulder removal are decided upon.</p> <p>Generally, we would recommend the boulders be demolished in a staged, top-down approach, with consideration to be given to portions of the slope or structures (i.e. the pool) that that the boulders may be supporting.</p> <p>Where the geometry of the boulder are unknown (e.g. where the boulder is deeply embedded in the soil, or covered by the pool structure) and where significant removal of rock is proposed, we will recommend the boulder be removed in its entirety to eliminate uncertainties about the geometry and</p>

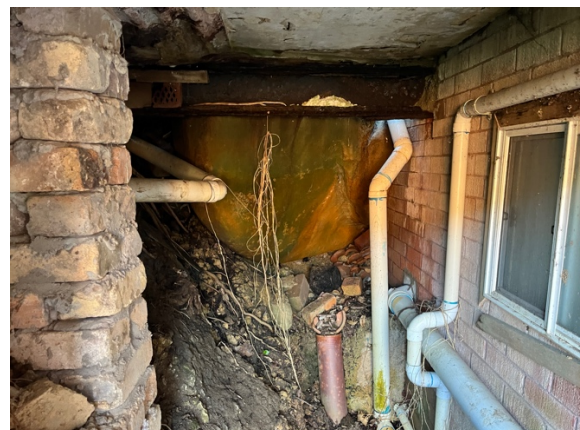
Photo 6: Sandstone boulder under the slab at the south-western corner of the house sits upon uncontrolled fill, sandy materials and brick pieces.

Recommendation	Description															
	<p>weight distribution of the remaining boulder. This may necessitate underpinning of the pool and/or slope stabilisation measures.</p> <p>We recommend that the boulder shown in Photo 6 be removed in its entirety. This boulder is sitting on uncontrolled fill materials including sands and brick pieces and is in direct contact with the brickwork at the south-western corner of the house. The boulder may be applying point loads to the structure and may be a contributing factor in the damage noted in Photo 4. Given this boulder is sitting on uncontrolled fill materials, it has a much greater potential for movement than the other large sandstone boulders on the site.</p> <p>Where large floaters are to be removed methods for removal may vary depending on their location, orientational geometry, and proximity to structures to be retained. Methods may include, rock breaking, rock sawing, or methodical break-up with expanding grout.</p>															
<p>Vibrations</p>	<p>The Australian Standard AS2670.1–2001 ‘Evaluation of human exposure to whole-body vibration General requirements. Part 1: General requirements’, suggests a daytime limit of 5mm/s component PPV for human comfort is acceptable. In general, vibration criteria for human disturbance are more stringent than vibration criteria for effects on building contents and building structural damage. Hence, compliance with the more stringent limits dictated for human exposure, would ensure that compliance is also achieved for the other two categories. Furthermore, it is noted that this approach satisfies the requirements of Appendix J of AS2187.2–2006 ‘Explosives – storage and use’, which also limits PPV to 5mm/s for residential settings.</p> <p>As such, we would suggest that the recommendations for method and/or equipment presented in the table below be adopted to maintain an allowable vibration limit of 5mm/s PPV.</p>

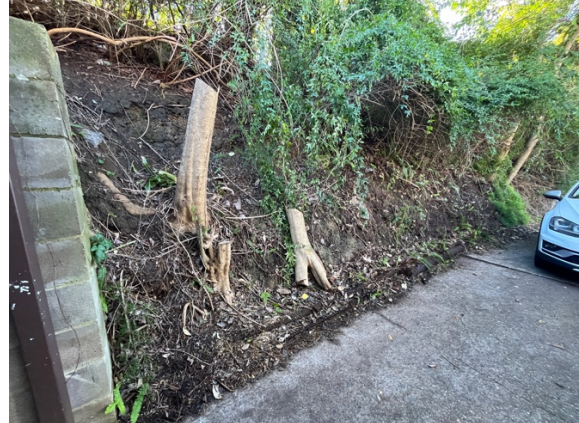
Photo 8: Uncontrolled slope on the western side of the driveway access

Recommendation	Description
	<p>Whilst not a requirement of this report, we suggest that consideration be given to the construction of a retaining wall along the upslope side of the driveway cut batter (Photo 8). We note that this area may be outside the site boundary and may require permissions from neighbours.</p>
<p>Footings</p>	<p>We recommend that all new footings are taken to and socketed no less than 500mm into the underlying shale bedrock (Unit 3) using piers as required.</p> <p>The allowable bearing pressure for footings taken to competent weathered bedrock of at least low strength is 600kPa. Higher allowable bearing capacities may be achievable subject to inspection and certification of excavated footings by AscentGeo.</p> <p>Pier footings should be of sufficient diameter to enable effective base cleaning to be carried out during construction. Small diameter piers that cannot be cleaned should be designed for shaft friction, resulting in a longer rock socket.</p> <p>To mitigate the risk of differential settlement, it is essential that all footings are founded on competent bedrock of similar consistency.</p> <p>It is essential that the foundation materials of all footing excavations be inspected and approved before steel reinforcement and concrete is placed. This inspection should be scheduled while excavation plant and operators are still on site, and before steel reinforcement has been fixed or the concrete booked.</p>
