PRELIMINARY GEOTECHNICAL ASSESSMENT:

54 Curl Curl Parade, Curl Curl

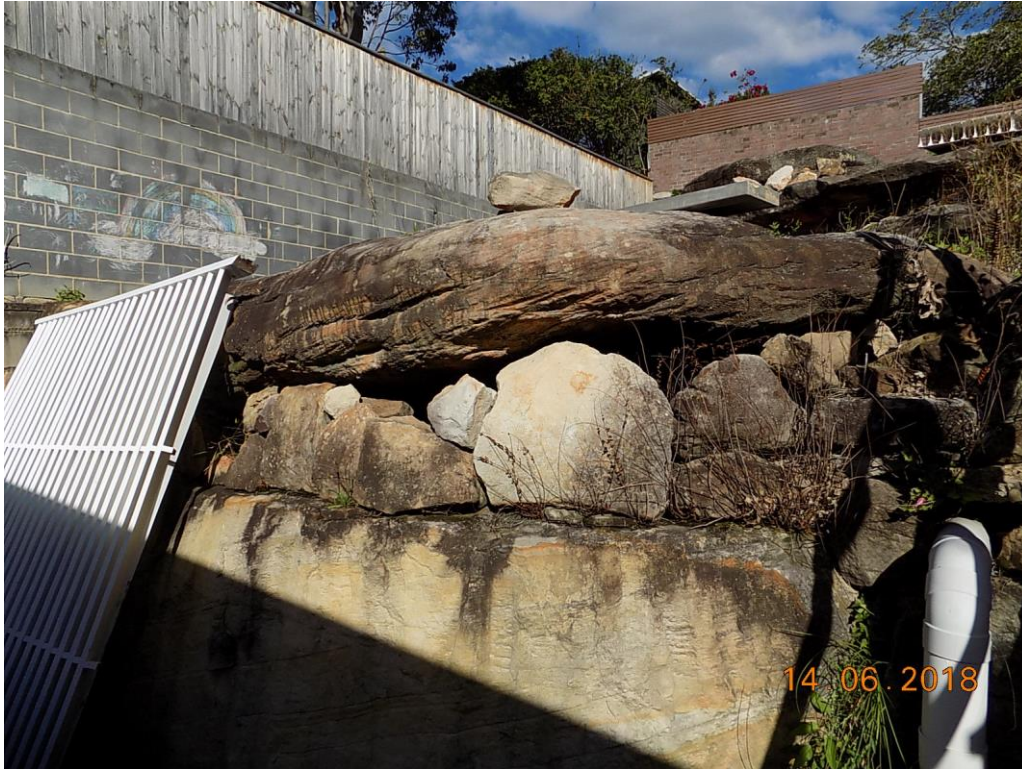
Photo 1

The proposed footprint of the pool may extend over the undercut rock (Photo 1). If the footings for the pool are to be supported on the undercut portion of the rock, the undercut joint block is to be underpinned using blade walls designed by the structural engineer in consultation with the geotechnical consultant. If the pool footings are to be set back from the undercut, no additional support is required.

- All footings, including those for the possible blade walls, are to be inspected and approved by the geotechnical consultant while the excavation equipment is still onsite and before steel reinforcing is placed or concrete is poured
