EVERGREEN TREE SERVICES

ATTN: Claire Cavanaugh
SUBJ: Tree Report as requested....24 Delecta Ave Clareville
DATE: 3 Apr 18

Observations and Recommendation(s)...24 Delecta Ave Clareville.

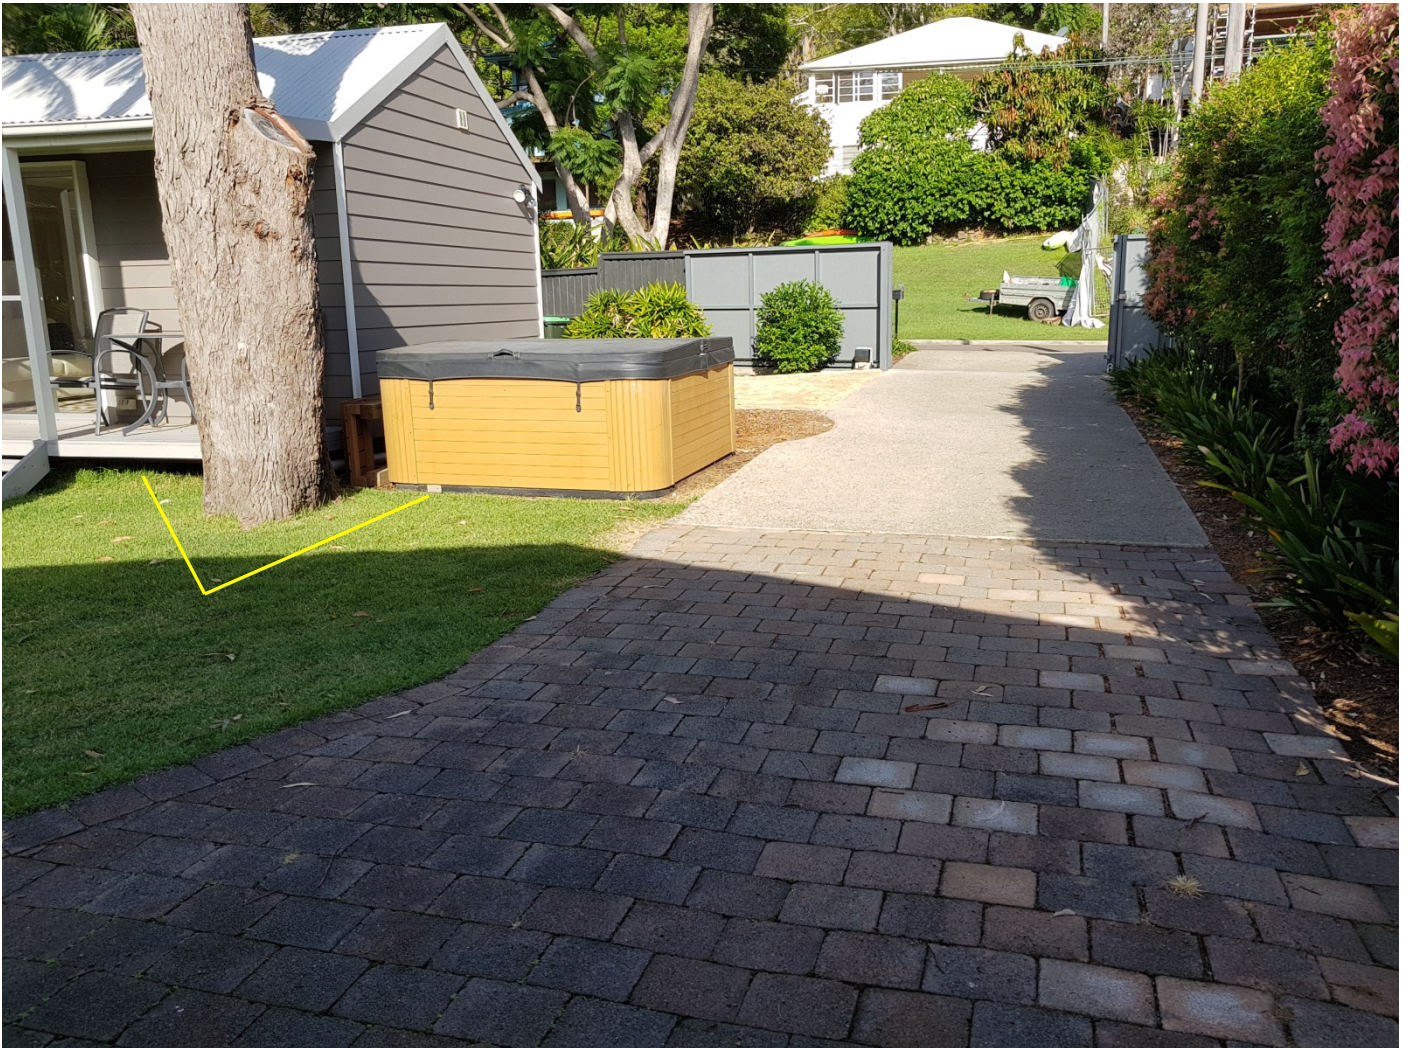
The present paving which is to be removed, is situated on a shallow concrete slab which has been in situ for some years. The proposed construction will have minimal impact of the roots of the tree in situ and additionally, as the earlier shallow concrete slab has not affected the progress or nature of the eucalypt, it is determined the tree will not have any major issues via the proposed construction.

Tree guard in situ

Paving to be removed and replaced with concrete driveway,

Recommendation is given however, to the erection of a tree protection barrier, approx. 2 metres in height, in a triangular form, 1.5mtrs from the trunk of the tree, to eliminate the possibility of damage, scarring or bruising of the bark/sapwood of the tree trunk.

A follow up fertilisation application to the drip line zone is recommended, within 7 days of the completion of works.
