PRELIMINARY GEOTECHNICAL ASSESSMENT:

12 Horning Parade, Manly Vale

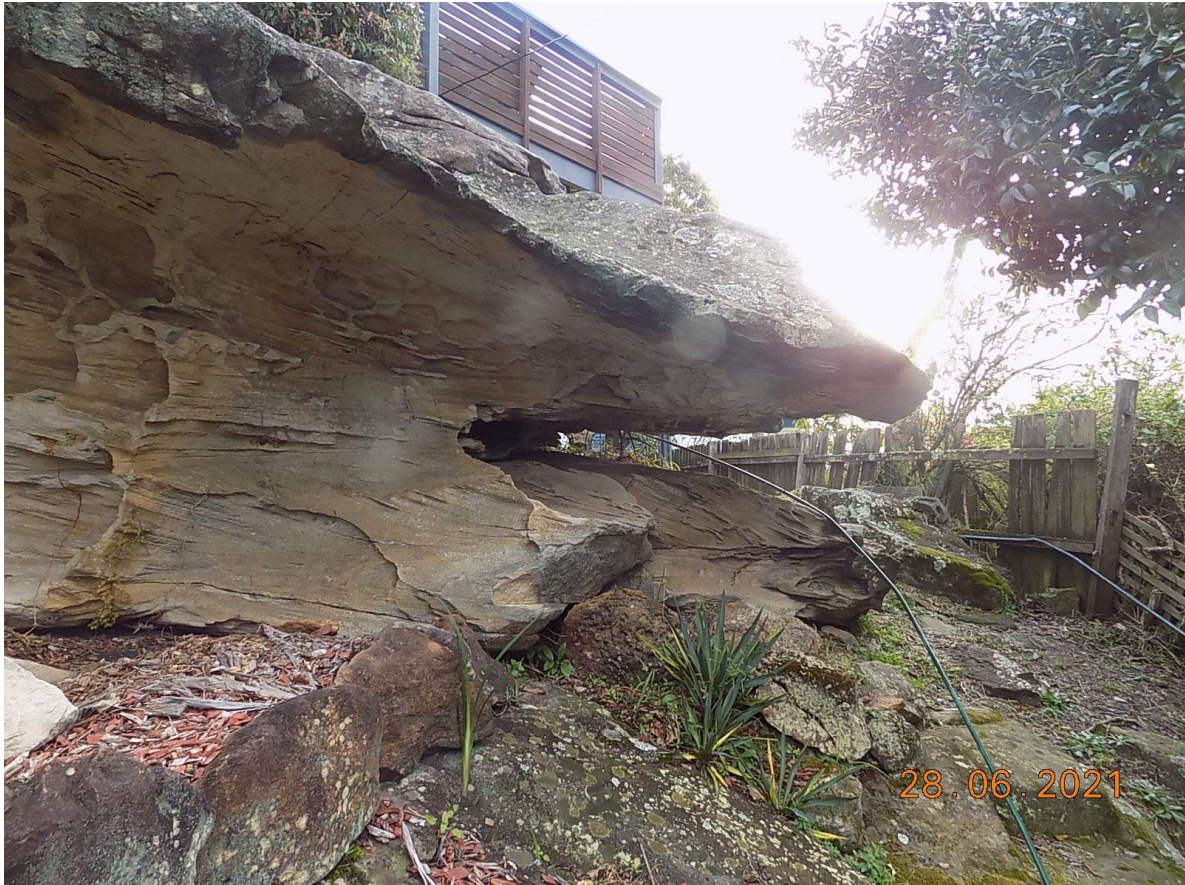
Photo 1

The natural slope rises across the site at an average angle of ~19°. At the road frontage, a concrete driveway runs to a timber framed and clad garage that will be demolished as part of the proposed works. The ~3.0m high cut for the garage has been taken entirely through competent Medium Strength Sandstone and displays no significant geological defects. A ~3.0m high rock face rises between the garage and the house. A portion of the outcrop has been undercut to ~1.2m (Photo 1). The relatively thick cantilever arm of the undercut rock does not show any jointing or cracking as viewed from above and below. As such, the rock is currently considered stable. See **Section 5** for recommendations regarding the proposed deck extension in this location. The single-storey brick and timber framed and clad house is supported on brick walls and steel and timber posts. The supporting brick walls of the house display no significant signs of movement and the supporting posts stand vertical. Some of the walls and piers were observed to be supported directly onto outcropping sandstone. An

The footprint of the proposed deck extension extends over the undercut rock (Photo 1). We recommend no footings for the deck extension be supported on the undercut portion of the rock. Alternatively, the undercut can be supported by not less than 0.5m x 0.5m piers, one of which is under the point load from any deck footing. The piers are to be designed by the structural engineer in consultation with the geotechnical consultant.
