GEOTECHNICAL INVESTIGATION:

New pool and Retaining Walls at 2/86 Anzac Avenue, Collaroy
aka: 58B Suffolk Avenue, Collaroy

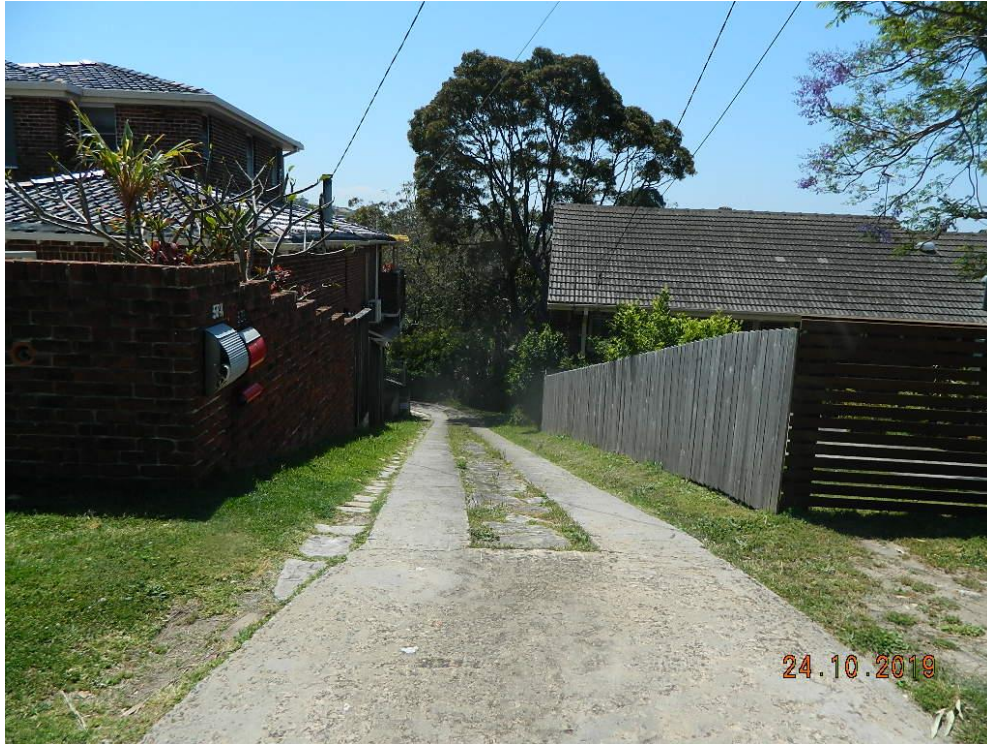
Photo 1

- 2.3** A concrete Right of Carriageway (ROW) extends downslope from Suffolk Ave to the property (Photo 1). Below the ROW a carport and timber stair case extend to the house (Photo 2). Next to the staircase is a landscaped slope that has been terraced with rough stack rock retaining walls (Photo 3). The up most stack rock retaining wall that lines the fill batter for the ROW has partially collapsed over a width of ~ 2.0m. The failed portion shows the fill consists of sandstone gravel and boulders (Photo 4). It is covered with a tarp (Photo 5). See **Section 16** for recommended remedial works that require immediate action. The plans show new retaining walls will be constructed as part of the proposed development for the pool below. The cut for the house is

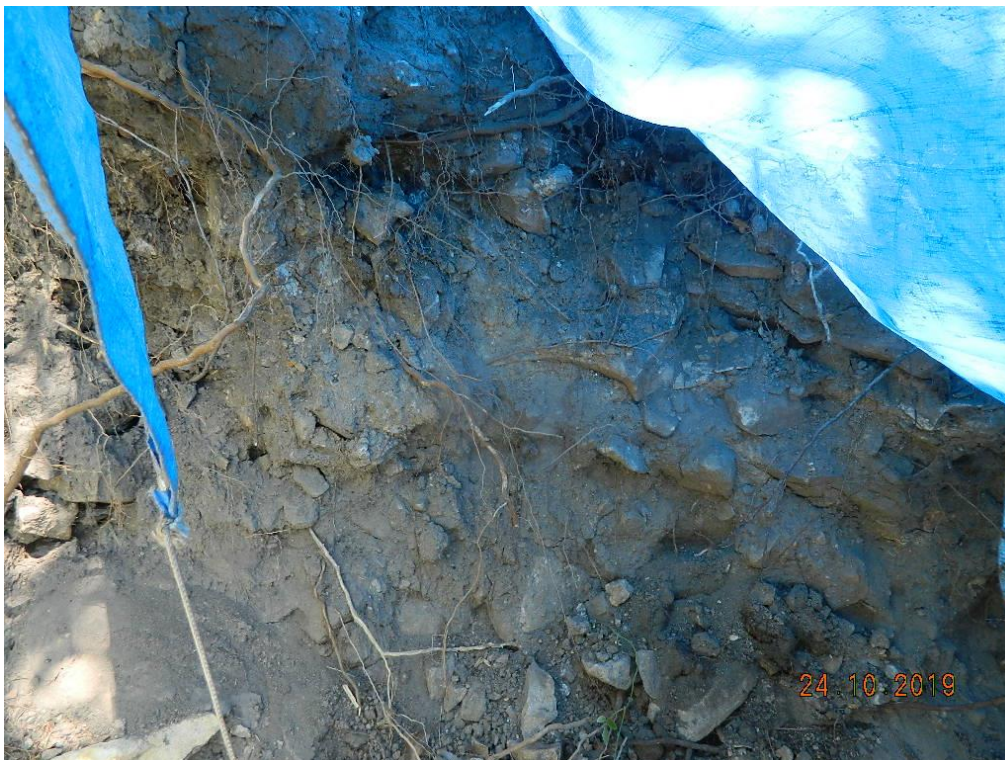
Photo 4

HAZARDS	Hazard One	Hazard Two	Hazard Three
TYPE	The vibrations produced during the proposed excavations impacting on the surrounding structures.	The proposed excavation collapsing onto the work site before the retaining walls are in place.	The fill batter for the ROW falling before new walls are in place (Photo 4).
LIKELIHOOD	'Possible' (10^{-3})	'Possible' (10^{-3})	'Likely' (10^{-2})
CONSEQUENCES TO PROPERTY	'Medium' (15%)	'Medium' (12%)	'Medium' (20%)
RISK TO PROPERTY	'Moderate' (2×10^{-4})	'Moderate' (2×10^{-4})	'Moderate' (6×10^{-4})
RISK TO LIFE	5.3×10^{-7} /annum	8.3×10^{-6} /annum	5.3×10^{-5} /annum
COMMENTS	This level of risk to property is 'UNACCEPTABLE'. To move risk to 'ACCEPTABLE' levels, the recommendations in Section 12 are to be followed.	This level of risk to life and property is 'UNACCEPTABLE'. To move risk to 'ACCEPTABLE' levels, the recommendations in Section 13 are to be followed.	This level of risk to life and property is 'UNACCEPTABLE'. To move risk to 'ACCEPTABLE' levels, the recommendations in Section 16 & 13 are to be followed.

Currently a stack rock retaining wall lining the fill batter for the ROW has partially collapsed. See recommended remedial works in **Section 16**.

It is recommended the failed portion of the fill batter for the ROW be temporarily supported with a sandbag retaining wall to be installed immediately. The wall is to be not less than 0.8m wide at the base. The back of the wall is to be flush against the remaining face of the failed material. The face of the sandbag wall is to be tapered back at $\sim 20^\circ$ from vertical from the downhill toe edge. It is recommended the sandbags be filled with 10% cement so once they are in place they set hard. This way they can remain in place permanently noting the proposed retaining wall below will be built and the backfill will cover/ partially cover the sandbag wall.

Until these works are complete the fill batter should be monitored by the owners on a daily basis. If further movement is noted in the fill batter the driveway is to be barricaded off so cars cannot access the ROW. Our office is to be informed immediately.

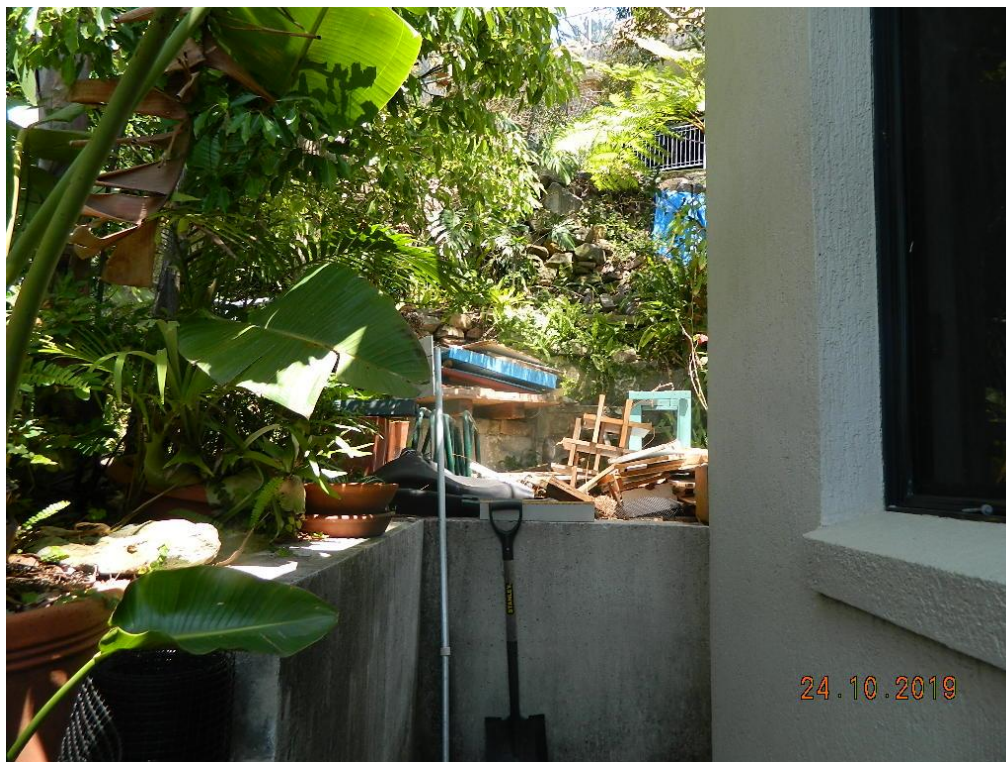
Photo 6

supported by a 1.0m concrete retaining wall (Photo 6). The one and two storey rendered house extends downslope where it ends at a party wall dividing the house and where the block below begins. There are no visible signs of movement and the house is considered stable.

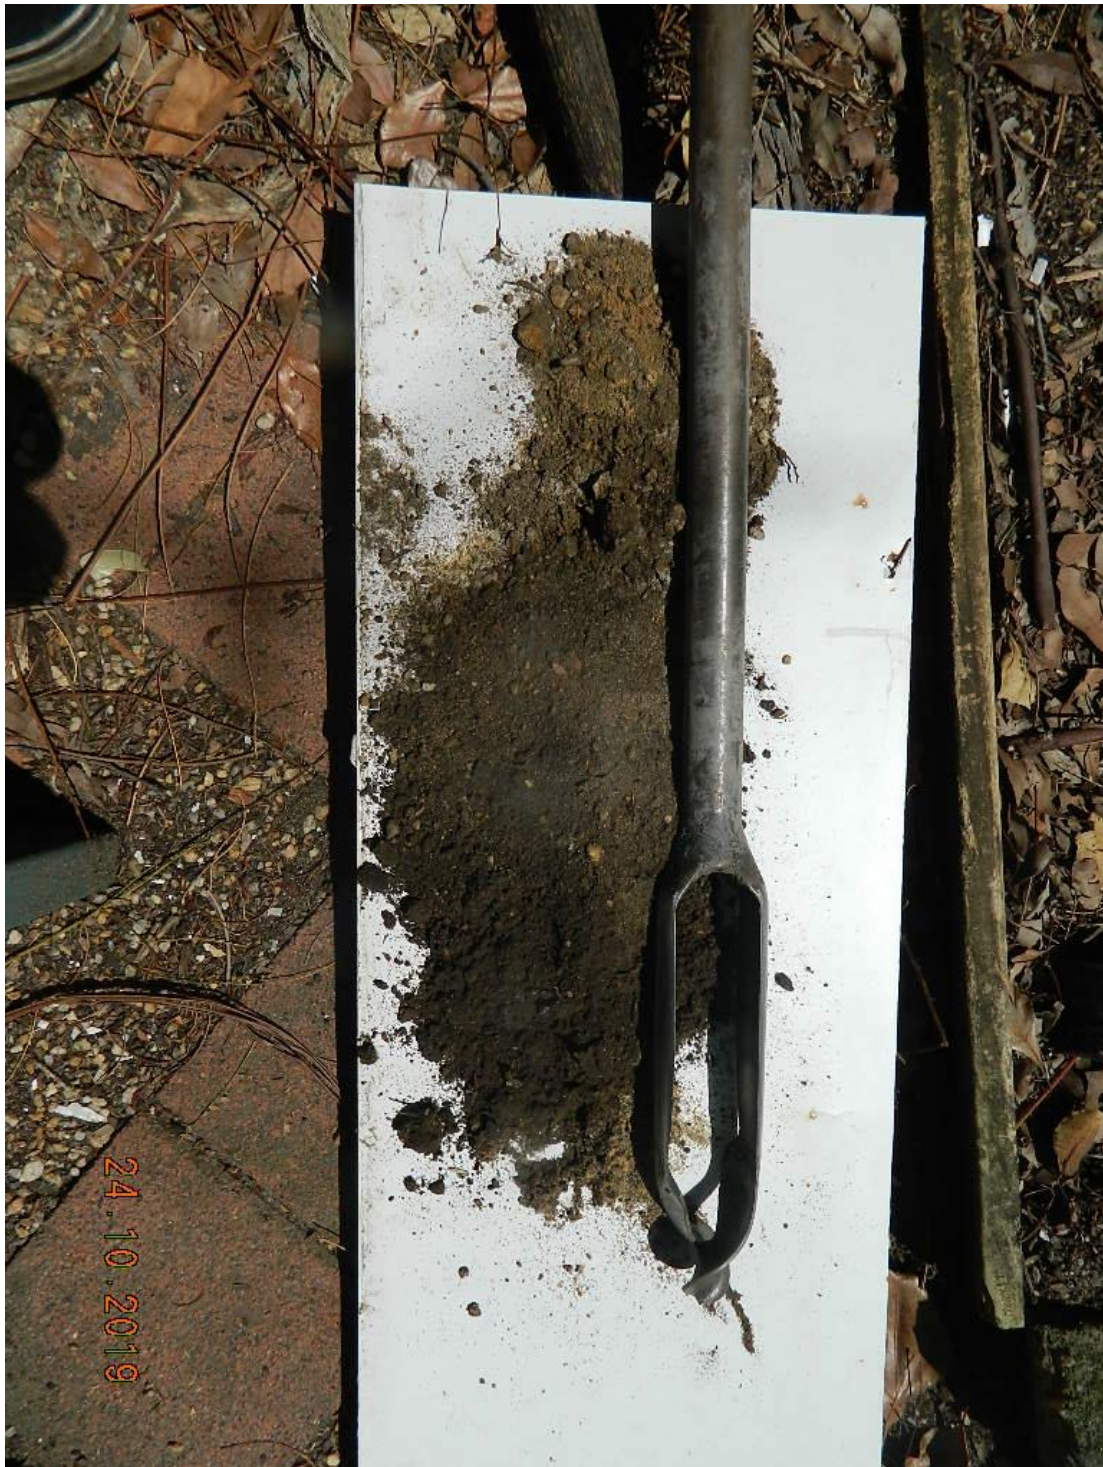
Photo 7 – AH1

AUGER HOLE 1 (~RL54.3) – AH1 (Photo 6)

Depth (m)	Material Encountered
0.0 to 0.5	SANDY SOIL , dark brown, medium grained with gravel.

Refusal @ 0.5m grinding on rock. No watertable encountered.
