Geotechnical Site Investigation Report for Proposed Single Dwelling

Project Address: 237 Mccarrs Creek Road, Church Point NSW 2105

Project No: KFMGR-00255

Date: 25/10/2024

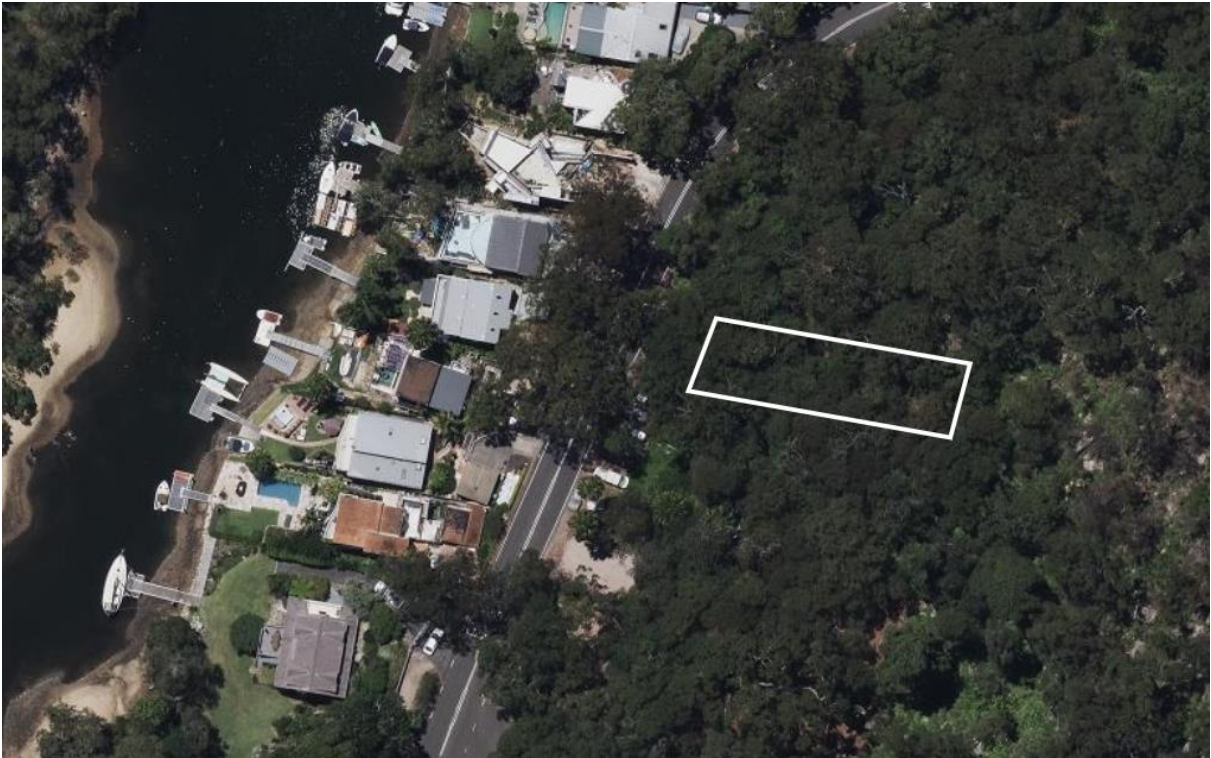
Figure 1. Aerial Photograph of the site

- No sign of slope instability was observed across the site.

The building in the adjacent southern properties (No. 241 and No. 243) are approximately 3m and 15m away from the proposed building on the site. At No. 241, excavation work has been completed, and the garage floor has been constructed, with the remainder of the building still under construction. Meanwhile, No. 243 contains a two-story building that spans approximately 10 meters in width. Notably the slope of the adjacent sites No. 241 and 243 is roughly the same as the site.

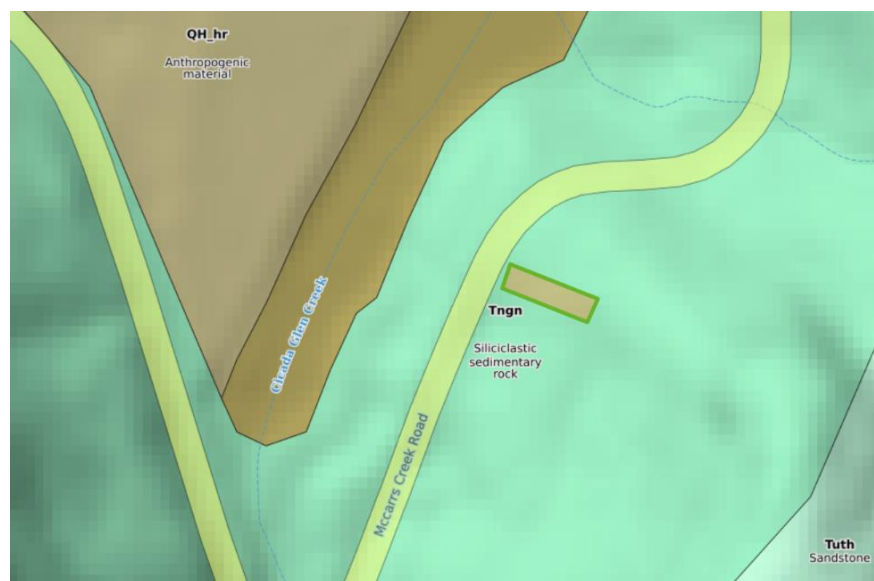
Figure 2. Geology map of Subject site and surroundings

The regional geology map of the area obtained from MinView.geoscience.nsw.gov.au demonstrates that the site is underlain by the Newport Formation (Tngn) unit. The geology of the unit comprises Interbedded laminite, shale and sandstone; white quartz to quartz-lithic, very fine- to medium-grained sandstone; minor shale breccia and pebble polymictic conglomerate (at base of sandstone units); minor red clays. The information obtained from the site inspection, and fieldwork observations confirm the geology of the site includes mainly Sandstone. The geology map of the site is shown in Figure 2.

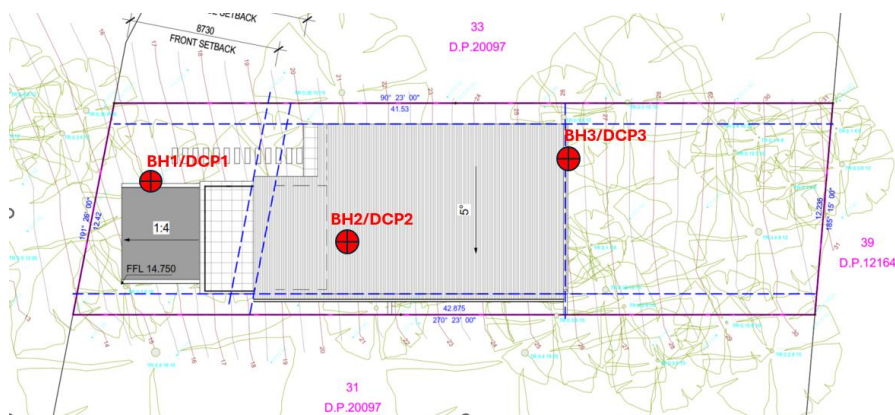
Figure 3. Boreholes Location

KFM Geotech (KFM), Geotechnical Engineer inspected the site on 21 October 2024 and drilled three (3) boreholes using a hand auger to a maximum depth of 1 m (bgl). Further drilling could not be advanced due to hand auger refusal. The boreholes' location is shown in Figure 4.

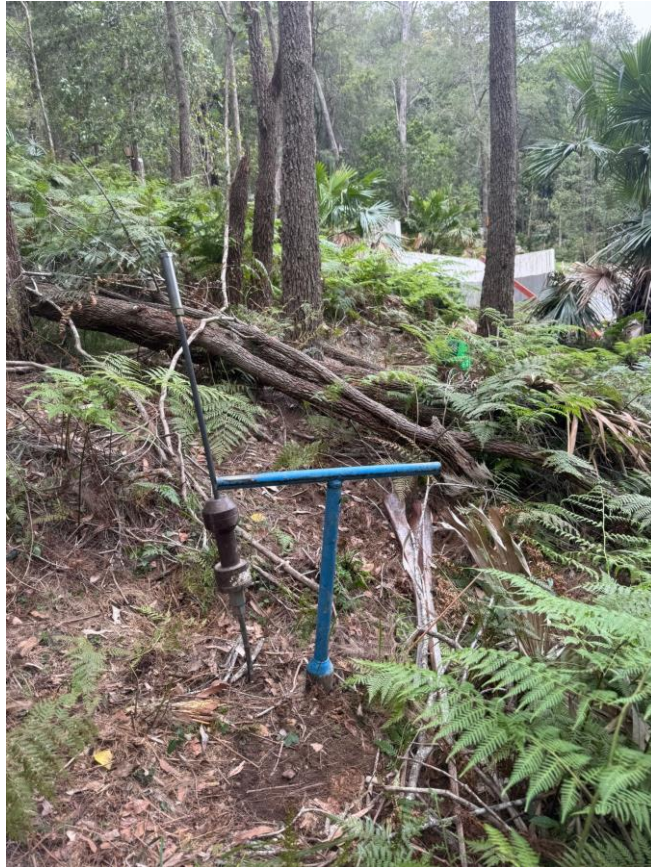
BH1/DCP

KFM GEOTECH					Boring Log					
Project: 237 Mccarrs Creek Road, Church Point NSW 2105					Project Number: KFMGR-00255		Client: Mr. Nima Asgari		Boring No. BH1 (RL~16)	
Logged By: SK					Drilling Date: 21/10/2024		Drilling Type: Hand Auger		Driller: MT	
Depth (m)	Sample Type	Sample Number	Graphic Log	USCS	Lithology			Density/Consistency	Moisture Content	DCP (blows per 100mm penetration)
					Soil Group Name: type, color, grain size, other descriptors					
0.0

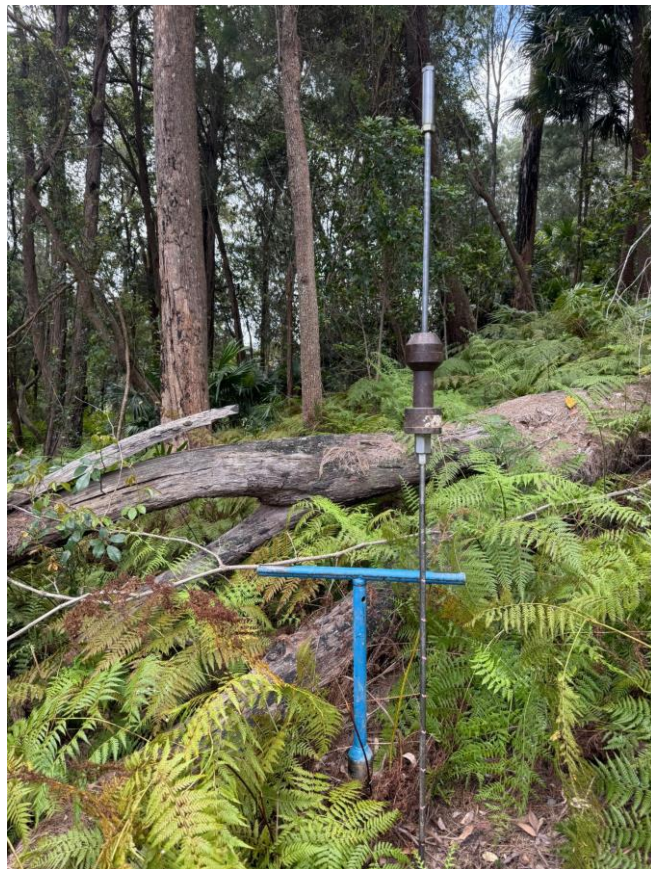
BH2/DCP2

<h1>Boring Log</h1>					
Project: 237 Mccarrs Creek Road, Church Point NSW 2105					Project Number: KFMGR-00255		Client: Mr. Nima Asgari		Boring No. BH2 (RL~20.75)	
Logged By: SK					Drilling Date: 21/10/2024		Drilling Type: Hand Auger		Driller: MT	
Depth (m)	Sample Type	Sample Number	Graphic Log	USCS	Lithology			Density/Consistency	Moisture Content	DCP (blows per 100mm penetration)
					Soil Group Name: type, color, grain size, other descriptors					
0.0					Fill: silty clay, dark brown, trace rootlets	PC	M	1 1 2 3		
0.				CH	Clay, red, brown, medium to high plasticity	F	M	3 3 3 3 4 3		
1.0					Hand auger terminated at 1.0 m of depth	St		5 5 5 4 5 7 9 5 7 7		
2.0					DCP reached bouncing at 2.0m of depth due to possible bedrock			B		
2.5										
3.0										
3.5										
4.0										
4.5										
5.0

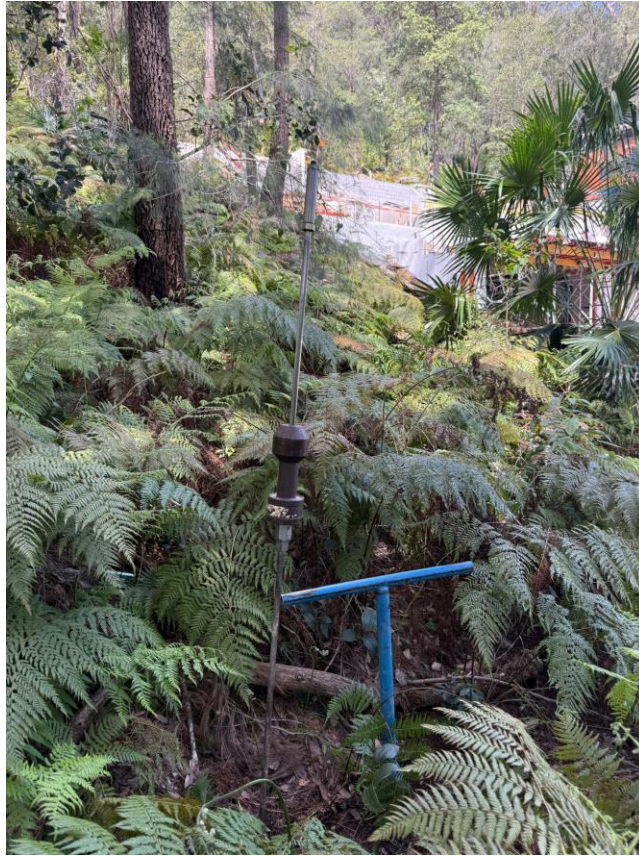
BH3/DCP3

<h1 style="margin: 0;">Boring Log</h1>						
Project: 237 Mccarrs Creek Road, Church Point NSW 2105				Project Number: KFMGR-00255		Client: Mr. Nima Asgari		Boring No. BH3 (RL-26)		
Logged By: SK				Drilling Date: 21/10/2024		Drilling Type: Hand Auger		Driller: MT		
Depth (m)	Sample Type	Sample Number	Graphic Log	USCS	Lithology			Density/Consistency	Moisture Content	DCP (blows per 100mm penetration)
					Soil Group Name: type, color, grain size, other descriptors					
0.0					Fill: silty clay, dark brown, trace rootlets			PC	M	1 2 2 3
0.5				CH	Clay, red, brown, medium to high plasticity			F St	M	3 5 5 5 7 10
1.0					Hand auger terminated at 1.0 m of depth					6 7 9 8 7 7 7 9 7 7 7 6 6 5 6 8 13 18 24
1.5										
2.0										
2.5								Vst H		
3.0					DCP reached refusal at 2.9m of depth due to possible bedrock					R
3.5										
4.0										
4.5										
5.0
