REPORT ON GEOTECHNICAL ASSESSMENT

PROPOSED ALTERATIONS AND ADDITIONS

1100 BARRENJOEY ROAD, PALM BEACH

Project No.: 2019-100

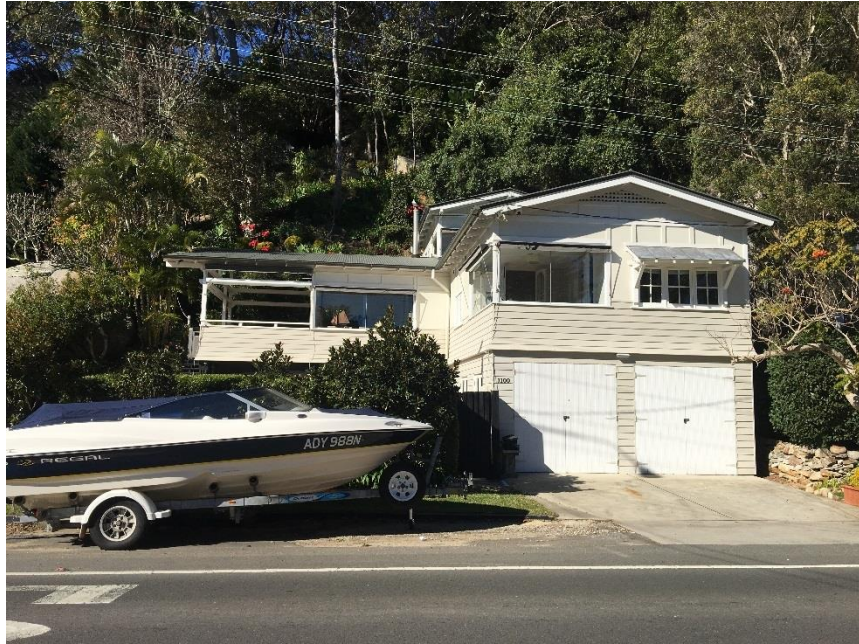
Photo: 2 – General view of front of site, facing east.

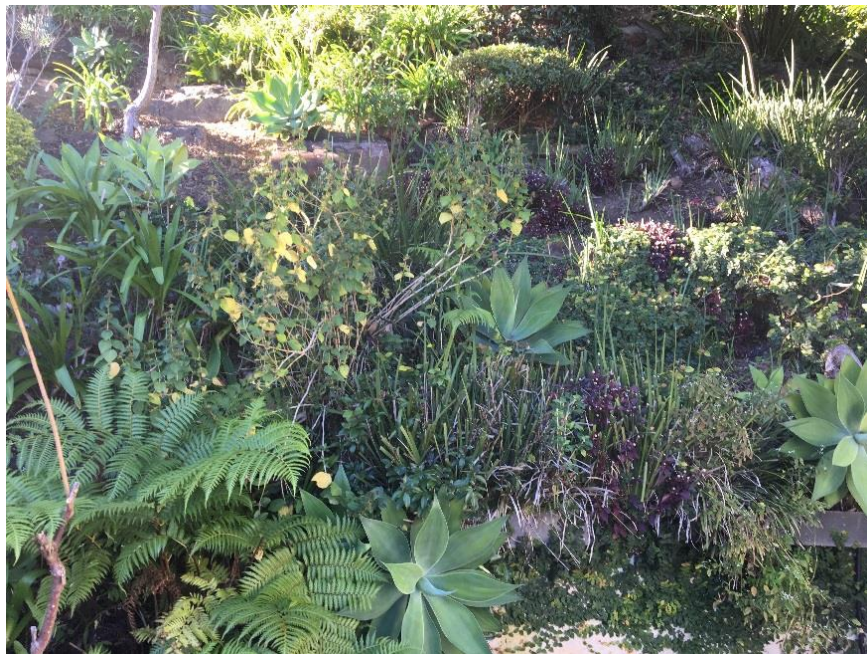
Photo: 3 – General view of landscaped slope at rear of house, facing east.

The steep soil/garden slope to the rear of the existing house is considered to present a long term slope stability hazard for shallow earth slides whilst future erosion and soil creep could destabilize the sandstone boulder upslope of the house under adverse conditions.

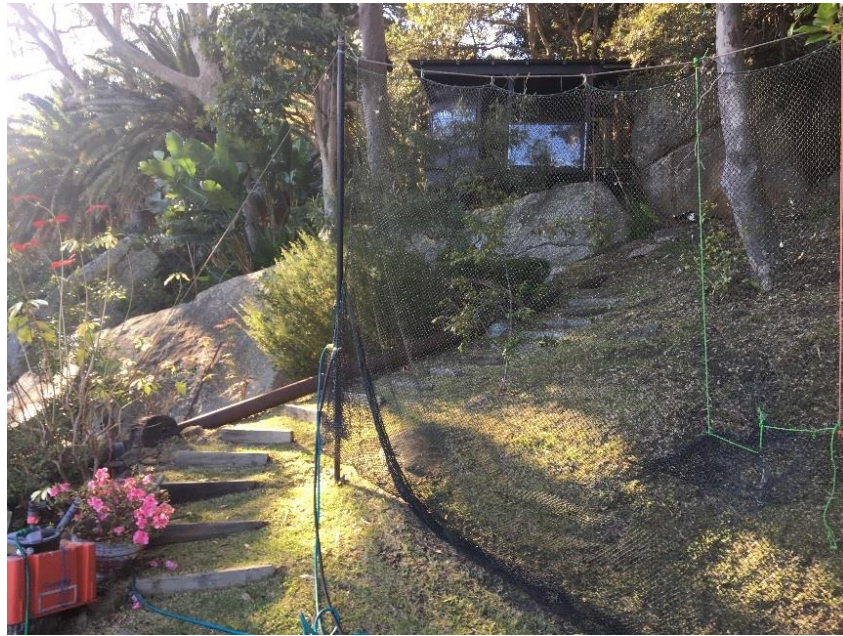
Photo: 4 – General view of upper portion of site, facing north-east.

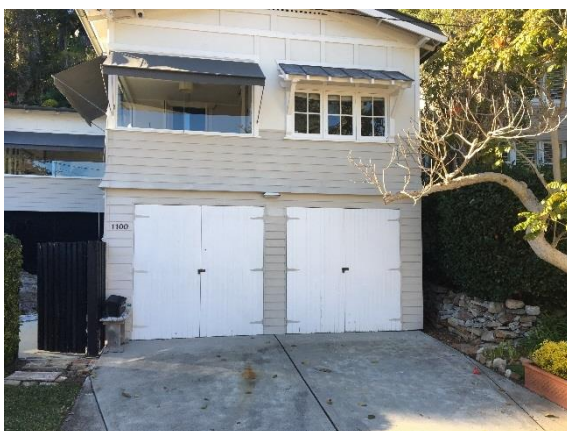
The front edge of the site is gently sloping and contains a concrete driveway at the south-east corner, Photo: 5, that provides access to two garage doors at lower level of the house. To the north is a concrete paved terrace containing a buried sandstone boulder with another paved driveway to parking bay located adjacent to the north side boundary.

Photo: 5 - Lower Ground level, viewed from street

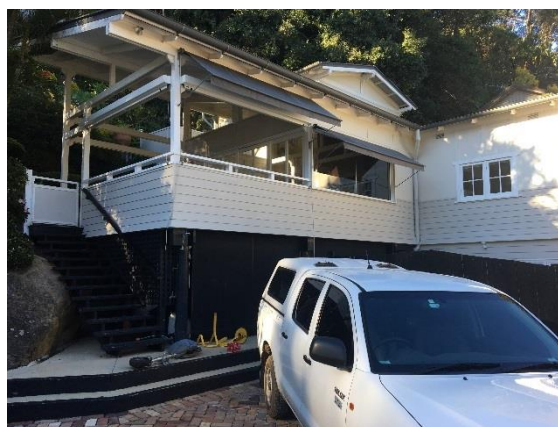
Photo: 6 - Parking bay on north boundary

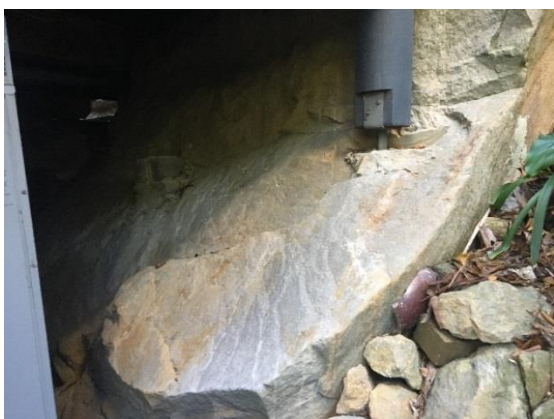
The Ground Floor is formed over the Lower Ground and also extends north as an L-shaped structure, see Photo: 6, that is formed slightly (<2.0m) above ground surface levels and supported via timber posts to unknown footings. One portion of the structure is supported off a sandstone boulder located within the slope, see Photo: 7.

Photo: 7 - House supported off boulder

The existing house appears at least 20 years of age and shows no signs of previous impact or slope movement. Soil creep within the steep garden slope to the rear of the house could result in a shallow and small earth slide whilst the buried boulder directly up from the house could undergo movement in extreme conditions. However, both potential hazards appear stable at present.

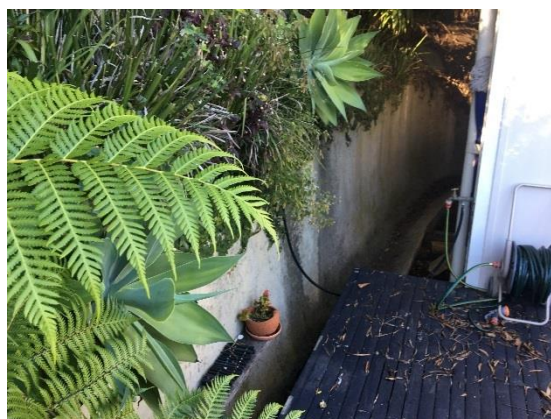
Photo: 8 - Retaining wall at rear of First Floor

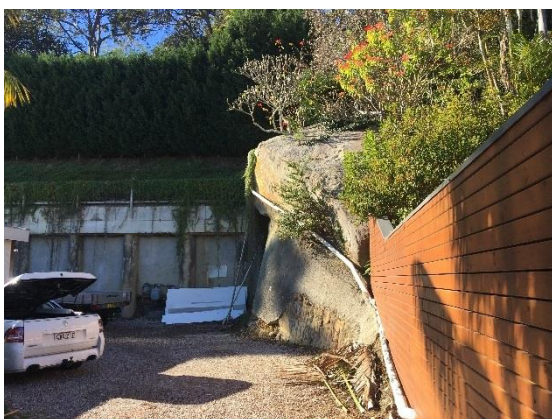
The neighbouring property to the north (No. 1110) contains a commercial development across the front half which is formed in part at the base of an excavation with moderately sloping lawns and driveways to the rear. The excavation is supported via a concrete retaining wall that also supports the front northern side of the site, see Photo: 9.

Photo: 9 - No. 1110 at common boundary with site

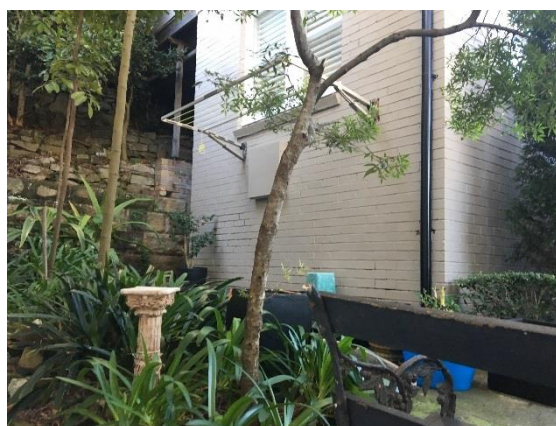
The neighbouring property to the south, No. 1098, contains a two storey brick and timber residential house at the front, elongated across the block within a narrow raised terrace with steep undeveloped and natural slopes rising up towards the rear, see Photo: 10.

Photo: 10 ó No. 1098 ó adjacent to boundary
