Report Title: Geotechnical Report 54 Morella Road, Whale Beach
Report Date: 30/9/20
Author: BEN WHITE
Author's Company/Organisation: WHITE GEOTECHNICAL GROUP PTY LTD

GEOTECHNICAL INVESTIGATION:

New Lift at **54 Morella Road, Whale Beach**

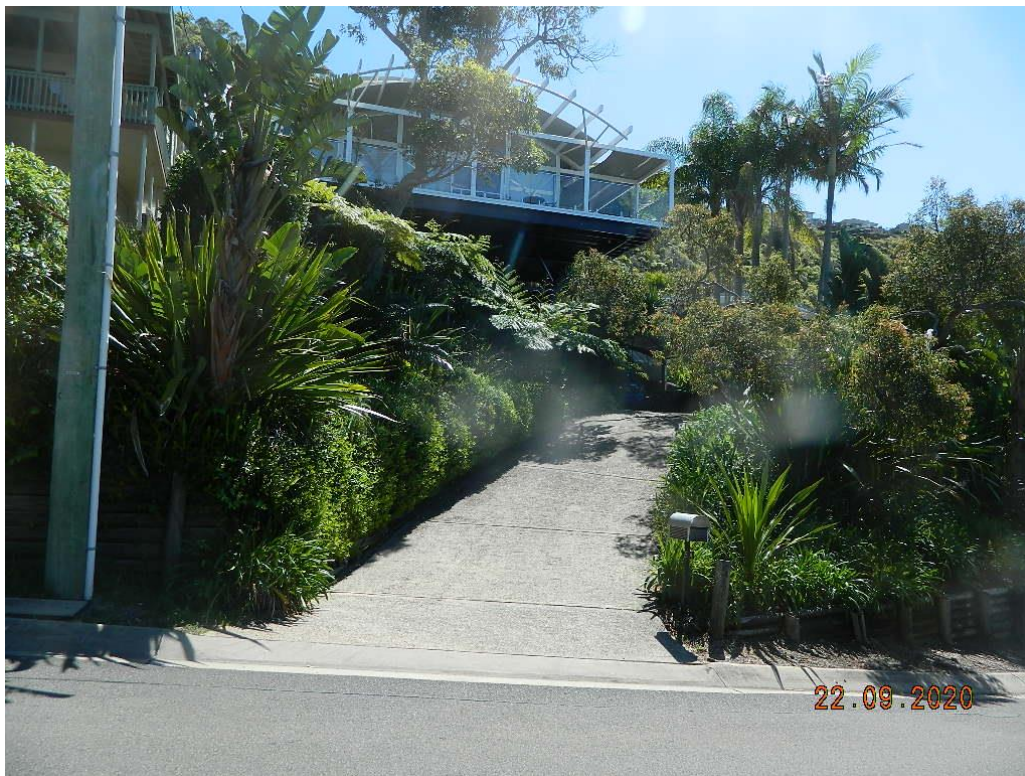
Photo 1

- 2.3** At the road frontage a concrete driveway runs up the slope to a carport (Photos 1 & 2). A stable timber retaining wall up to ~1.2m high supports the cut for the road. Stable low concrete crib retaining walls support the cut and fill for the driveway. The suspended two storey steel and timber clad house is supported by steel posts and concrete piers (Photos 1 & 3). The supporting posts and piers stand vertical and show no significant signs of movement (Photo 4). Hawksbury Sandstone bedrock is outcropping underneath the uphill side of the house and on the slope above

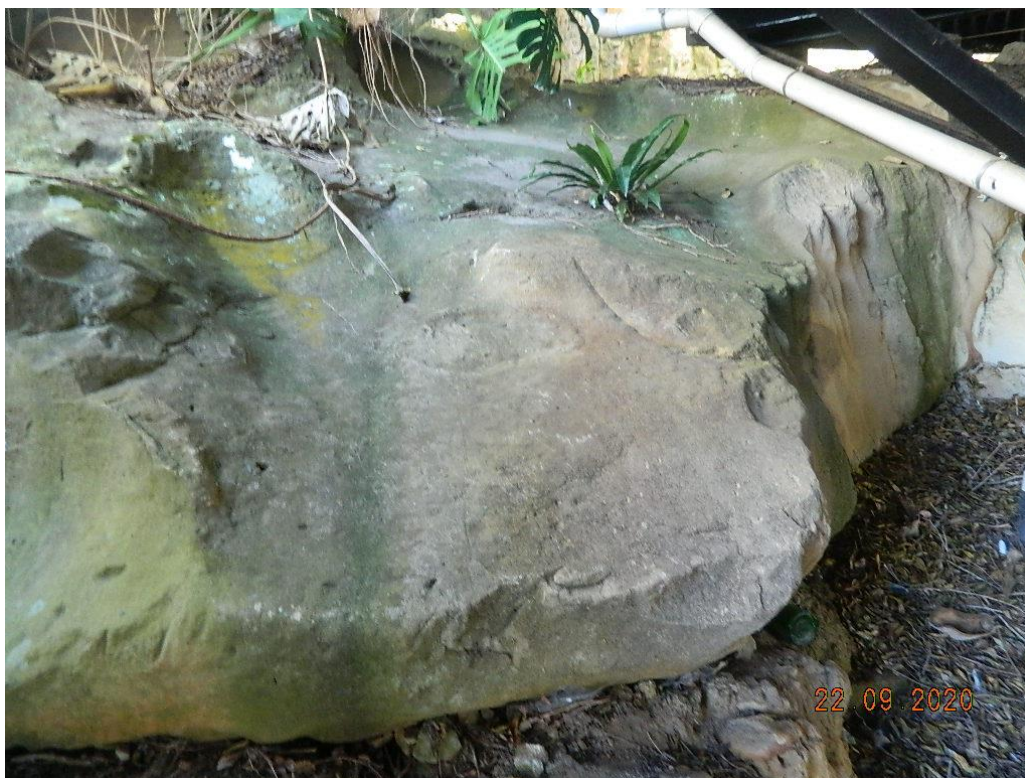
Photo 5

(Photo 5). A timber deck extends off the uphill side of the house. Sandstone bedrock, boulders and detached joints blocks are located on the steep slope uphill of the property in stable positions (Photo 6). No signs of slope instability were observed on the property. The adjoining neighbouring properties were observed to be in good order as seen from the street and subject property

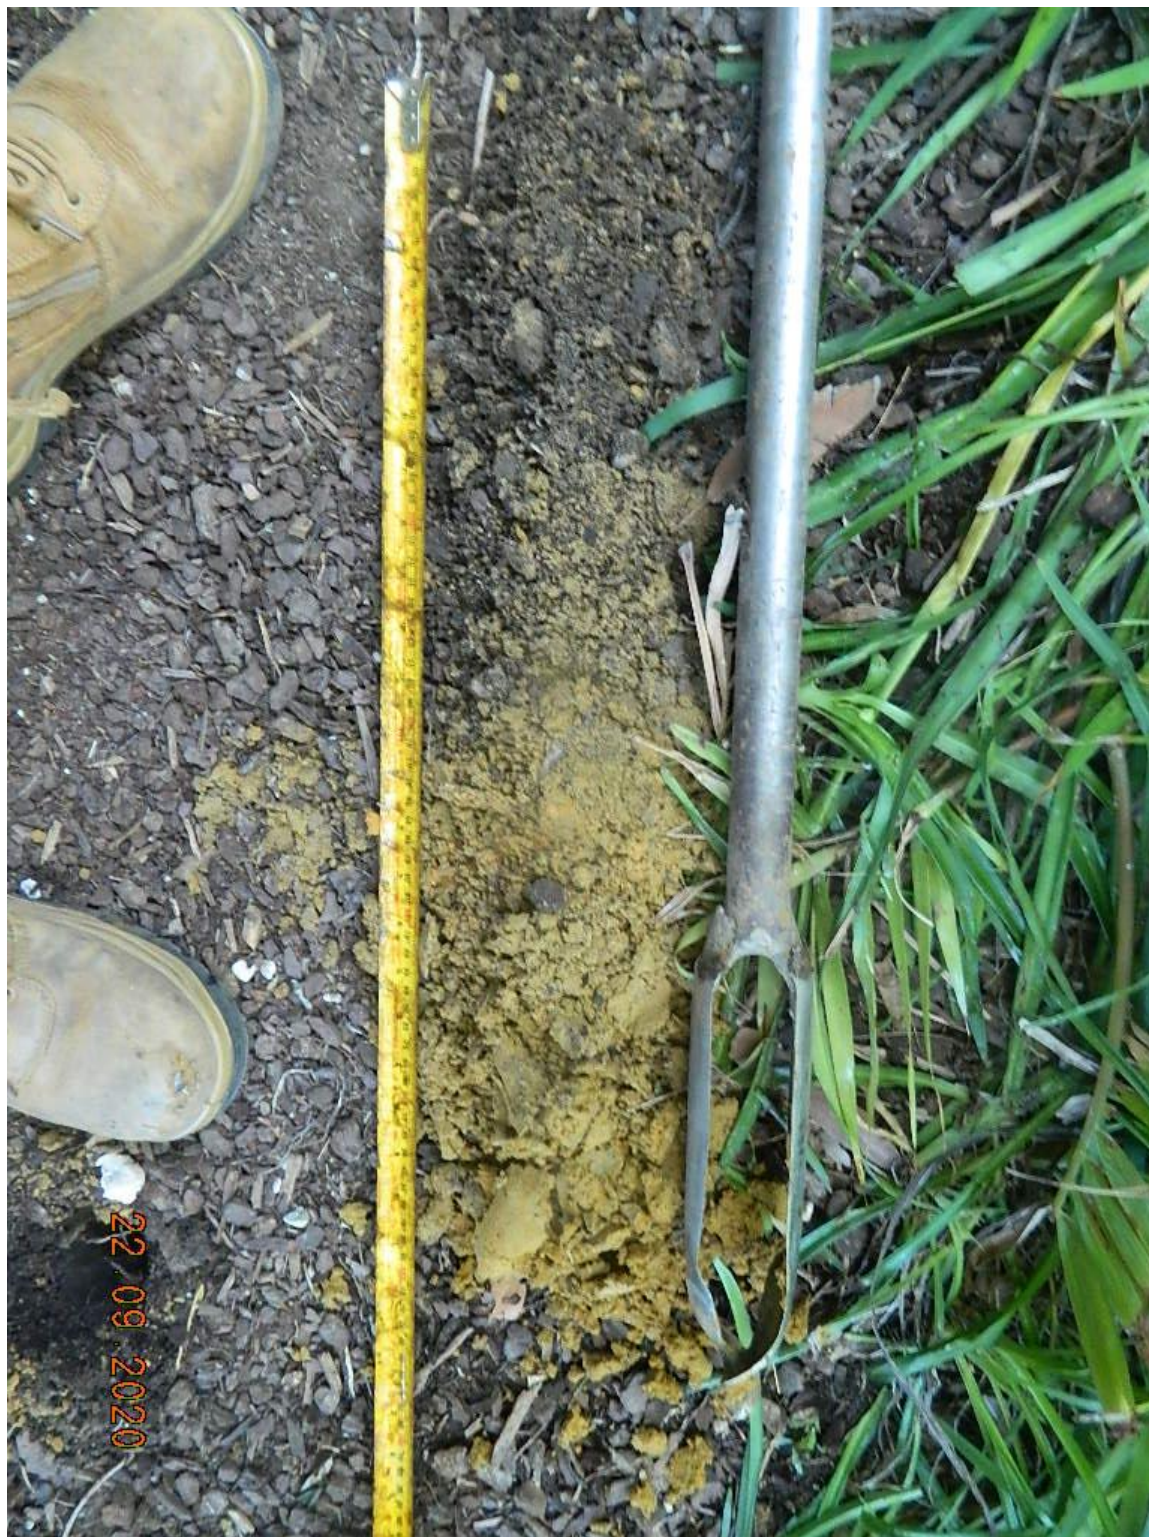
AUGER HOLE 1 (~RL45.6) – AH1 (photo 7)

Depth (m)	Material Encountered
0.0 to 0.2	TOPSOIL , sandy soil, dark brown, moist, fine to medium grained with fine trace organic matter.
0.2 to 0.4	CLAYEY SAND , light orange/brown, moist.
0.4 to 0.6	SANDY CLAY , light orange/brown, firm to stiff, moist.

End of hole @ 0.6m in firm to stiff sandy clay. No watertable encountered.

Photo 7: AH1 – Downhole is from top to bottom.
