# Arborist Impact Assessment

Proposed Development  
Lot 180 DP752017  
40 Myoora Road, Terrey Hills, NSW

**April 2025**

**AEP Ref: 3550**

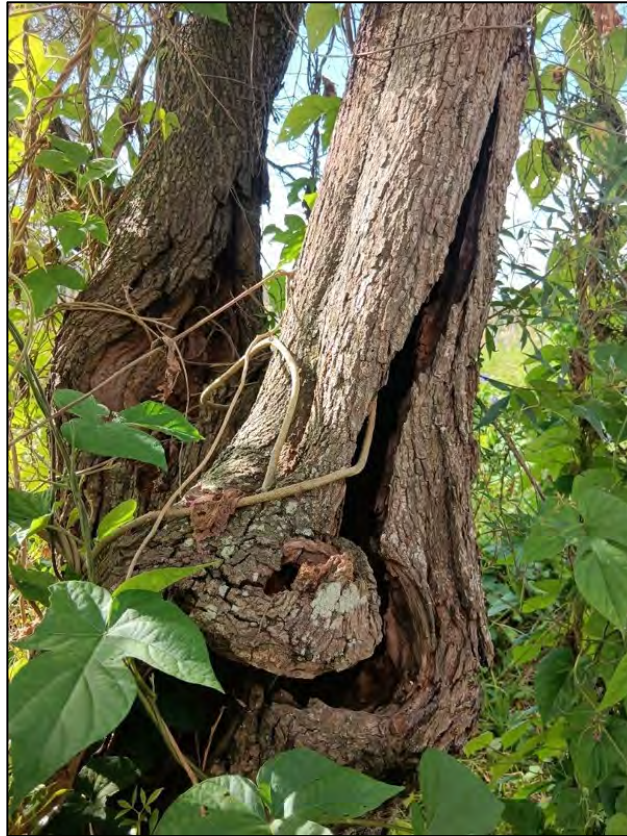
- Tree 15 – *Ceratopetalum gummiferum* (NSW Christmas Bush) has two co-dominate leaders with large cracks and fractures below at the base. A small hollow was also located at the base. The twisted form individual contains multiple dead branches and has the canopy crossing and/or rubbing with other nearby trees;
- Tree 18 – *Eucalyptus cinera* (Argyle Apple) has a twisted form. The overall canopy health of the individual display's poor health; and
- Tree 33 – *Eucalyptus grandis* (Flooded Gum) is an overmature individual with abundant deadwood and an asymmetric crown.

**Plate 1 Above: Tree 15 – *Ceratopetalum gummiferum* cracks along the stem.**

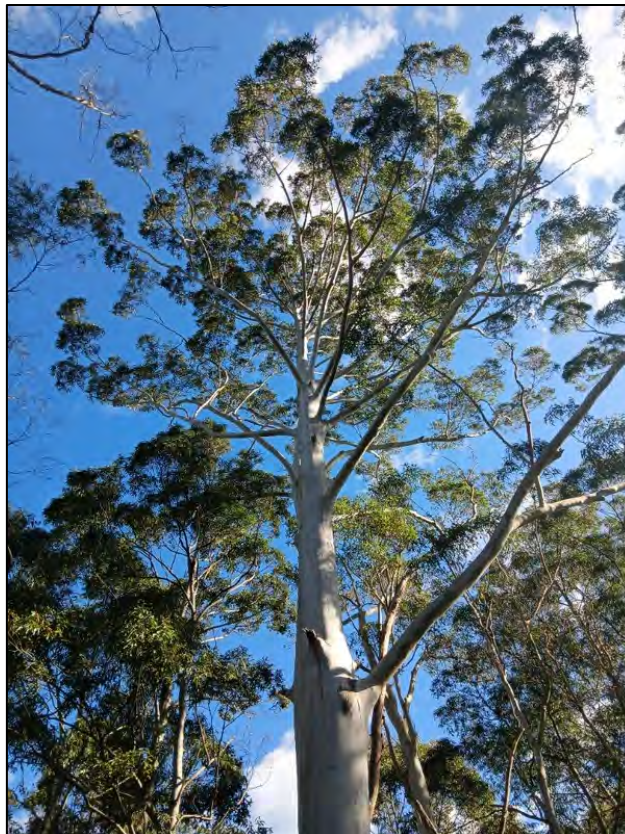
**Plate 2 Below: Tree 35 – *Eucalyptus grandis* with evidence of previous failures.**

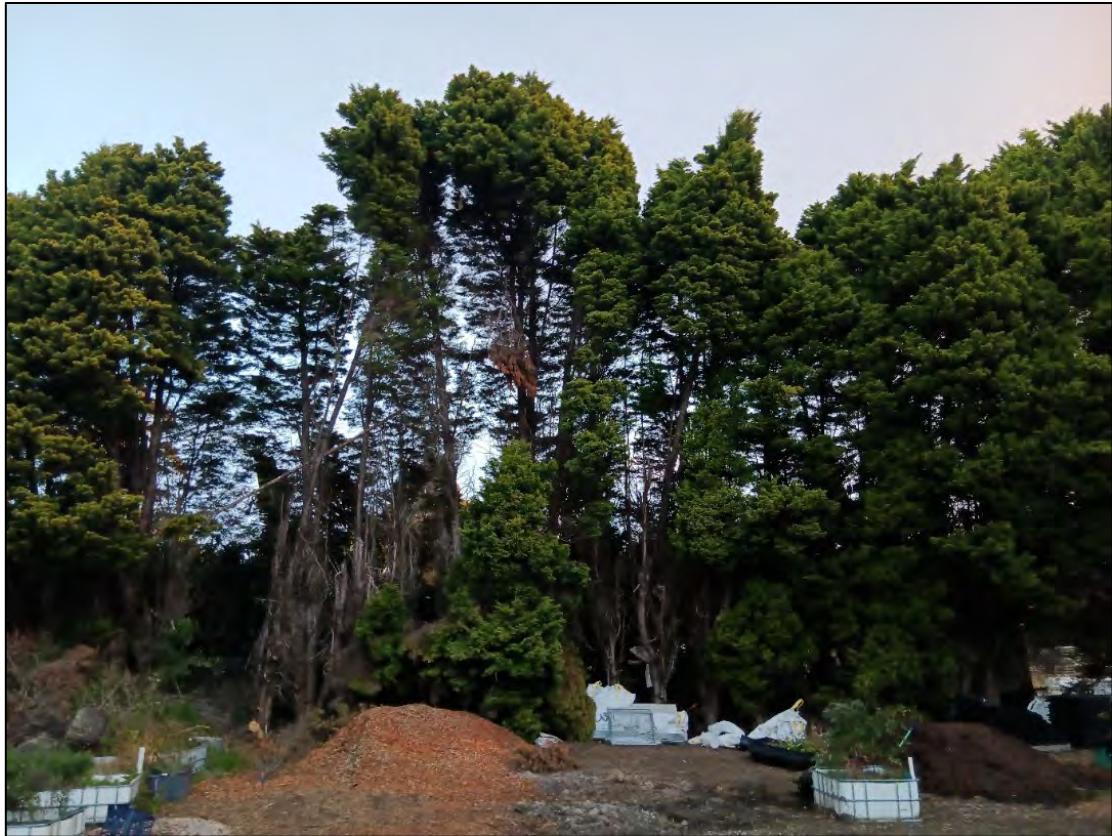
- Stand 1 has approximately 18 *Cupressus sp.* individuals that have an average DBH of 0.31m in overall Fair condition.

**Plate 3 Below: Stand 1 – *Cupresses sp.* facing north-west.**
