Report on  
Geotechnical Assessment

Proposed New Residence  
50 Minkara Road, Bayview

Project 86886.00  
October 2019

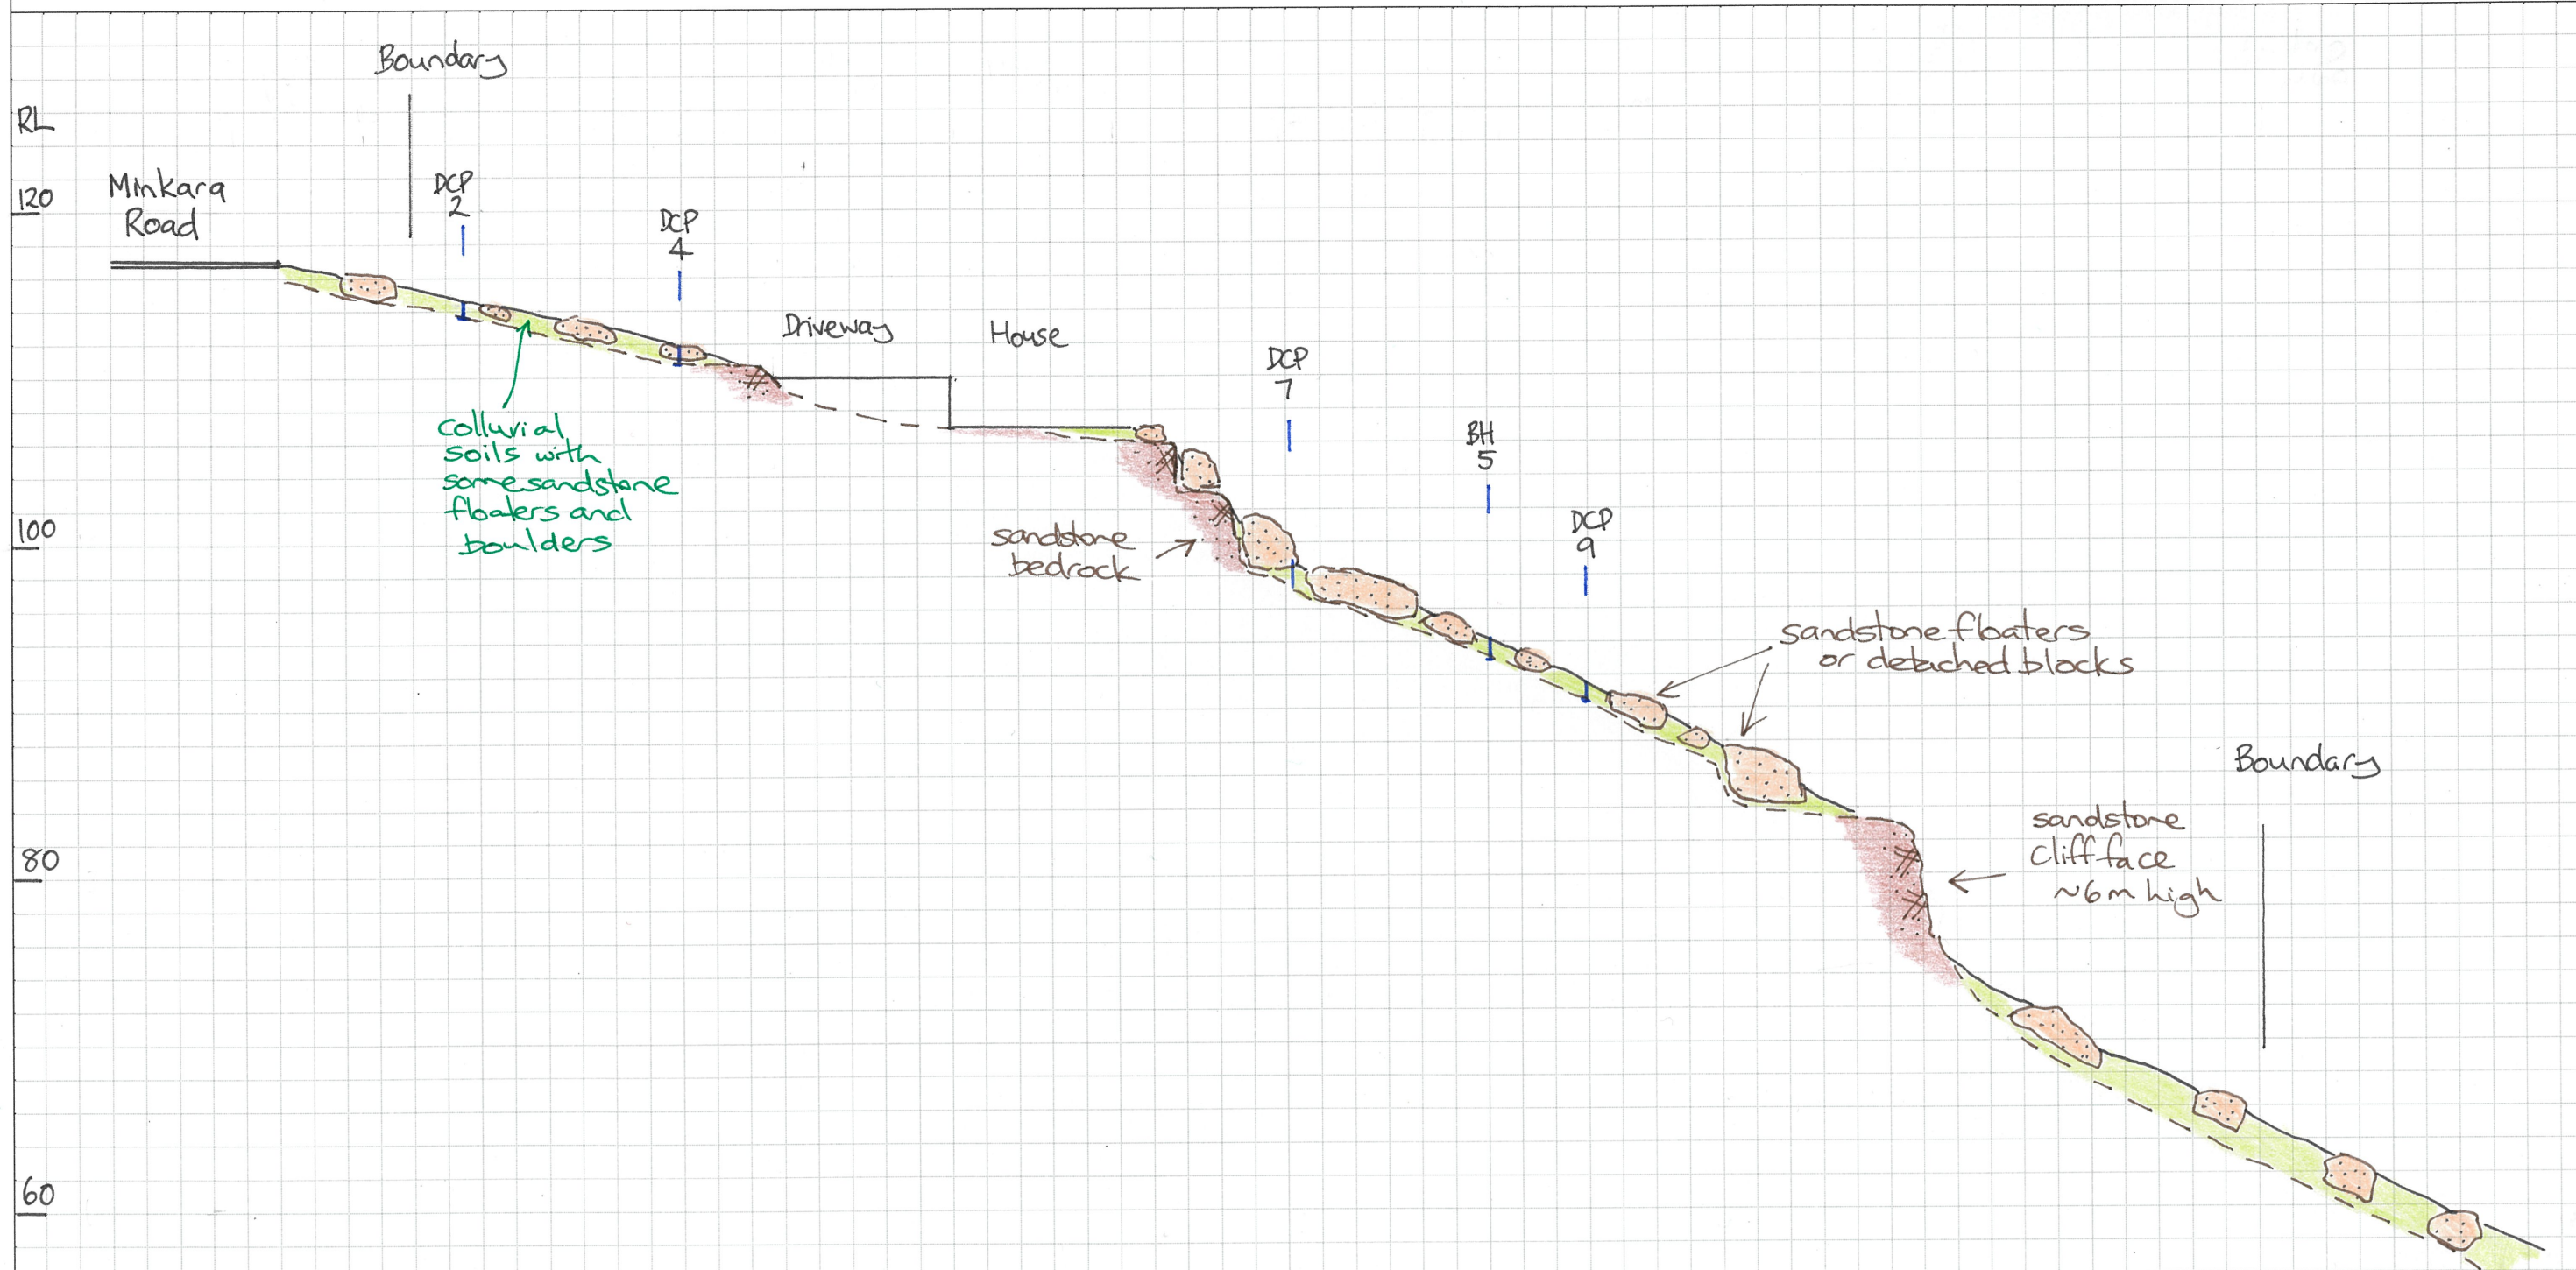
Interpreted Geological Section  
50 Minkara Road, Bayview  
Project 86886.00  
Drawing 2

The inferred geotechnical model of the subsurface conditions across the site is illustrated on Drawing 2 and comprises silty sand and sandy clay colluvium with numerous included boulders and floaters, possibly over a thin layer of residual soil, then mostly sandstone bedrock with some highly weathered siltstone layers.

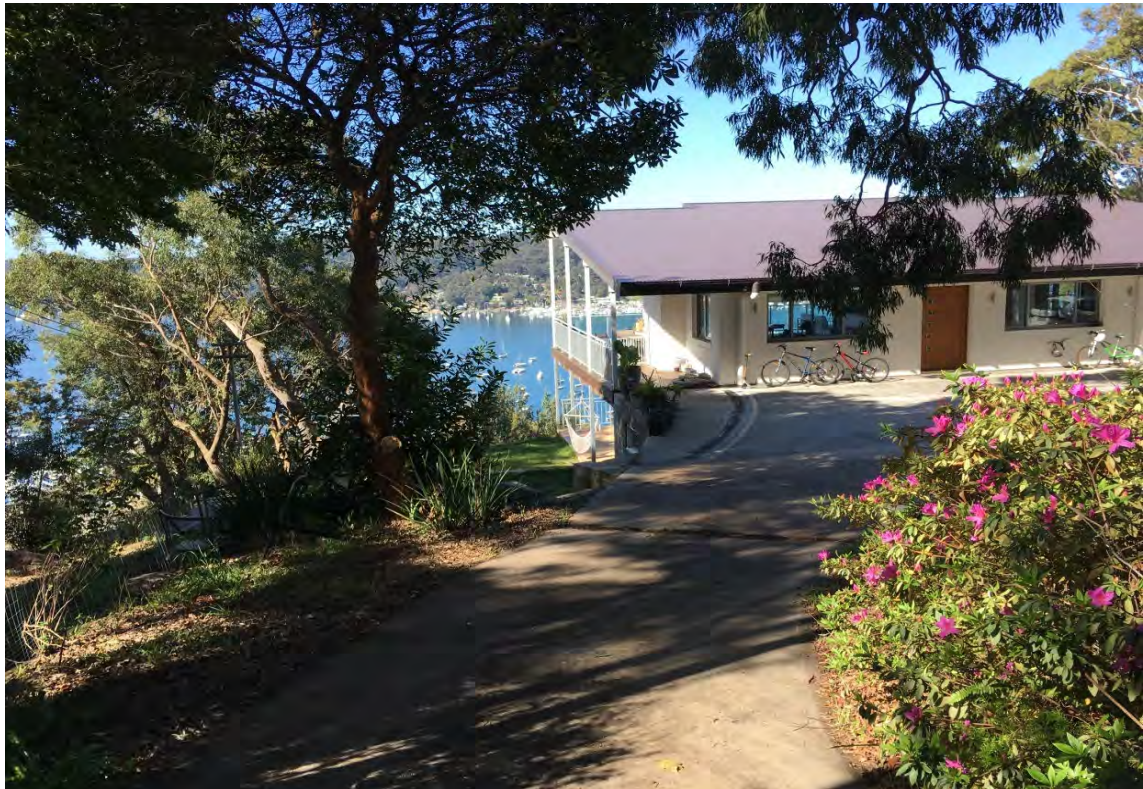
Photo 1 - view down driveway towards existing house

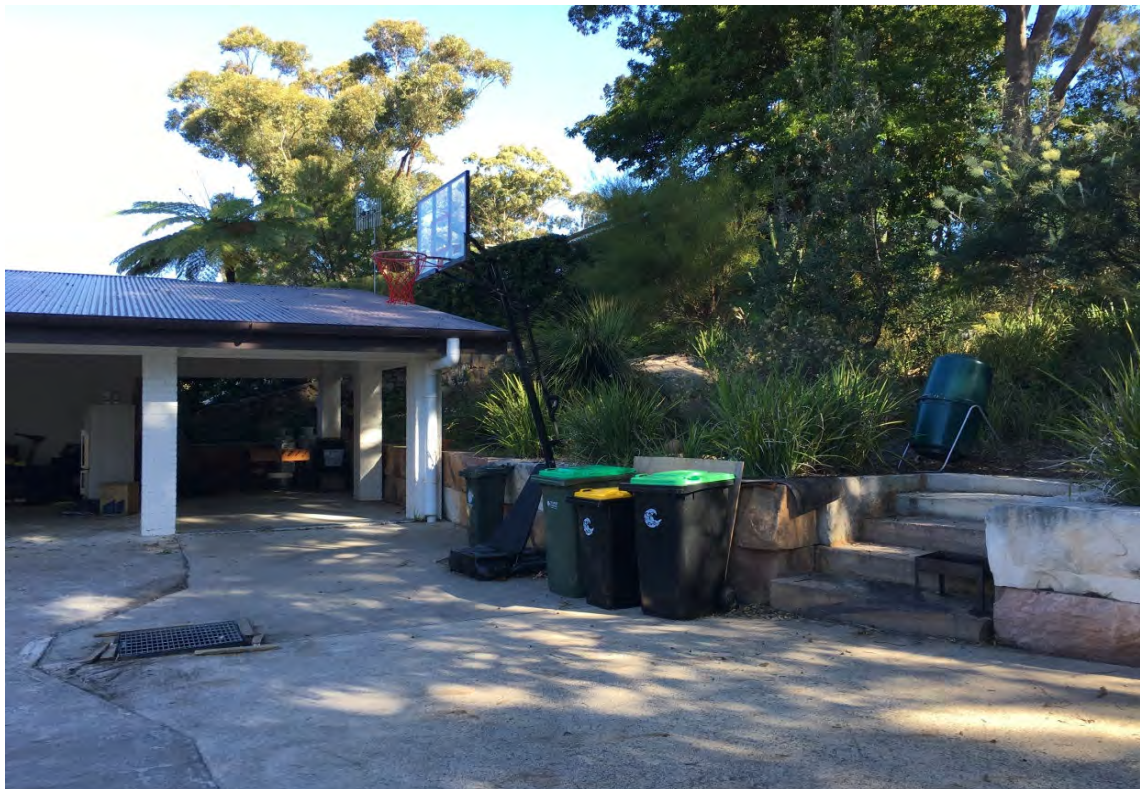
- sandstone is present in the excavation on the southern and western sides of the garage, as well as in cut along the western side of the residence in the undercroft area below the suspended driveway/carport slab. The existing residence appears to be sound with no significant cracking observed;

Photo 2 - view of existing carport area

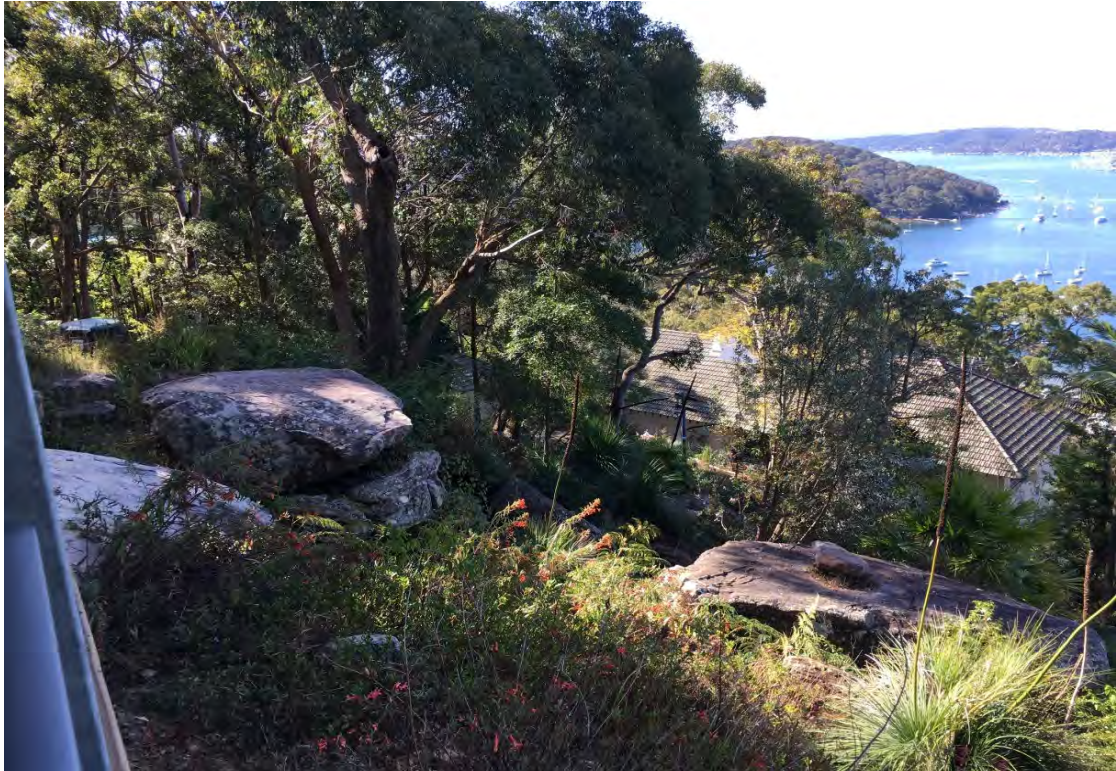
- sandstone floaters are present both on the outcrop (as detached blocks or slabs) and on the slope of the central section of the site below;
- some seepage was noted along a bedding plane within the sandstone outcrop (Photo 4);

Photo 3 - looking north from eastern side of house (note large floaters)

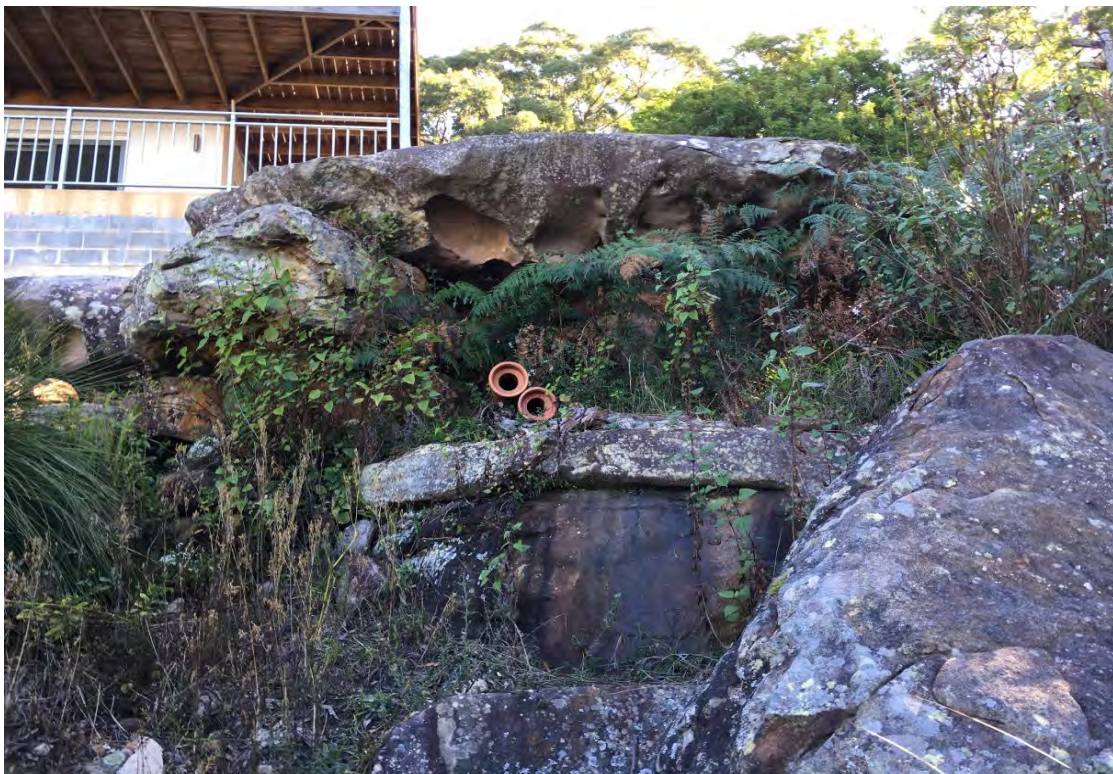
Seepage was observed out of one of the rock faces and it is likely that there is always some gradual seepage along the top of the rock and along bedding planes within the rock. This seepage is likely to increase after periods of heavy rainfall. The permanent groundwater table is likely to be a subdued reflection of the surface topography, probably located well below the proposed excavation levels.

Photo 4 - looking back up at rocks below north-eastern corner of house

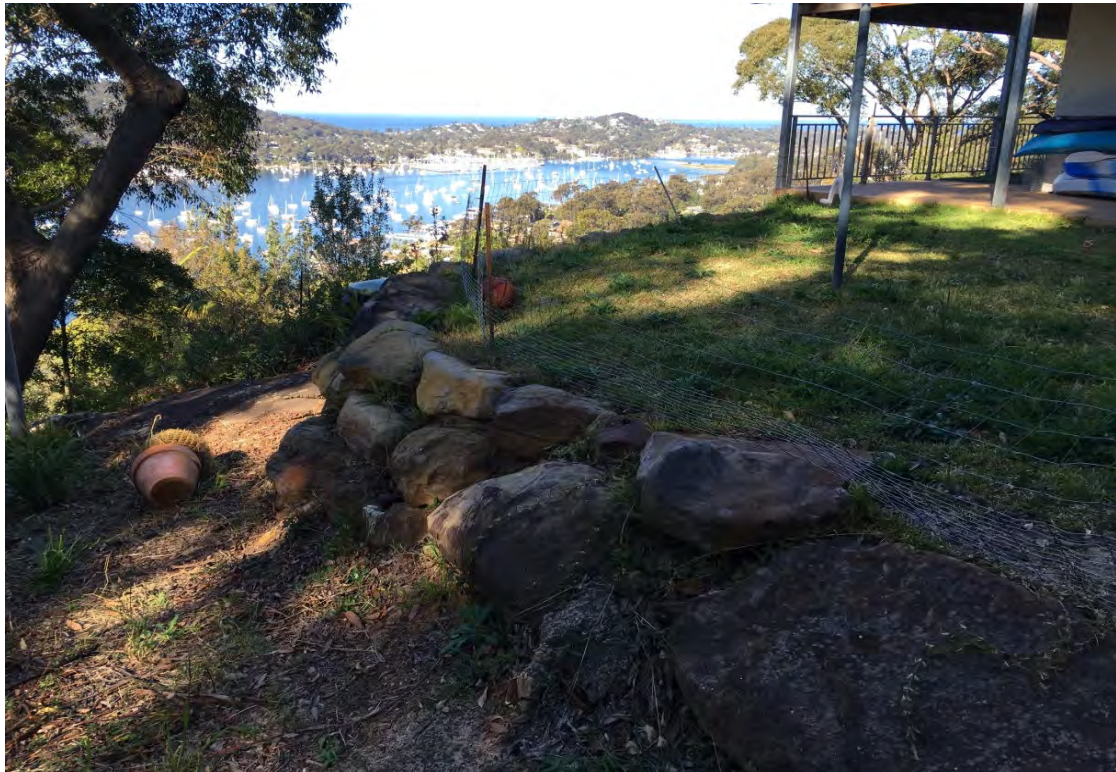
Photo 5 - lawn area near north-eastern corner of house

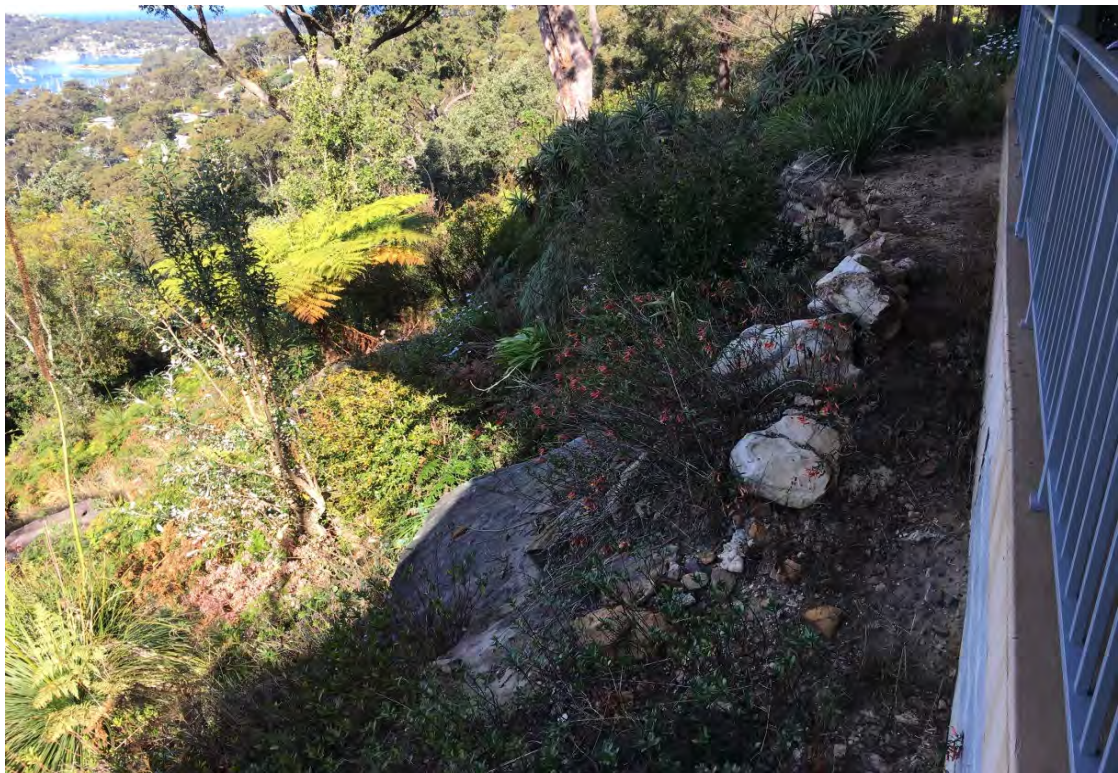
Photo 6 - view south from existing house
