RE: DEVELOPMENT APPLICATION- GEOTECHNICAL ADVICE: ALTERATIONS AND ADDITIONS AT 13 BRUCE ST, WARRIEWOOD, NSW

Geotechnical and Stormwater Assessment: 13 Bruce Street, Warriewood, NSW

P0601550JR01_v1
January 2008

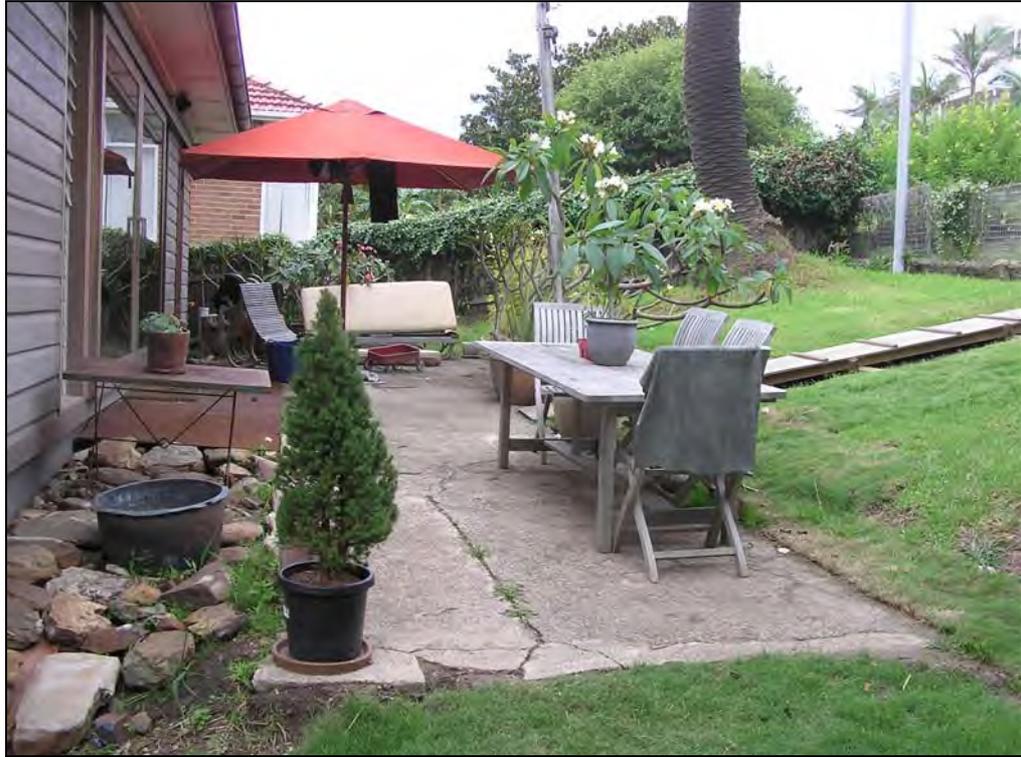
The site is presently occupied by a predominantly timber weatherboard cottage with a tiled roof located in the centre of the allotment (Figure 1). A brick and weatherboard garage is located in the north-western corner. Both the cottage and garage are founded on brick piers. Other prominent site features include a concrete paved area and stairs on the western side of the cottage, a concrete footpath and stairs on the southern side, one large and one medium-sized palm tree in the front yard and a large Norfolk pine in the north-east corner.

Figure 1: Existing allotment showing front of weatherboard cottage and palm tree to the front of the dwelling. Photograph taken looking south-west

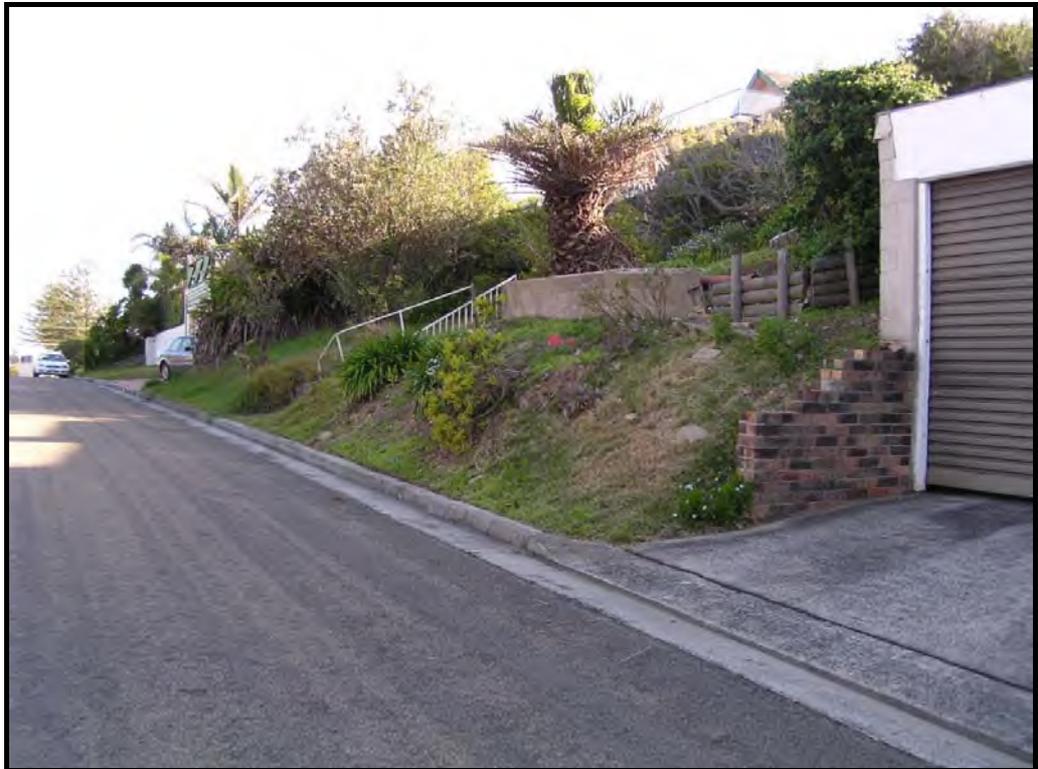
No stormwater easements were identified on the site. It was observed that there was no kerb and gutter system for road drainage on the east side of Bruce Street, adjacent to the western site boundary. There is, however, a kerb and gutter on the western side of the street. The slope of Bruce Street is predominantly from south to north at approximately 5% and surface runoff would generally be conveyed in this direction past the site (Figure 2). The street pavement falls from the centreline to either side and it is expected that a small area of the road (up to approximately 50 m²) drains via sheet flow to the site with runoff infiltrating to subsoils in the grass verge.

Figure 2: View of Bruce Street towards the south.

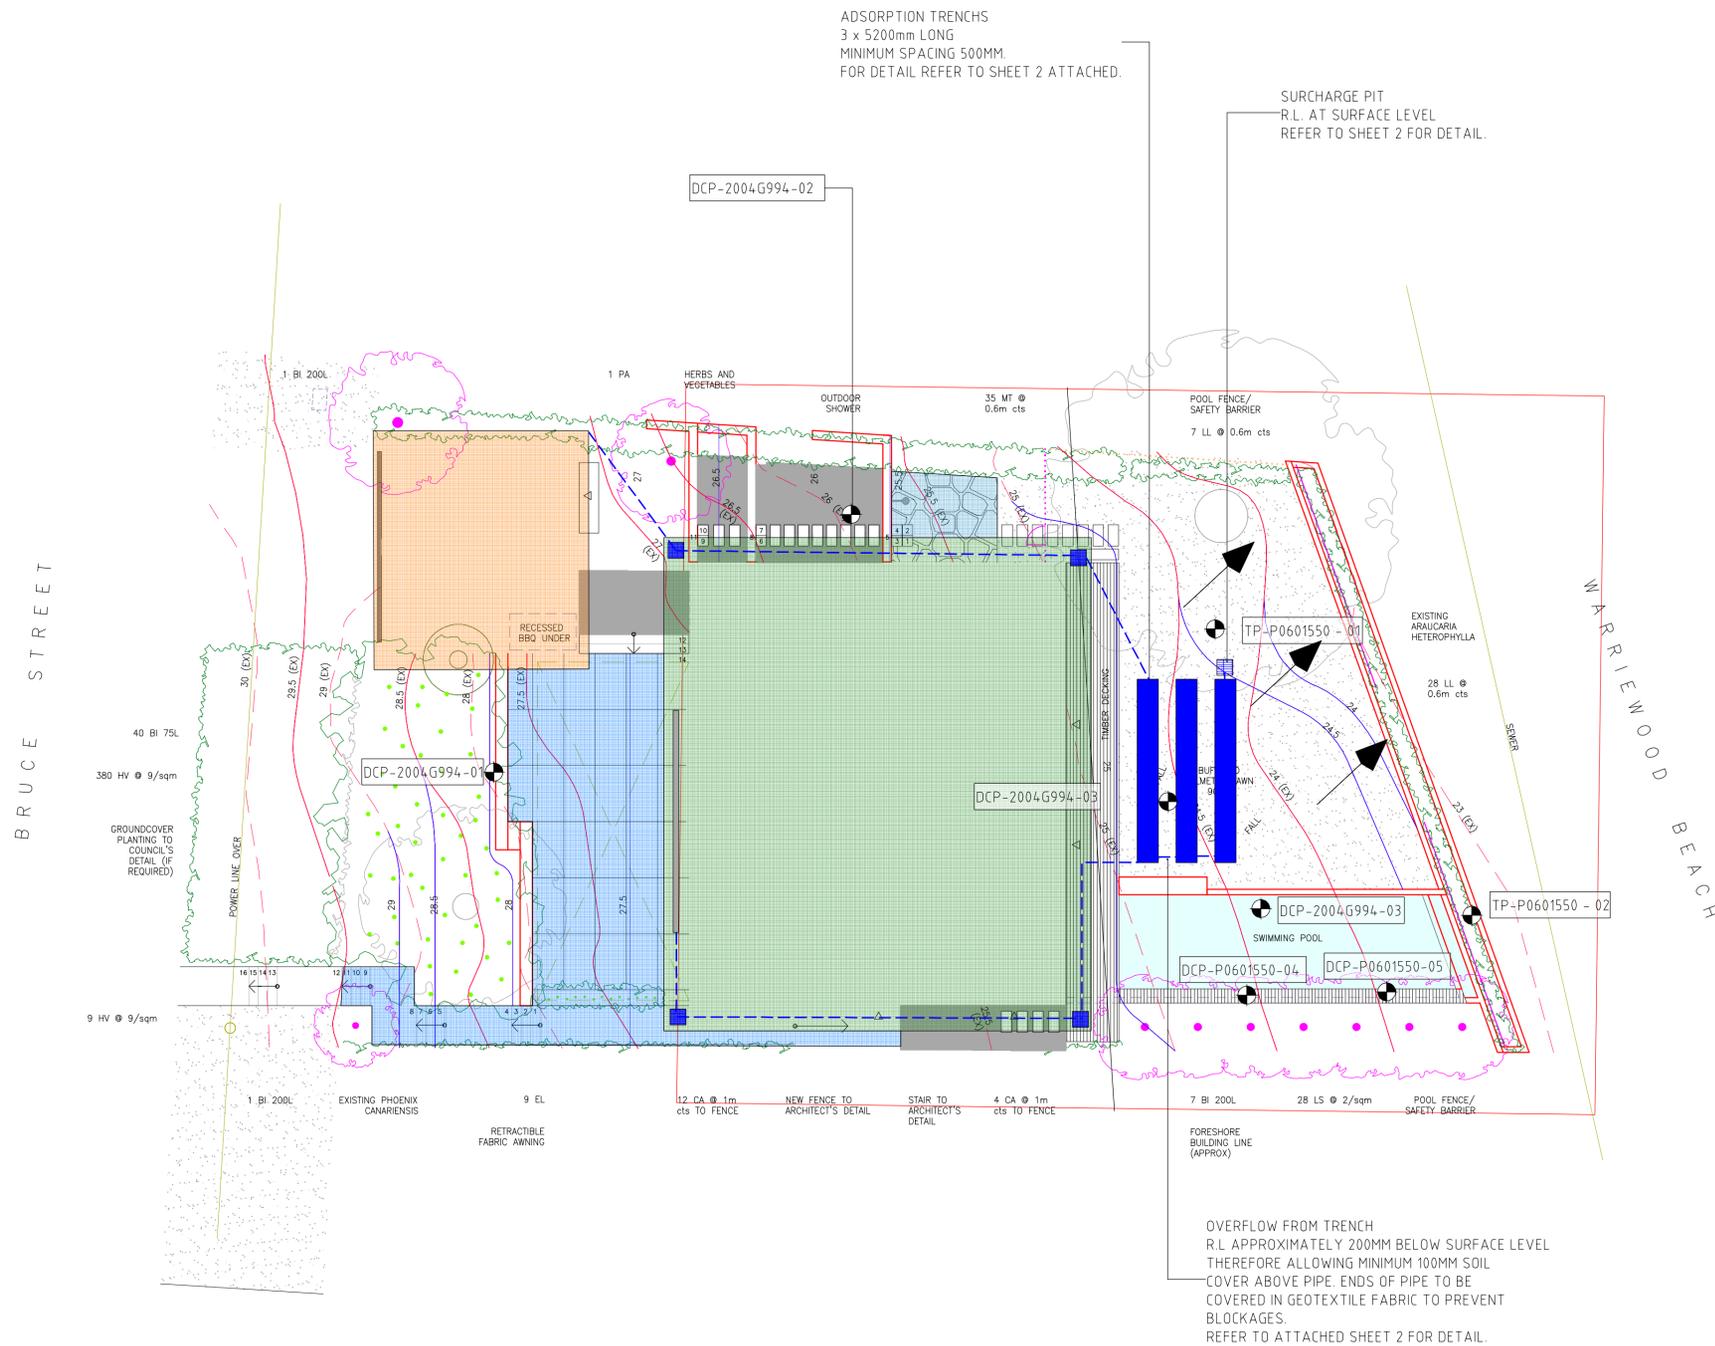
| | MICHAEL KING 13 BRUCE STREET WARRIEWOOD | STORMWATER MANAGEMENT AND SITE PLAN | GT | AHD | 2 | 1 | INFILTRATION TRENCH DESIGN | 22.10.2007 | GT | |

The catchment draining to the infiltration trench has an area of approximately 270 m². This combined area consists of a 41 m² garage roof, 169m² existing dwelling and 59m² from the courtyard and hardstand areas.

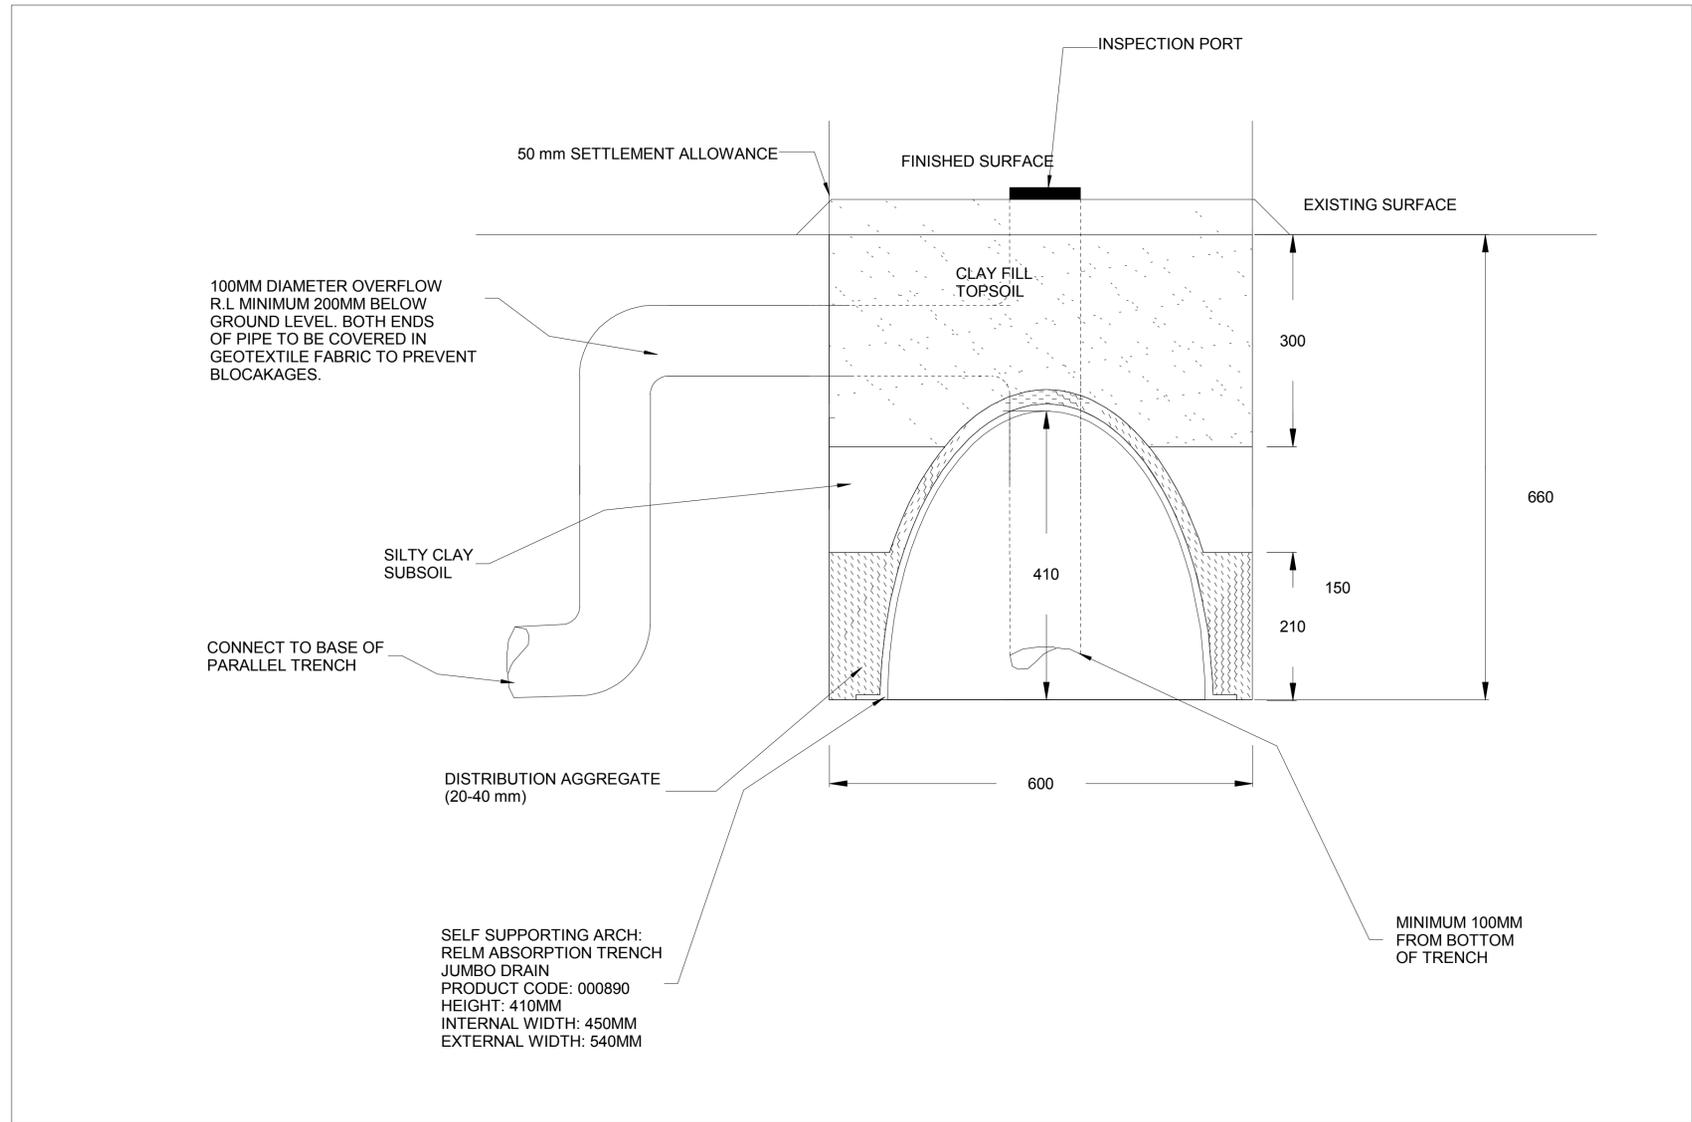
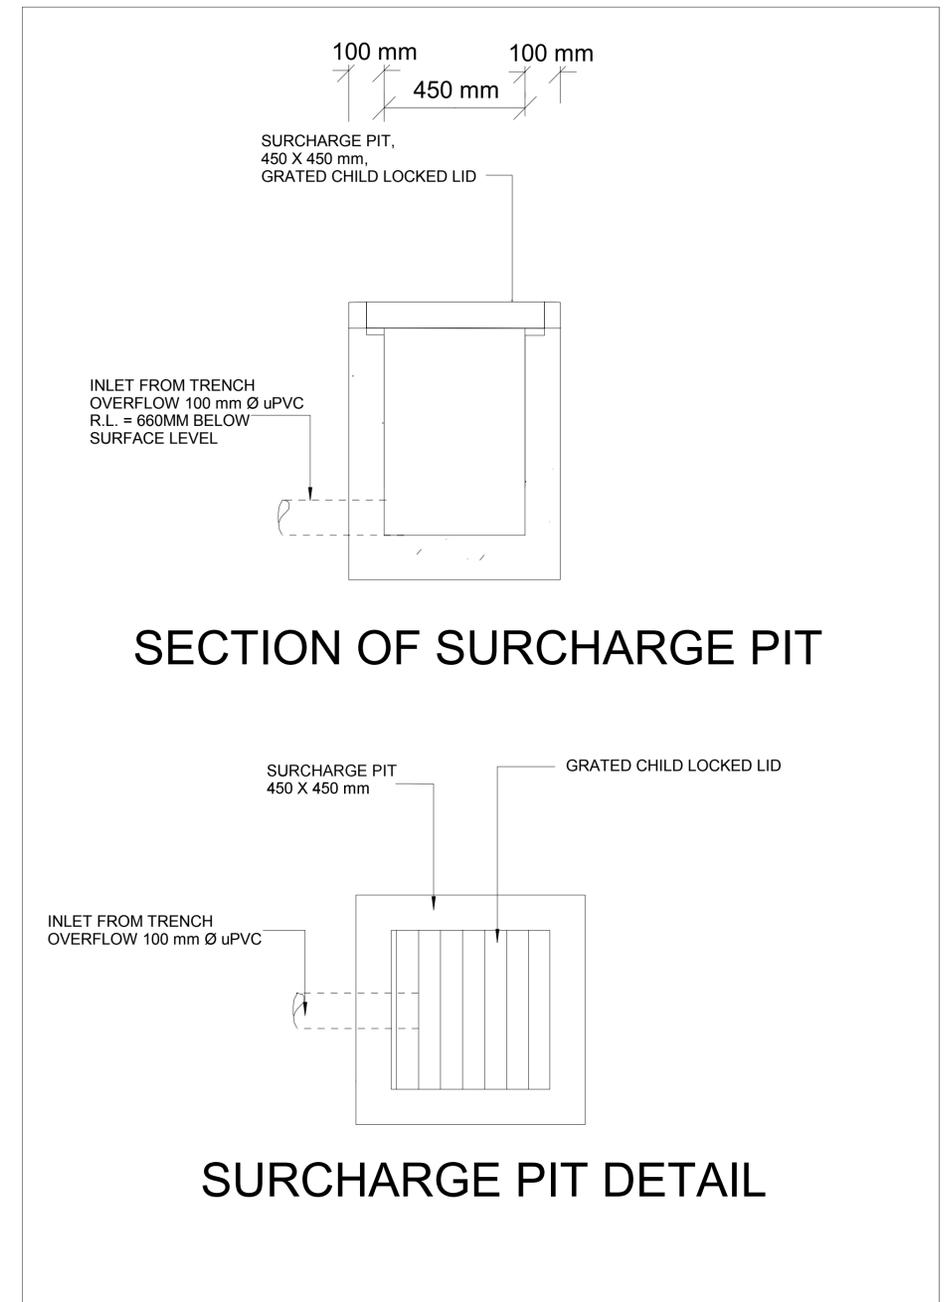
Sheet 4: Surcharge Pit and Infiltration Trench Detail

To accommodate and subsequently absorb the overflow generated from a 1:20 year ARI rainfall event with duration of 5 minutes the infiltration trench will require a total storage capacity of 7541.3 litres ((1/0.6) x 4524.8 = 7541.3). This figure was calculated based on a trench porosity of 60%. To achieve this, the infiltration trench requires dimensions of 15000 mm x 600 mm x 660 mm. These dimensions are a minimum and have been derived assuming all hardstand flows go to the infiltration trench/basin. Refer to Attachment A 'Plan Set' for plan and section drawings of the site and proposed infiltration trench.

TRENCH SECTION
SCALE 1:10 @ A1 AND 1:20 @A3

SECTION OF SURCHARGE PIT

We recommend inspection by a suitably qualified engineer prior to backfilling of infiltration trenches.

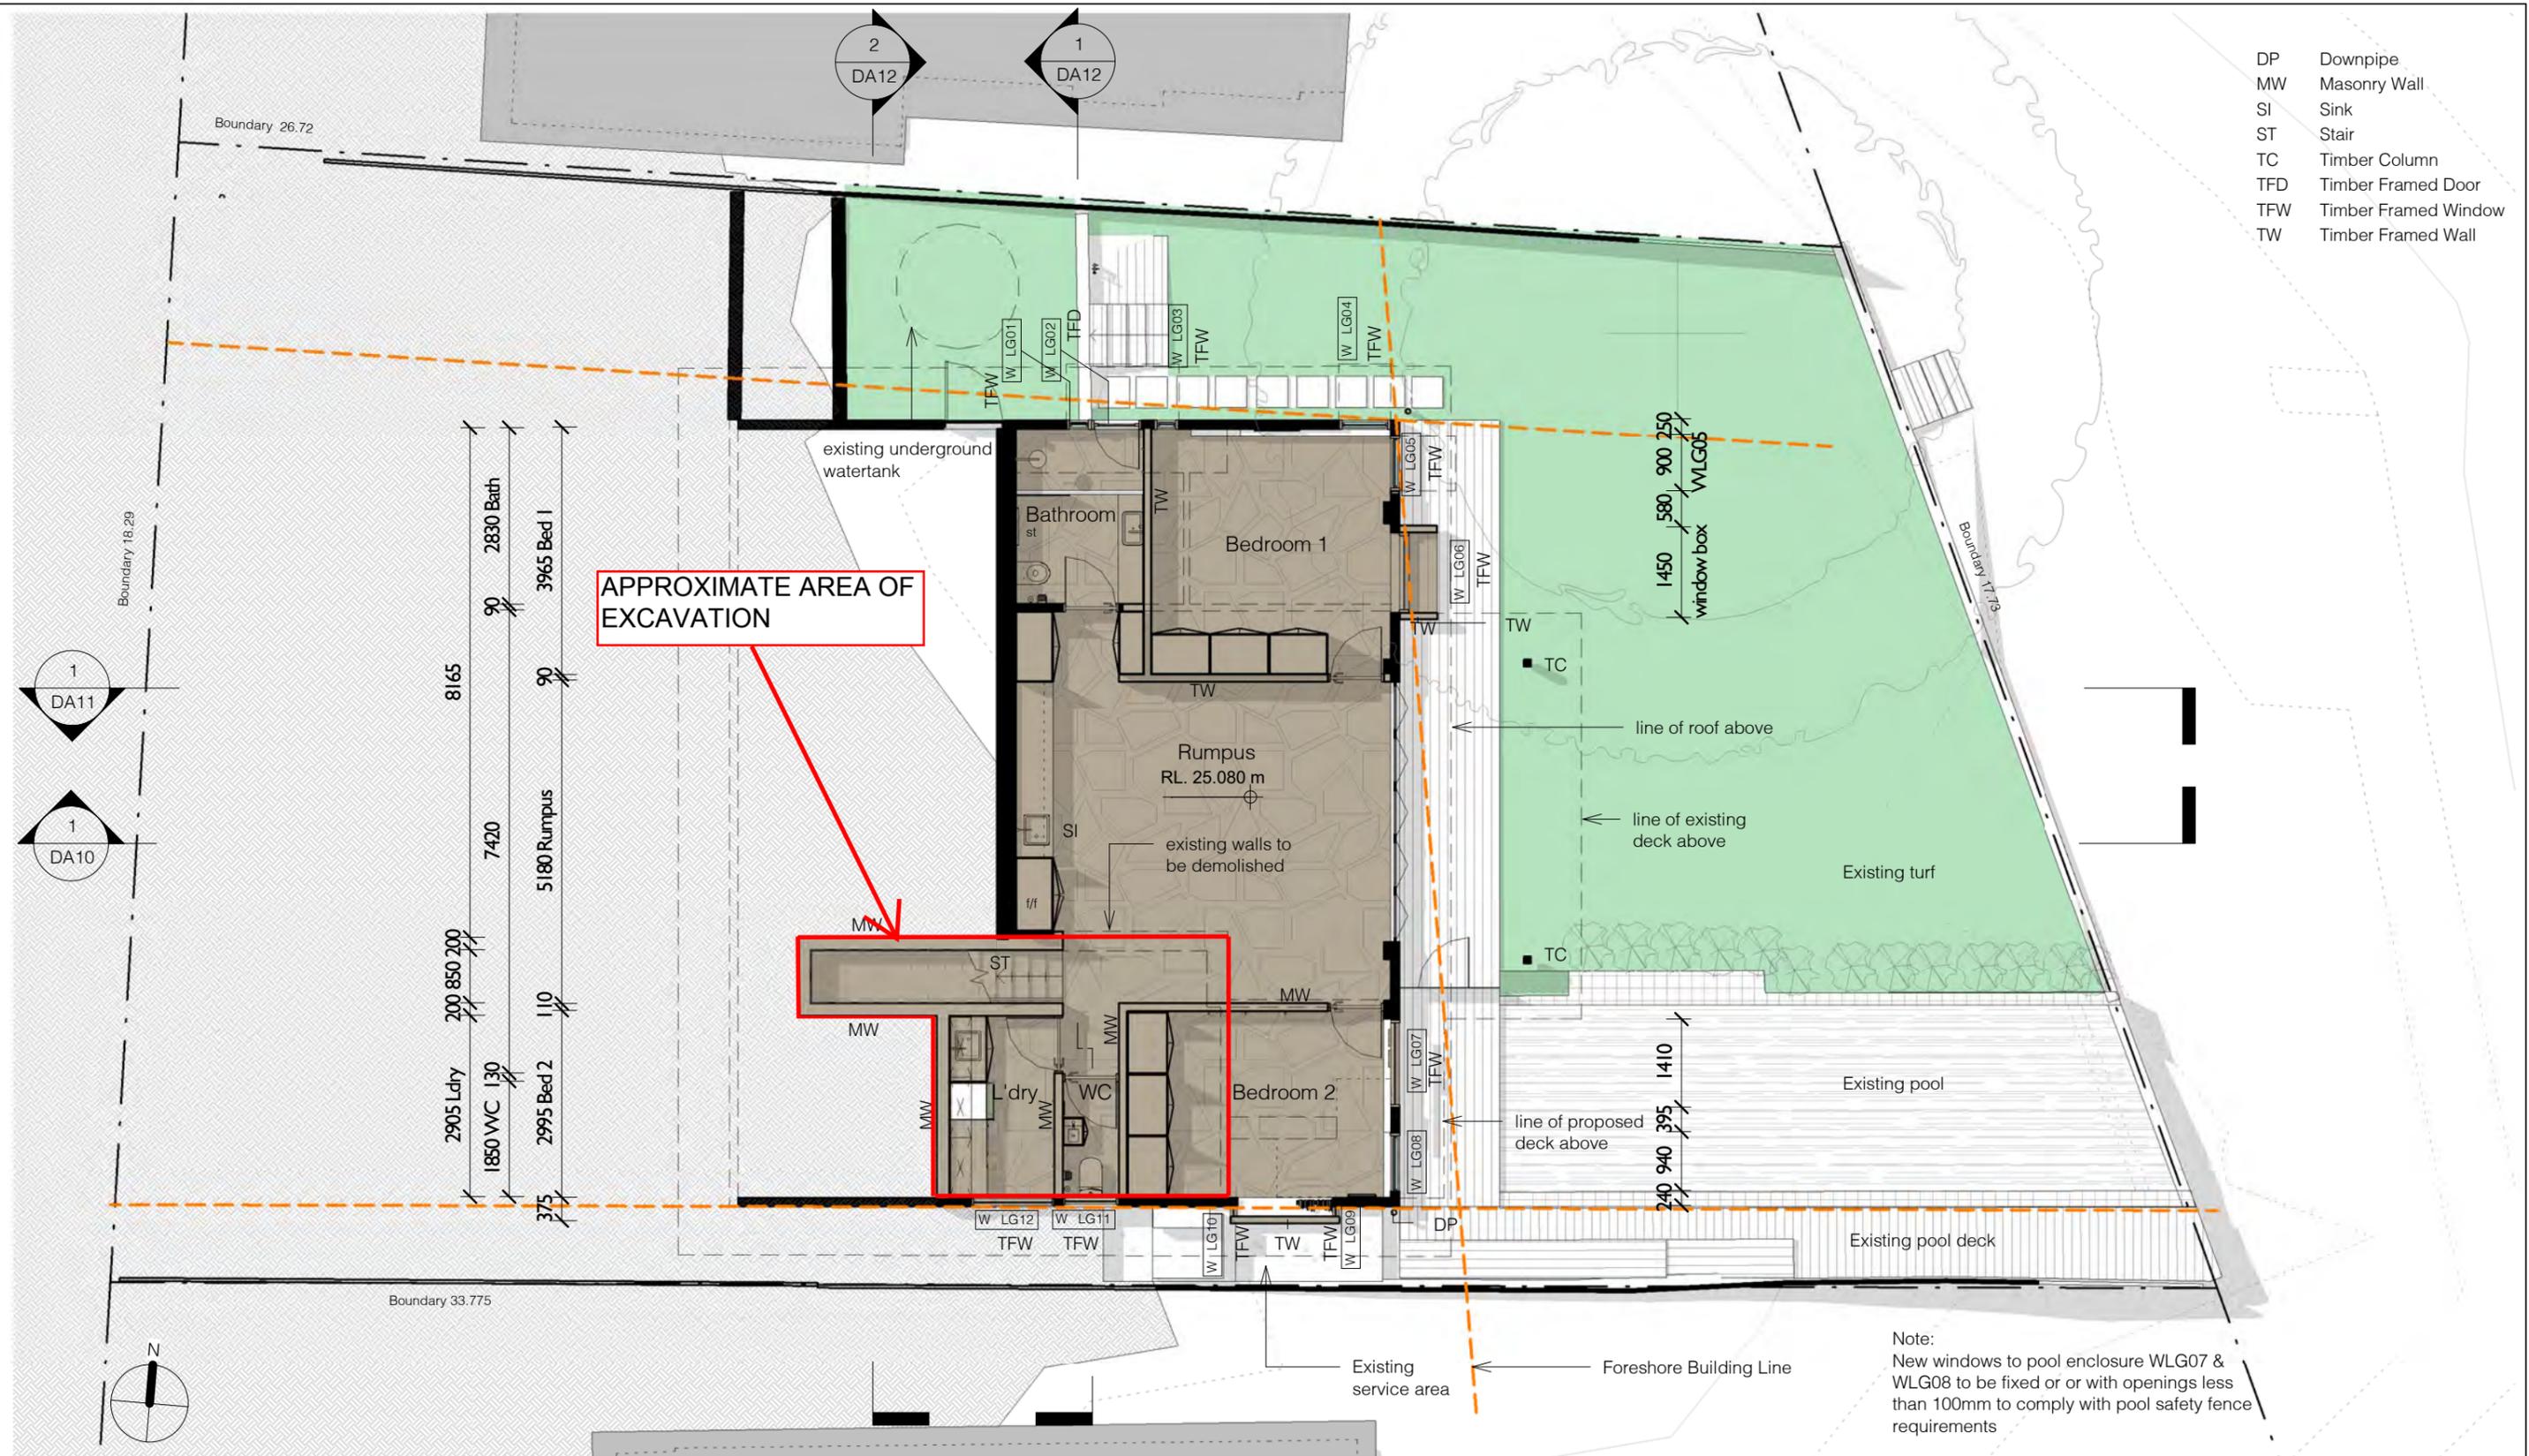
APPROXIMATE AREA OF EXCAVATION

- The existing piers appeared to be stable showing no signs of movement.
- The approximate area of excavation (as marked on the plan in Attachment C) is to be excavated up to 1.0m deep. Based on the site inspection, the material is likely to be clay soil with some floaters. Several piers will need to be removed.

With regards to the lower ground floor excavation, due care is to be taken to ensure excavation works do not undermine any existing footings. Where the excavation cannot be excavated with a temporary batter slope of 1(V):2(H) without undermining any existing footings, shoring is to be utilised during excavation with the post excavation support provided by an engineered retaining wall and/or new pier.
