## Inspection summary

Project Name: 27-29 NORTH AVALON RD, AVALON (STORMWATER I	Project number:	Date: 14/03/2019	Contact:	
---	-----------------	---------------------	----------	--

Sewer Reference: SPI56440	Section length: 61.41 m
Section Numer: 1	Pipe length:
Start node: SPP50848	Material: Reinforced concrete
End node: SPP50847	Shape: Circular

Sewer Reference: SPI56439	Section length: 94.56 m
Section Numer: 2	Pipe length:
Start node: SPP50849	Material: Reinforced concrete
End node: SPP50848	Shape: Circular

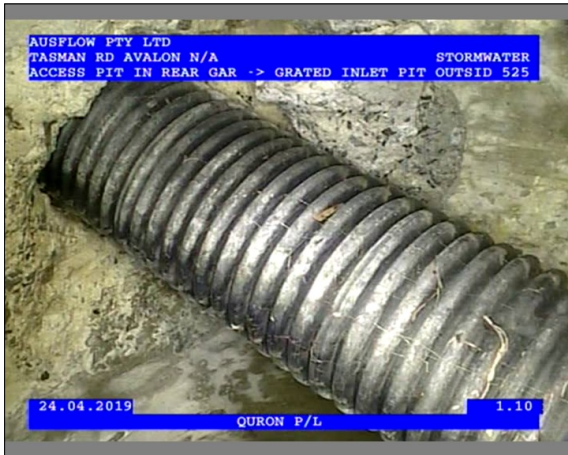
Photo: 2\_1\_2\_24042019\_122516\_A.JPG  
1.1m, Intruding connection, magnitude of intrusion: <5%,  
General Comments AGGI LINE, at 11 o'clock

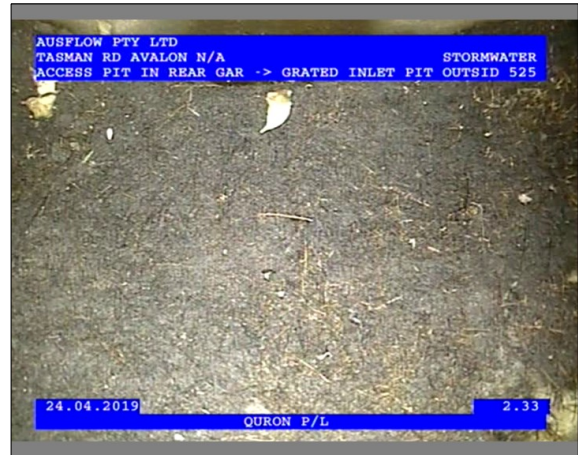
Photo: 2\_1\_3\_24042019\_122619\_A.JPG  
2.33m, Deposit is fine sediments- Sand or Silt in the invert, at joint , Obstruction: 5-20% , from 5 to 7 o'clock

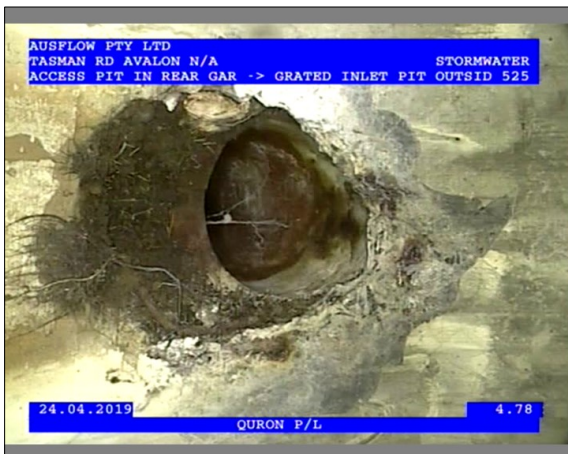
Photo: 2\_1\_4\_24042019\_122920\_A.JPG  
4.78m, Defective Connection - The connecting pipe is damaged, magnitude of obstruction <5%, General Comments NOT FULLY ENTERING PIPE, at 10 o'clock

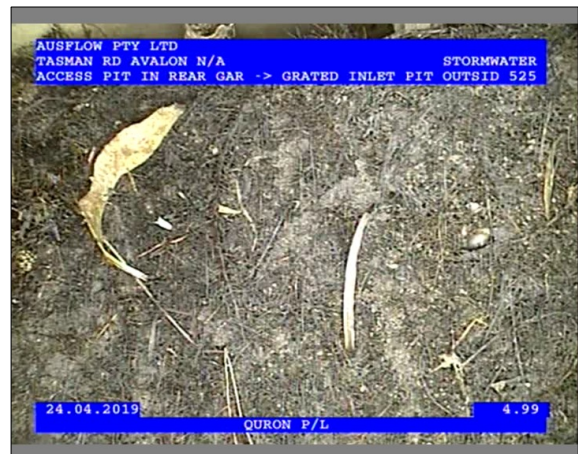
Photo: 2\_1\_5\_24042019\_123001\_A.JPG  
4.99m, A Mass of mostly fine Roots, which has developed into an interwoven clump, at joint, Obstruction: 5-20% , from 4 to 8 o'clock

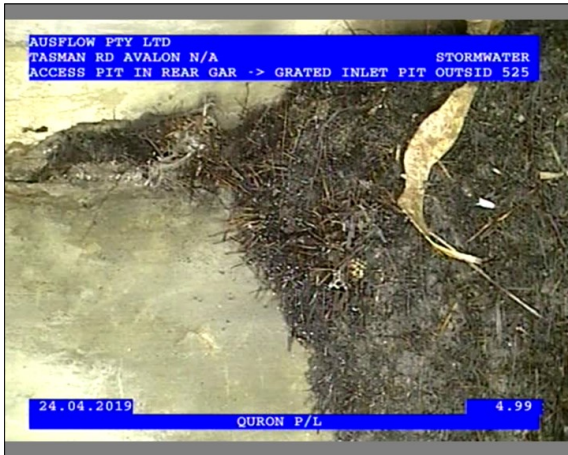
Photo: 2\_1\_5\_24042019\_123007\_B.JPG  
4.99m, A Mass of mostly fine Roots, which has developed into an interwoven clump, at joint, Obstruction: 5-20% , from 4 to 8 o'clock

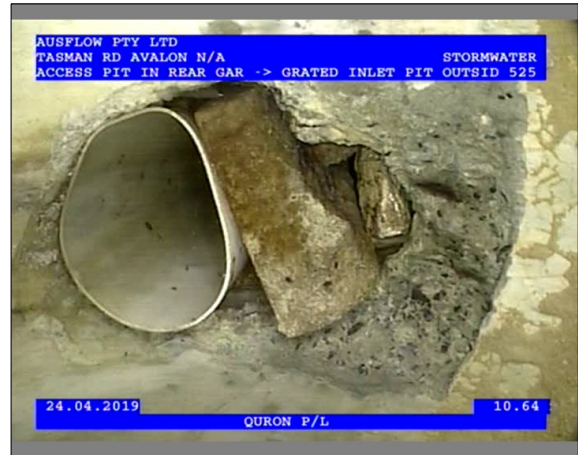
Photo: 2\_1\_7\_24042019\_123135\_A.JPG  
10.64m, Hole in wall , at 9 o'clock

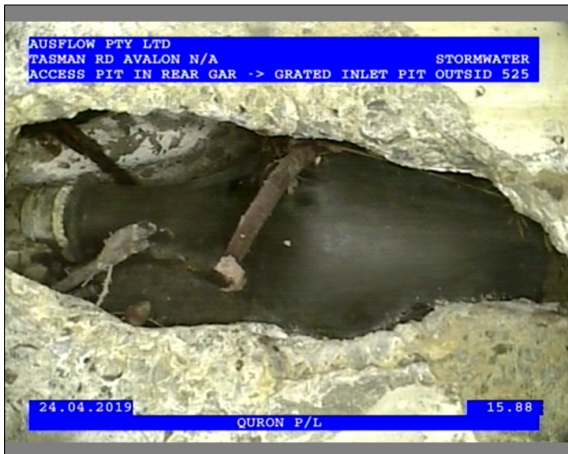
Photo: 2\_1\_8\_24042019\_123420\_A.JPG  
15.88m, Hole in wall , at 3 o'clock

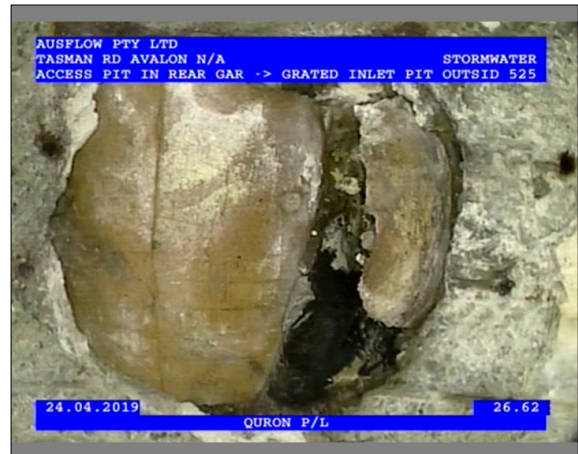
Photo: 2\_1\_11\_24042019\_123930\_A.JPG  
26.62m, Hole in wall , at 2 o'clock

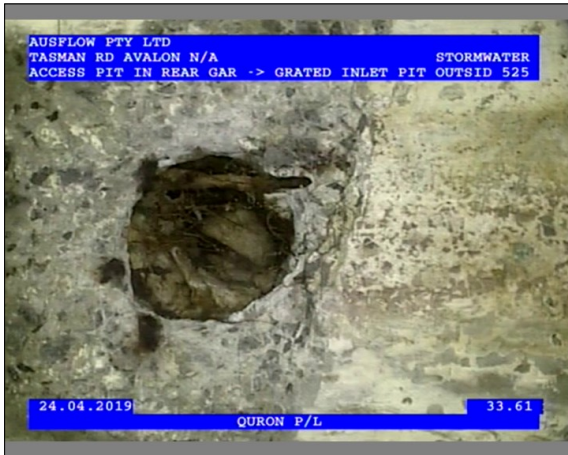
Photo: 2\_1\_12\_24042019\_124101\_A.JPG  
33.61m, Hole in wall , at 3 o'clock

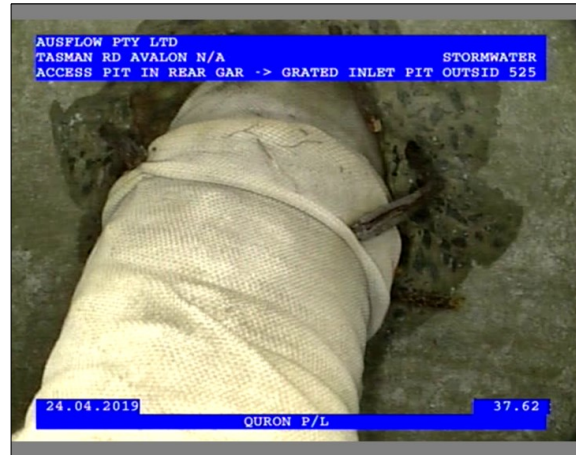
Photo: 2\_1\_13\_24042019\_124200\_A.JPG  
37.62m, Intruding connection, magnitude of intrusion: <5%,  
General Comments AGGI LINE, at 1 o'clock

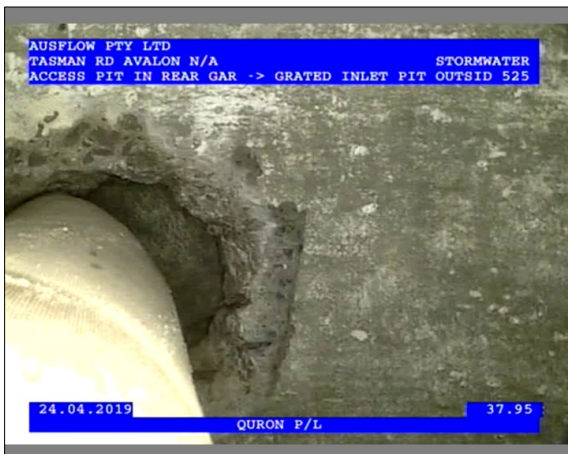
Photo: 2\_1\_14\_24042019\_124238\_A.JPG  
37.95m, Intruding connection, magnitude of intrusion: <5%,  
General Comments AGGI LINE, at 11 o'clock

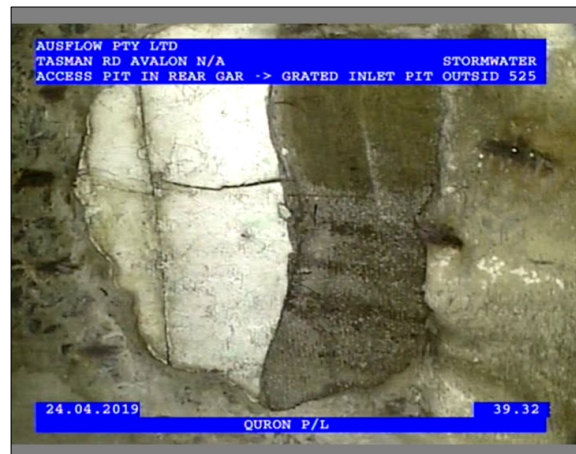
Photo: 2\_1\_15\_24042019\_124412\_A.JPG  
39.32m, Hole in wall , at 3 o'clock

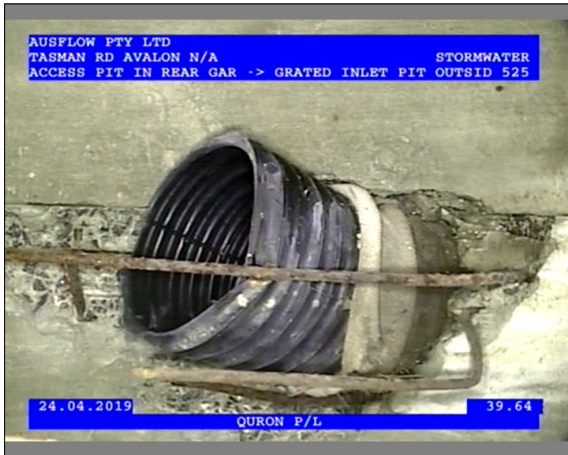
Photo: 2\_1\_16\_24042019\_124451\_A.JPG  
39.64m, Intruding connection, magnitude of intrusion: <5%,  
General Comments AGGI LINE, at 12 o'clock

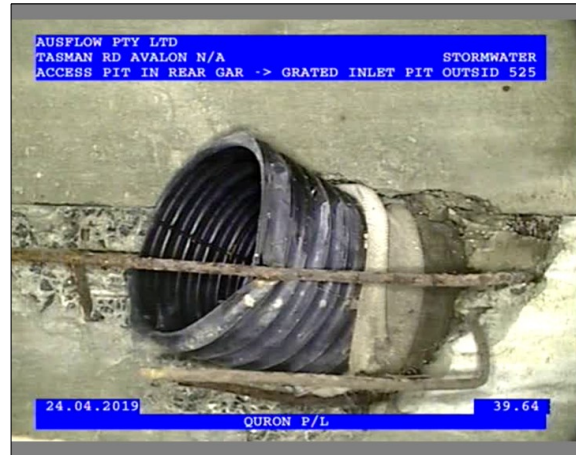
Photo: 2\_1\_17\_24042019\_124523\_A.JPG  
39.64m, Reinforcement is exposed and corroded, at joint , from  
10 to 2 o'clock

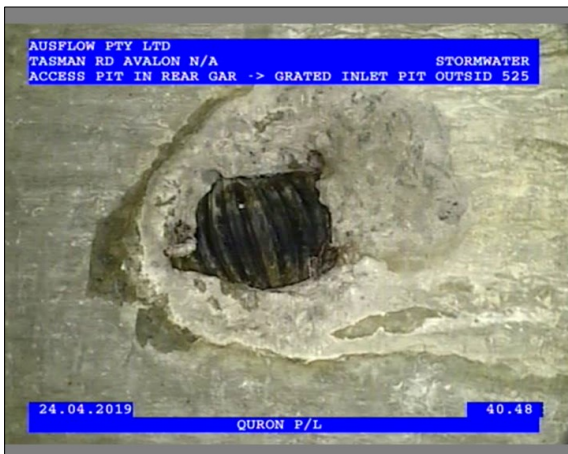
Photo: 2\_1\_18\_24042019\_124547\_A.JPG  
40.48m, Hole in wall , at 1 o'clock

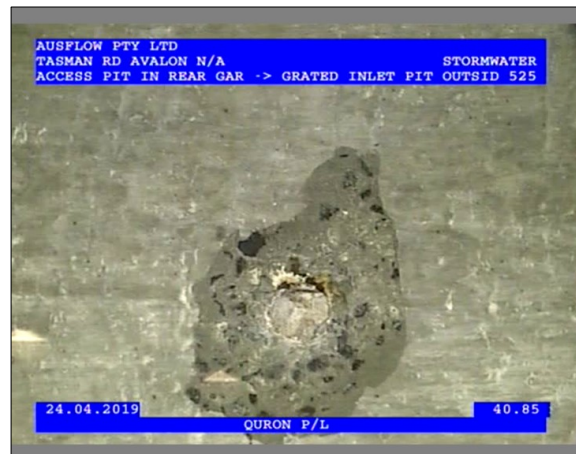
Photo: 2\_1\_19\_24042019\_124605\_A.JPG  
40.85m, Hole in wall , at 12 o'clock

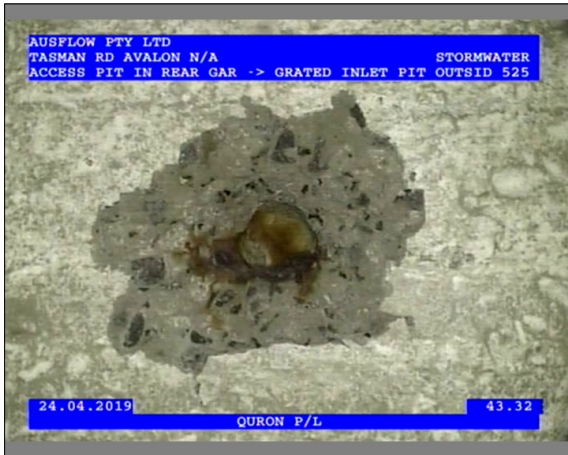
Photo: 2\_1\_20\_24042019\_124653\_A.JPG  
43.32m, Hole in wall , at 12 o'clock

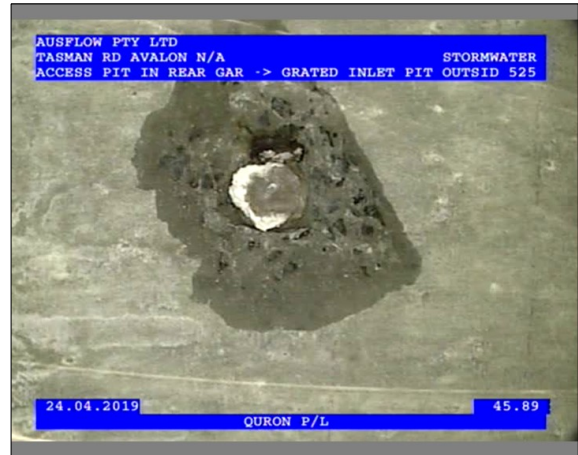
Photo: 2\_1\_21\_24042019\_124746\_A.JPG  
45.89m, Hole in wall , at 12 o'clock

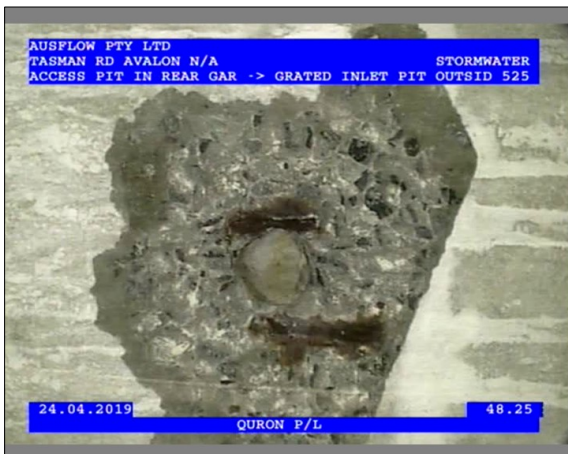
Photo: 2\_1\_22\_24042019\_124946\_A.JPG  
48.25m, Hole in wall , at 12 o'clock

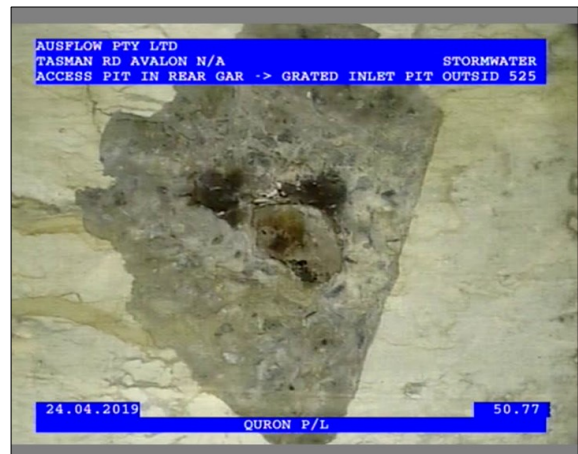
Photo: 2\_1\_23\_24042019\_125037\_A.JPG  
50.77m, Hole in wall , at 12 o'clock

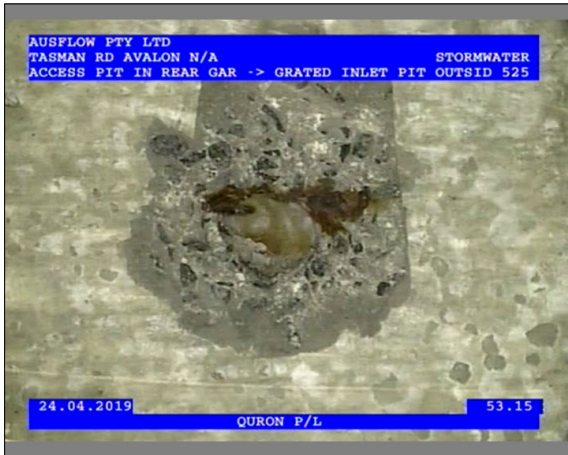
Photo: 2\_1\_24\_24042019\_125127\_A.JPG  
53.15m, Hole in wall , at 12 o'clock

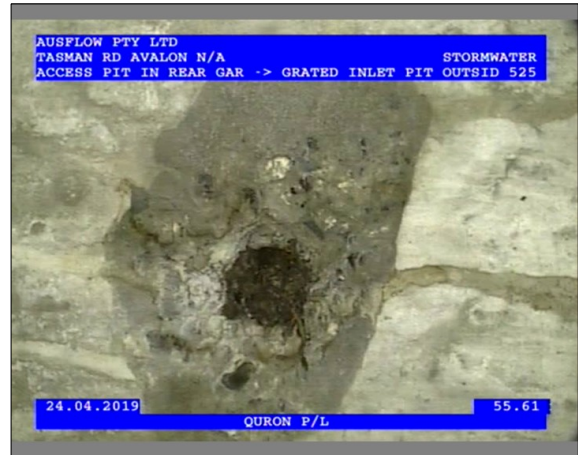
Photo: 2\_1\_25\_24042019\_125230\_A.JPG  
55.61m, Hole in wall , at 12 o'clock

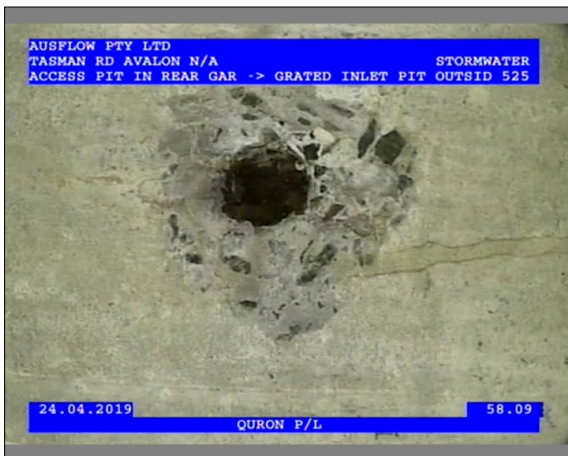
Photo: 2\_1\_26\_24042019\_125319\_A.JPG  
58.09m, Hole in wall , at 12 o'clock

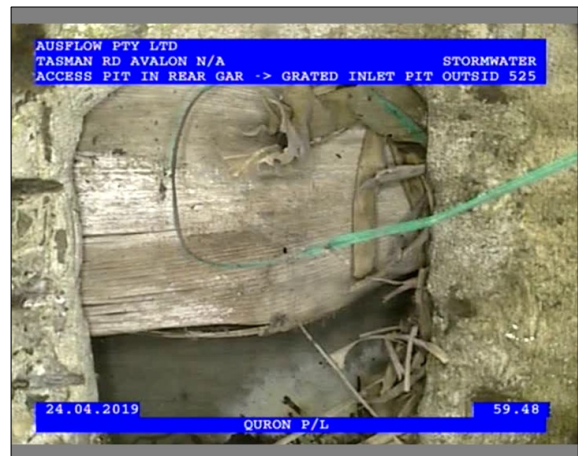
Photo: 2\_1\_27\_24042019\_125404\_A.JPG  
59.48m, Hole in wall , at 12 o'clock

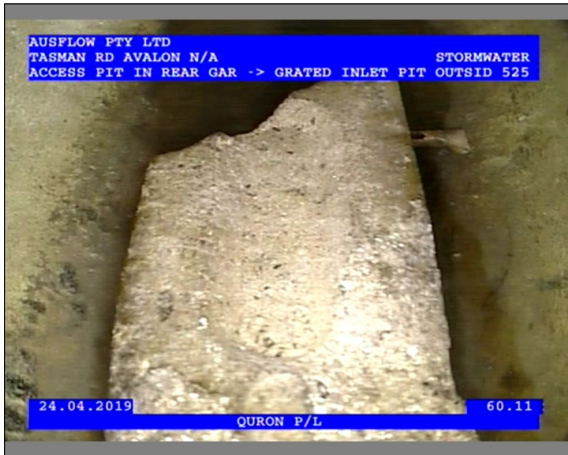
Photo: 2\_1\_28\_24042019\_125456\_A.JPG  
60.11m, Obstruction, dislodged brick or masonry unit lying in the invert , reduction in cross sectional area: 5-20% , at 6 o'clock

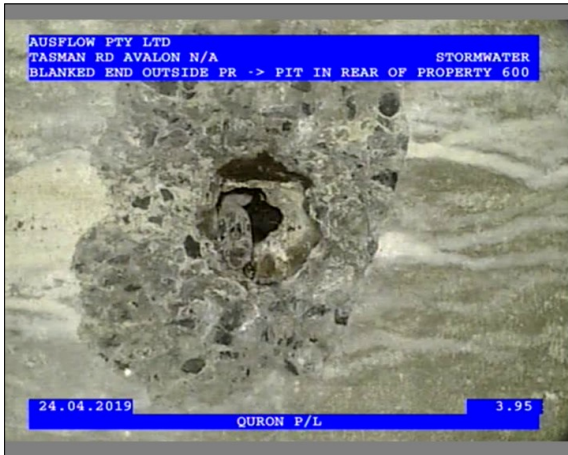
Photo: 3\_1\_3\_24042019\_131101\_A.JPG  
3.95m, Hole in wall , at 12 o'clock

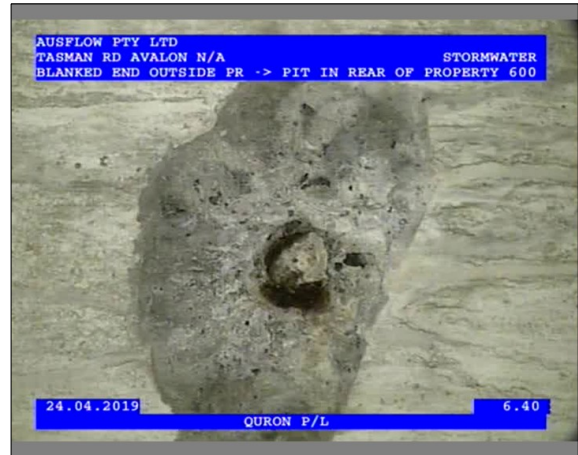
Photo: 3\_1\_4\_24042019\_131436\_A.JPG  
6.4m, Hole in wall , at 12 o'clock

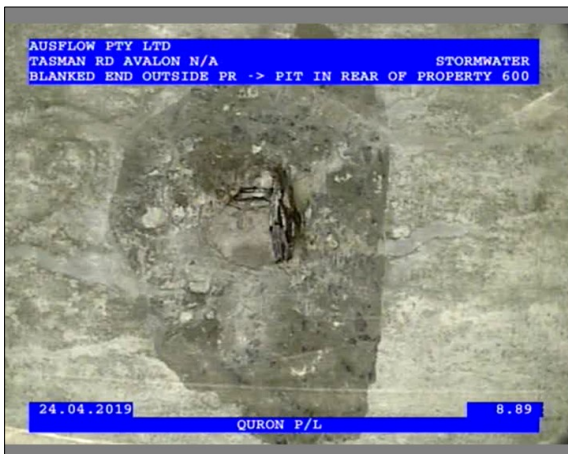
Photo: 3\_1\_5\_24042019\_131711\_A.JPG  
8.89m, Hole in wall , at 12 o'clock

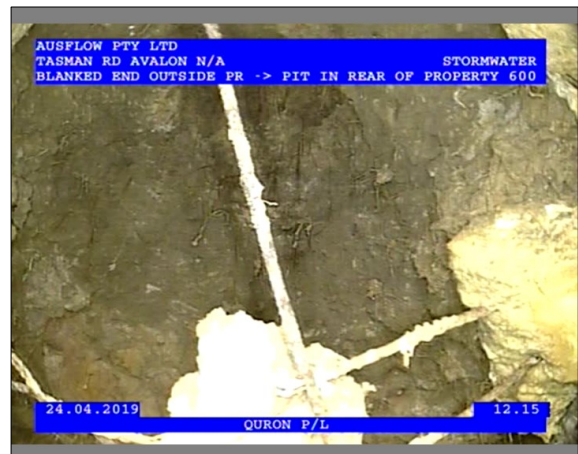
Photo: 3\_1\_6\_24042019\_131843\_A.JPG  
12.16m, Hole in wall , from 11 to 1 o'clock

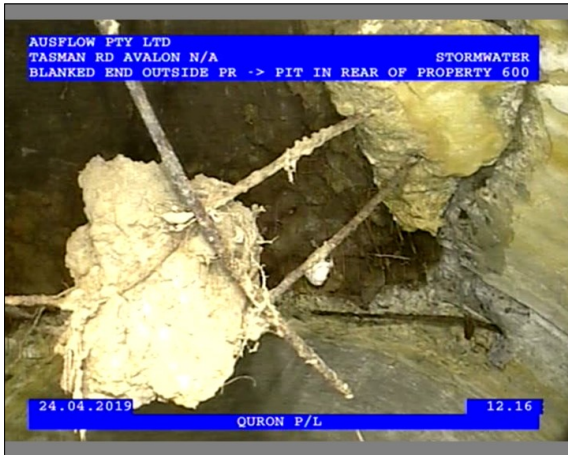
Photo: 3\_1\_7\_24042019\_131909\_A.JPG  
12.16m, Reinforcement is exposed and corroded , from 11 to 1 o'clock

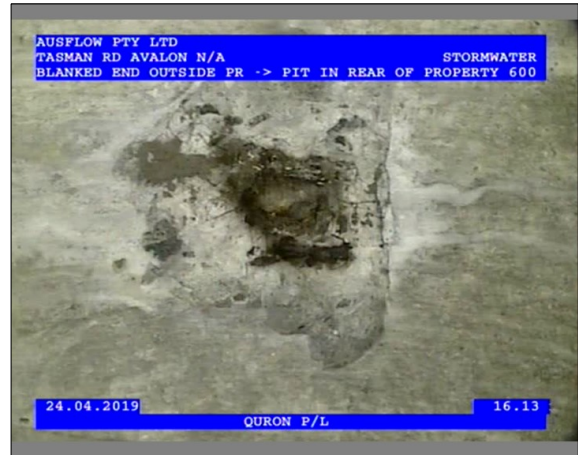
Photo: 3\_1\_8\_24042019\_132022\_A.JPG  
16.13m, Hole in wall , at 12 o'clock

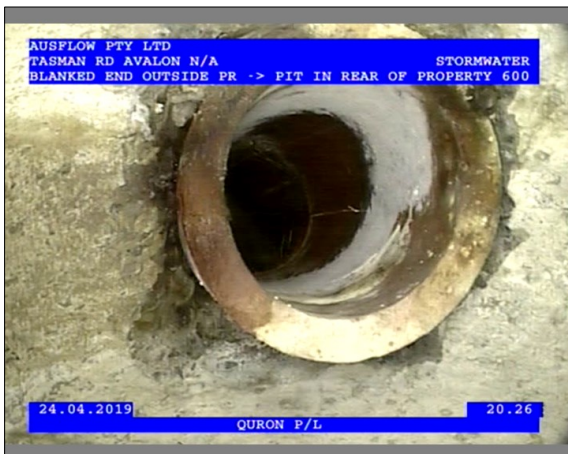
Photo: 3\_1\_9\_24042019\_132215\_A.JPG  
20.26m, Connection, good workmanship, connection appears to be open, diameter 100mm , at 10 o'clock

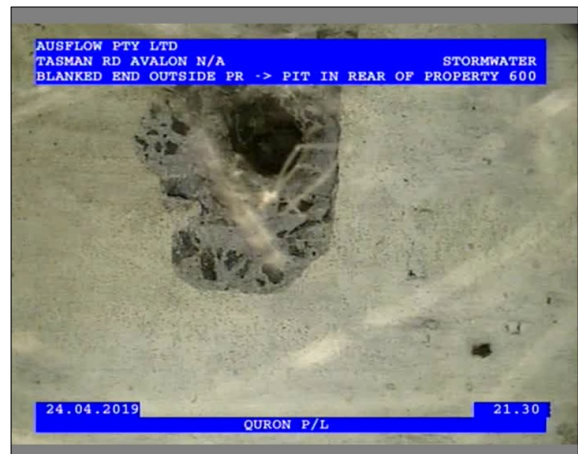
Photo: 3\_1\_10\_24042019\_132300\_A.JPG  
21.3m, Hole in wall , at 12 o'clock

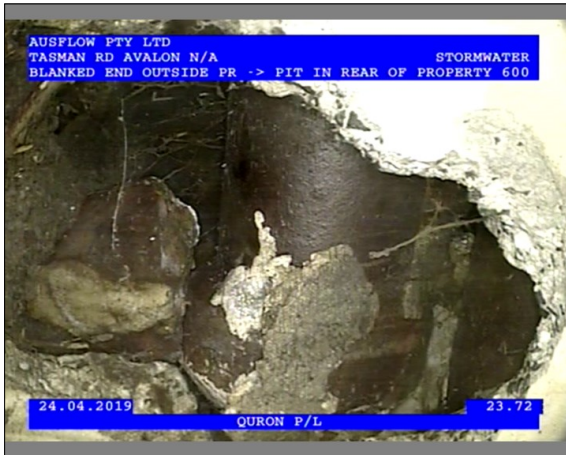
Photo: 3\_1\_11\_24042019\_132420\_A.JPG  
23.72m, Hole in wall , at 9 o'clock

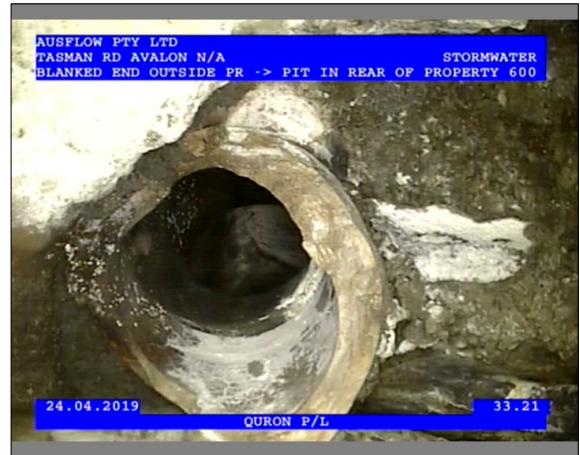
Photo: 3\_1\_13\_24042019\_132720\_A.JPG  
33.21m, Hole in wall , from 9 to 11 o'clock

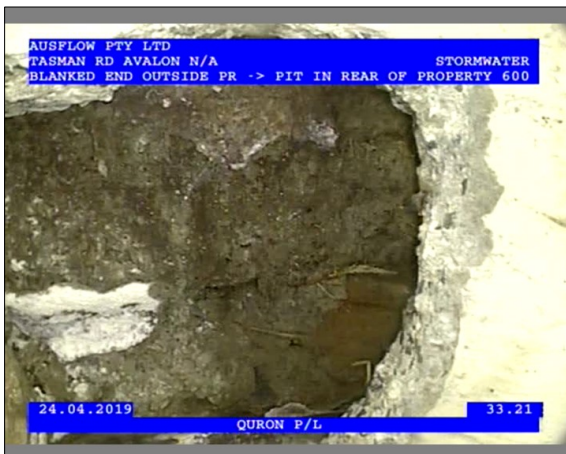
Photo: 3\_1\_13\_24042019\_132726\_B.JPG  
33.21m, Hole in wall , from 9 to 11 o'clock

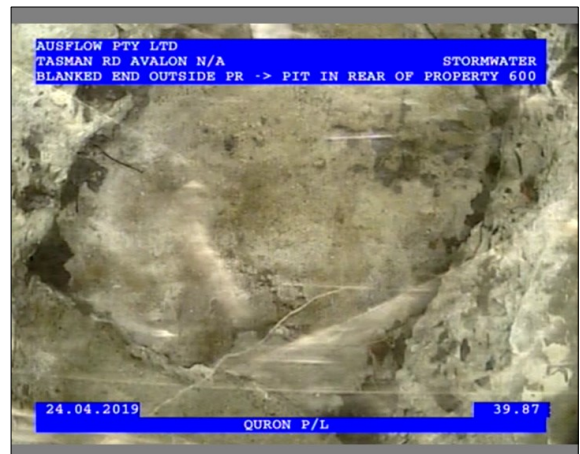
Photo: 3\_1\_14\_24042019\_132908\_A.JPG  
39.87m, Hole in wall , from 10 to 11 o'clock

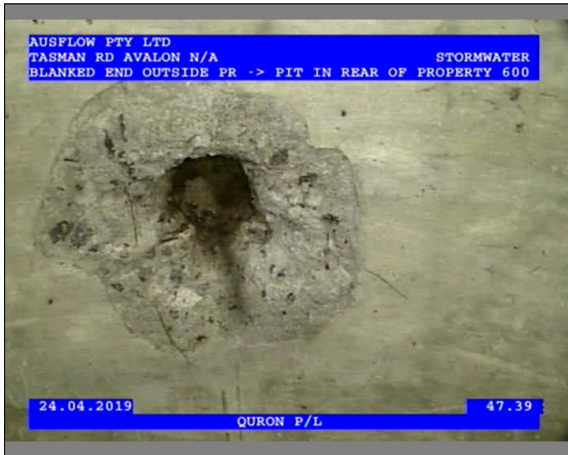
Photo: 3\_1\_15\_24042019\_133015\_A.JPG  
47.39m, Hole in wall , at 12 o'clock

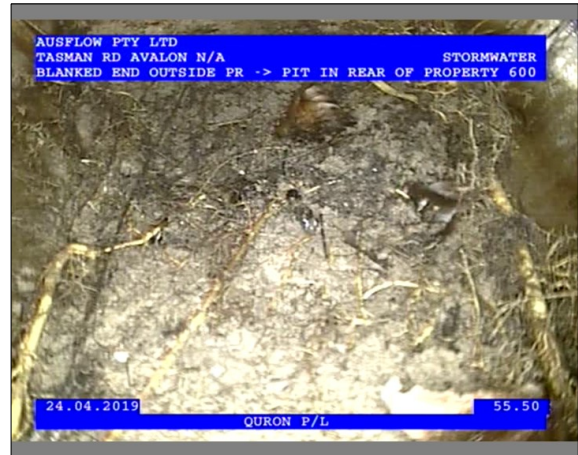
Photo: 3\_1\_17\_24042019\_133342\_A.JPG  
55.5m, A Mass of mostly fine Roots, which has developed into an interwoven clump , Obstruction: 21-50% , from 4 to 8 o'clock

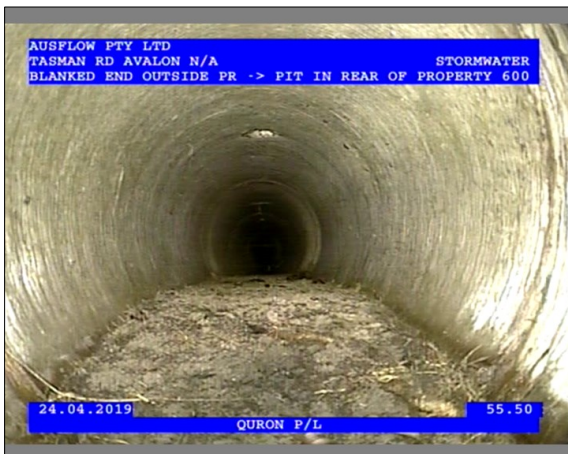
Photo: 3\_1\_17\_24042019\_133347\_B.JPG  
55.5m, A Mass of mostly fine Roots, which has developed into an interwoven clump , Obstruction: 21-50% , from 4 to 8 o'clock

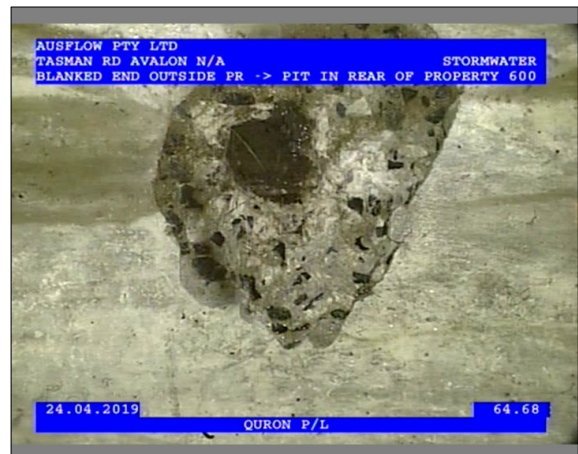
Photo: 3\_1\_18\_24042019\_134029\_A.JPG  
64.68m, Hole in wall , at 12 o'clock

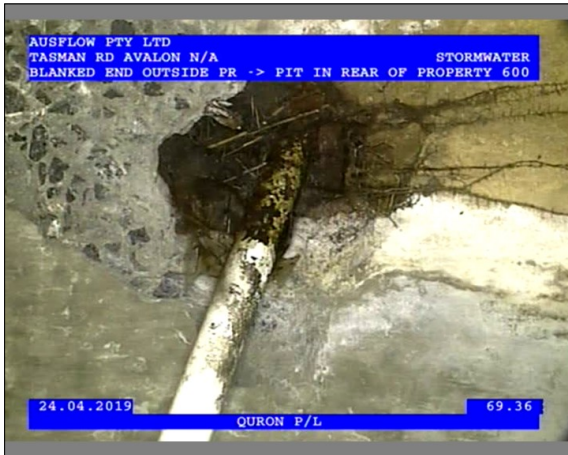
Photo: 3\_1\_19\_24042019\_134125\_A.JPG  
69.36m, Hole in wall , at 2 o'clock

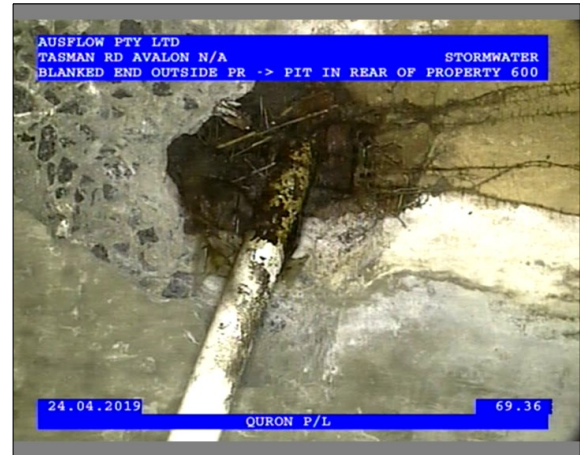
Photo: 3\_1\_20\_24042019\_134302\_A.JPG  
69.36m, Obstruction, an object is intruding through the wall , reduction in cross sectional area: <5%, General Comments CONDUIT, from 10 to 2 o'clock

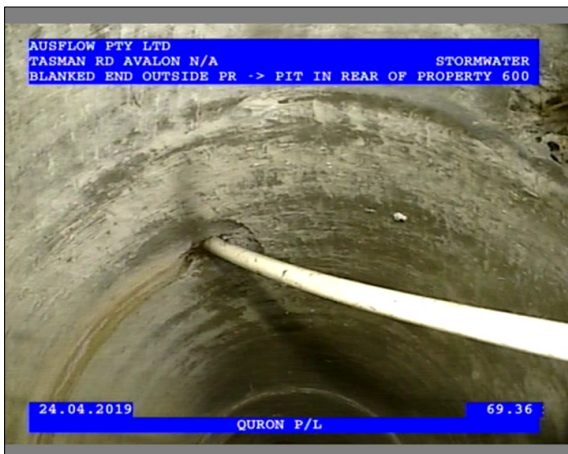
Photo: 3\_1\_20\_24042019\_134312\_B.JPG  
69.36m, Obstruction, an object is intruding through the wall , reduction in cross sectional area: <5%, General Comments CONDUIT, from 10 to 2 o'clock

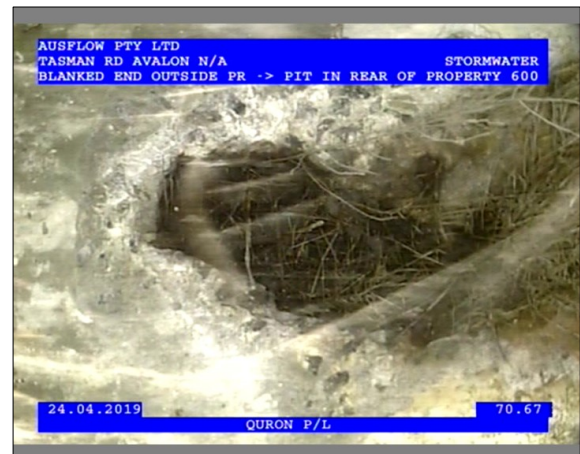
Photo: 3\_1\_21\_24042019\_134342\_A.JPG  
70.67m, Hole in wall , at 3 o'clock

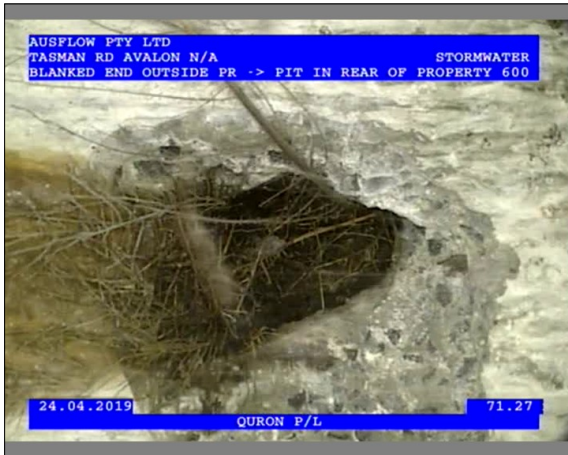
Photo: 3\_1\_22\_24042019\_134414\_A.JPG  
71.27m, Hole in wall , at 9 o'clock

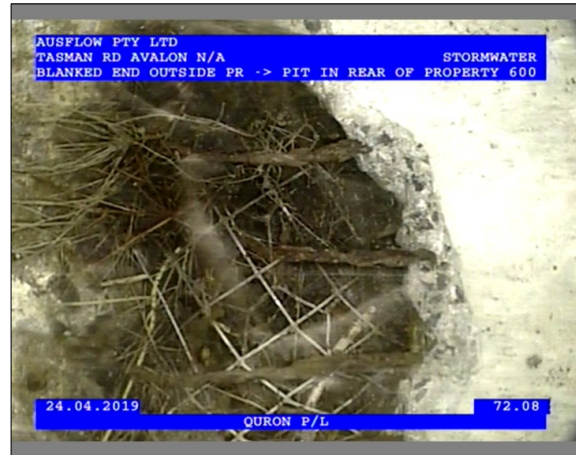
Photo: 3\_1\_23\_24042019\_134443\_A.JPG  
72.08m, Hole in wall , at 9 o'clock

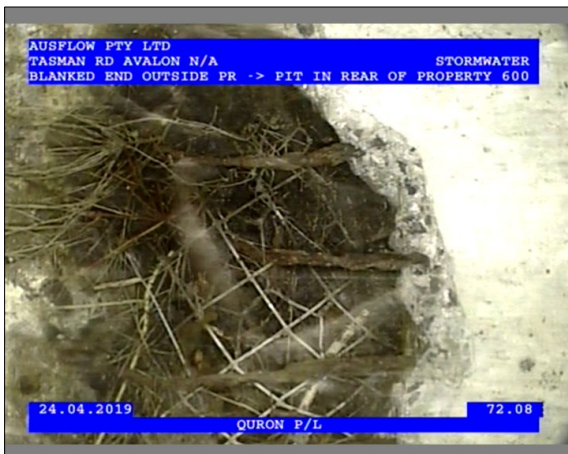
Photo: 3\_1\_24\_24042019\_134511\_A.JPG  
72.08m, Reinforcement is exposed and corroded , at 9 o'clock

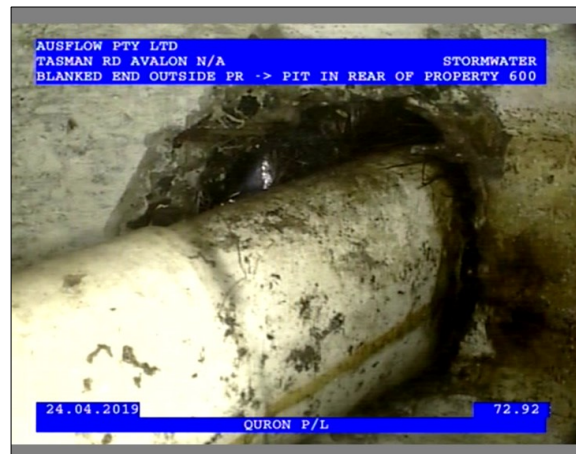
Photo: 3\_1\_25\_24042019\_134545\_A.JPG  
72.92m, Connection, poor workmanship, connection appears to be open , diameter 100mm

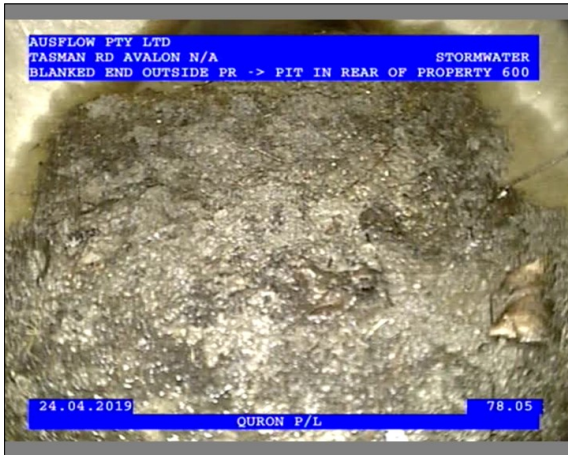
Photo: 3\_1\_26\_24042019\_134649\_A.JPG  
78.04m, Deposit is fine sediments- Sand or Silt in the invert ,  
Obstruction: 5-20% , from 5 to 7 o'clock

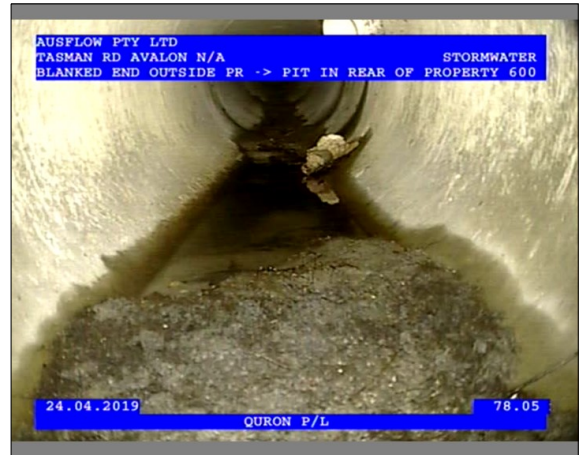
Photo: 3\_1\_26\_24042019\_134654\_B.JPG  
78.04m, Deposit is fine sediments- Sand or Silt in the invert ,  
Obstruction: 5-20% , from 5 to 7 o'clock

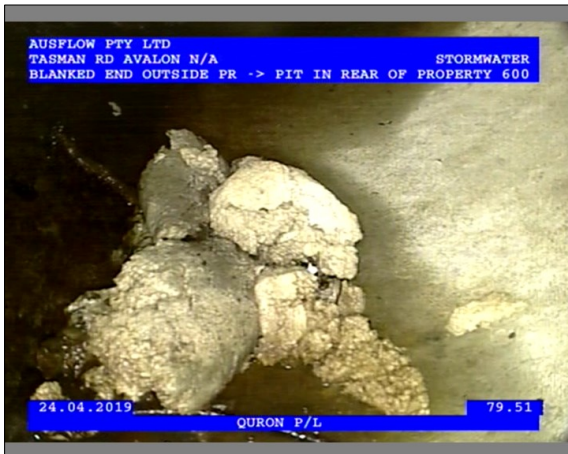
Photo: 3\_1\_28\_24042019\_134754\_A.JPG  
79.51m, Deposit is coarse sediments- Gravel or Rubble in the  
invert , Obstruction: <5% , at 5 o'clock

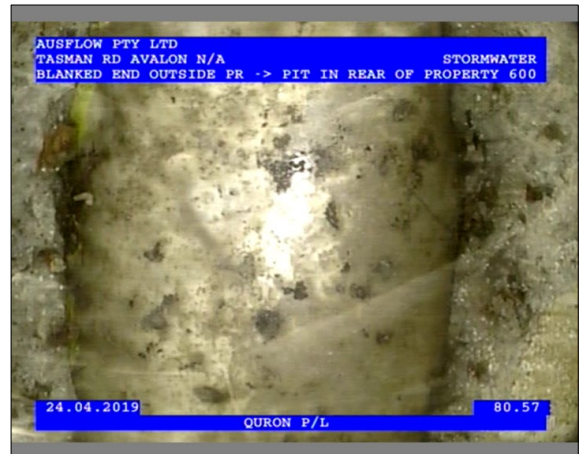
Photo: 3\_1\_30\_24042019\_134859\_A.JPG  
80.57m, Hole in wall , at 12 o'clock

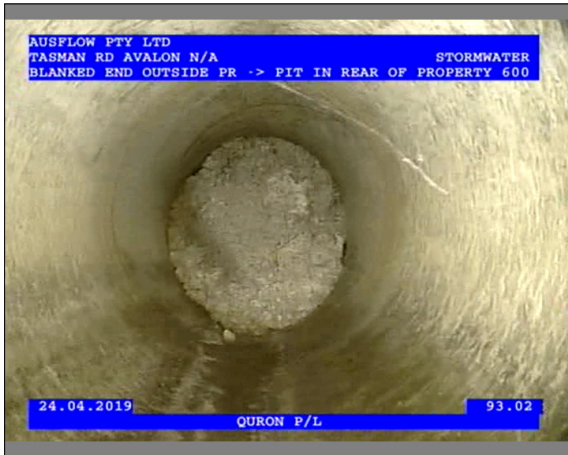
Photo: 3\_1\_31\_01052019\_111808\_A.jpg  
94.56m, Finish node, dead end, Nodename: SPP50849

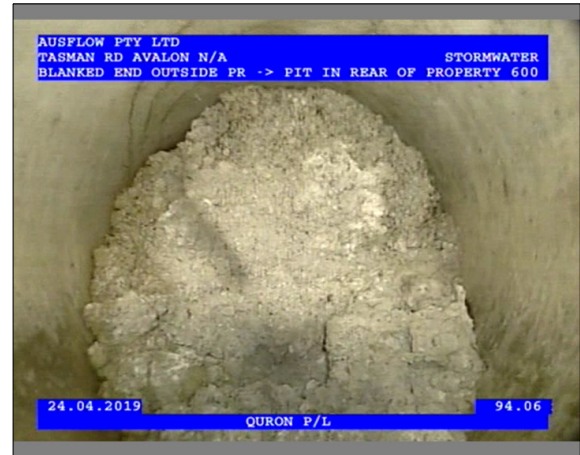
Photo: 3\_1\_31\_01052019\_111841\_B.jpg  
94.56m, Finish node, dead end, Nodename: SPP50849
