Geotechnical Assessment

Project: Alterations & Additions
13 Baltic Street, Fairlight NSW

Ref: AG 24526

3 December 2024

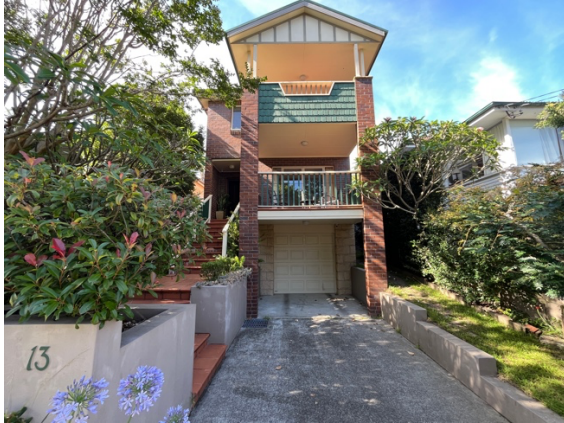
Photo 1: Site frontage

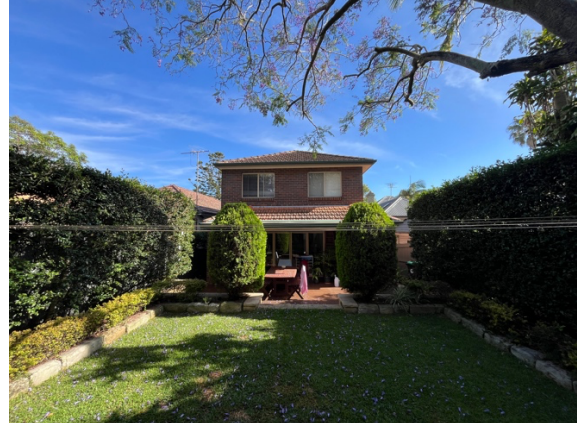
Photo 2: Residence rear

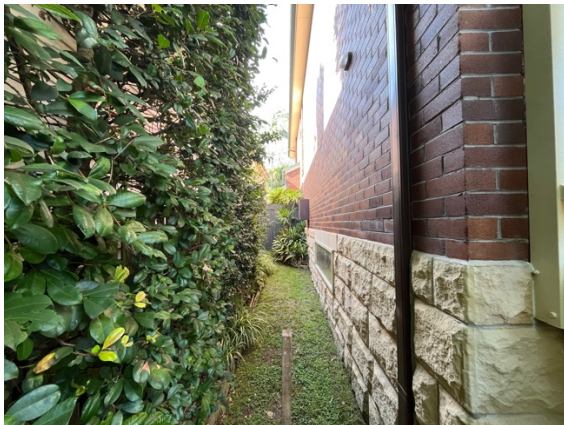
Photo 3: Looking south, along eastern boundary

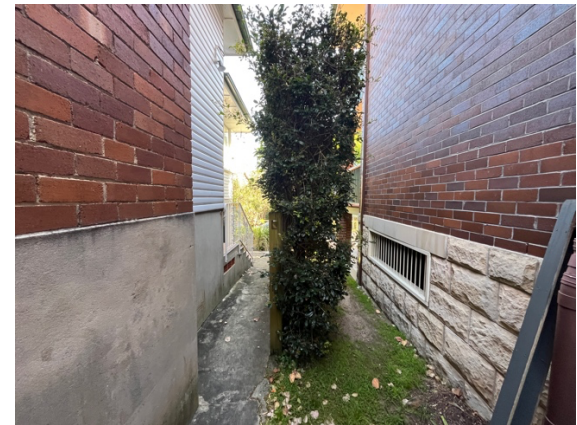
Photo 4: Looking north, along western boundary
