Report Title: Geotechnical Report 3 Coolawin Road, Avalon  
Report Date: 26/11/24

## **GEOTECHNICAL INVESTIGATION:**

### **Alterations and Additions at 3 Coolawin Road, Avalon**

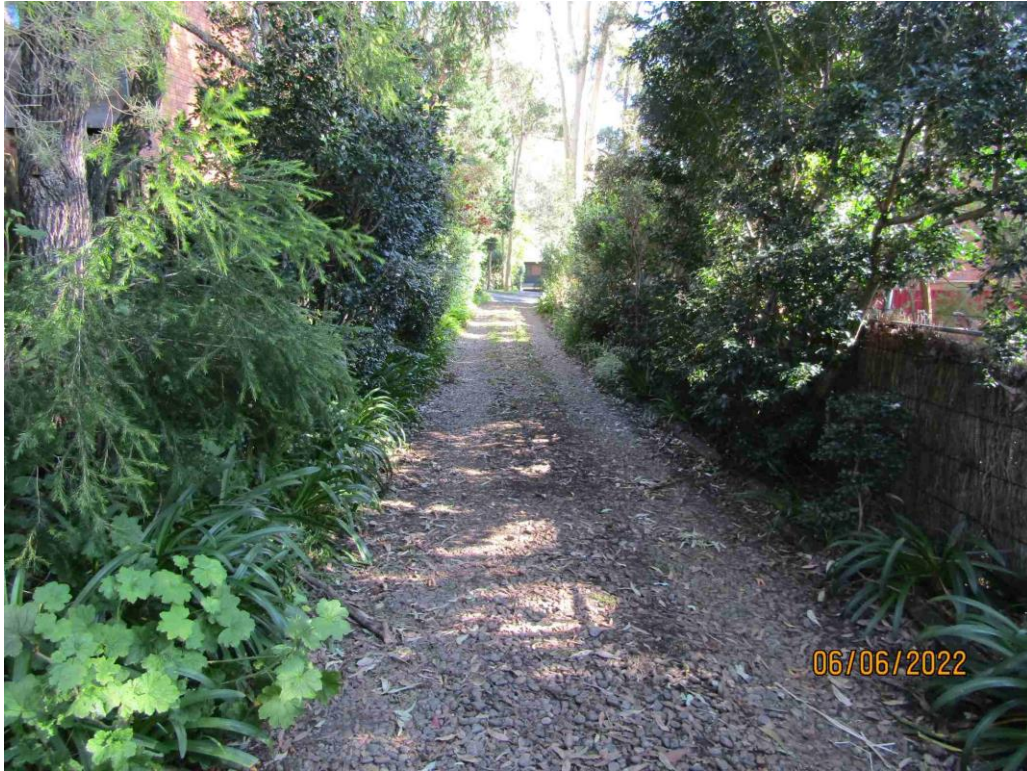
Photo 1

- 2.3** At the road frontage, a concrete and gravel driveway runs up to the slope to a carport beside the house (Photos 1 & 2). Sandstone bedrock is exposed at the surface on the downhill neighbouring property near the common boundary (Photo 3). A garden area and gently sloping lawn are located on the downhill side of the house (Photo 4). A timber deck extends off the downhill side of the house. The timber posts supporting the deck stand vertical. The part two storey timber clad house is supporting by brick walls and brick piers (Photos 4 & 5). The supporting walls and piers stand

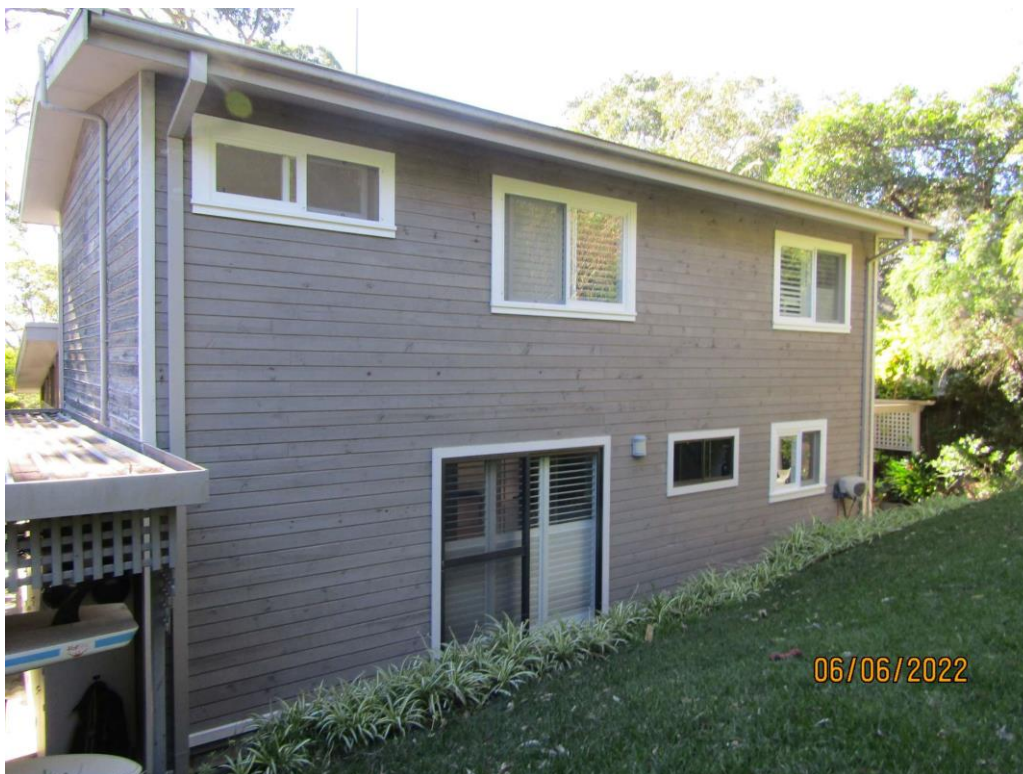
Photo 5

vertical and show no significant signs of movement (Photo 6). A cut provides a level platform for the house and carport. The cut is supported by a stable concrete crib retaining wall ~1.2m high (Photo 7). A gently sloping lawn is located on the uphill side of the retaining wall. No signs of slope instability were observed on the property. The adjoining neighbouring properties were observed to be in good order as seen from the street and subject property.

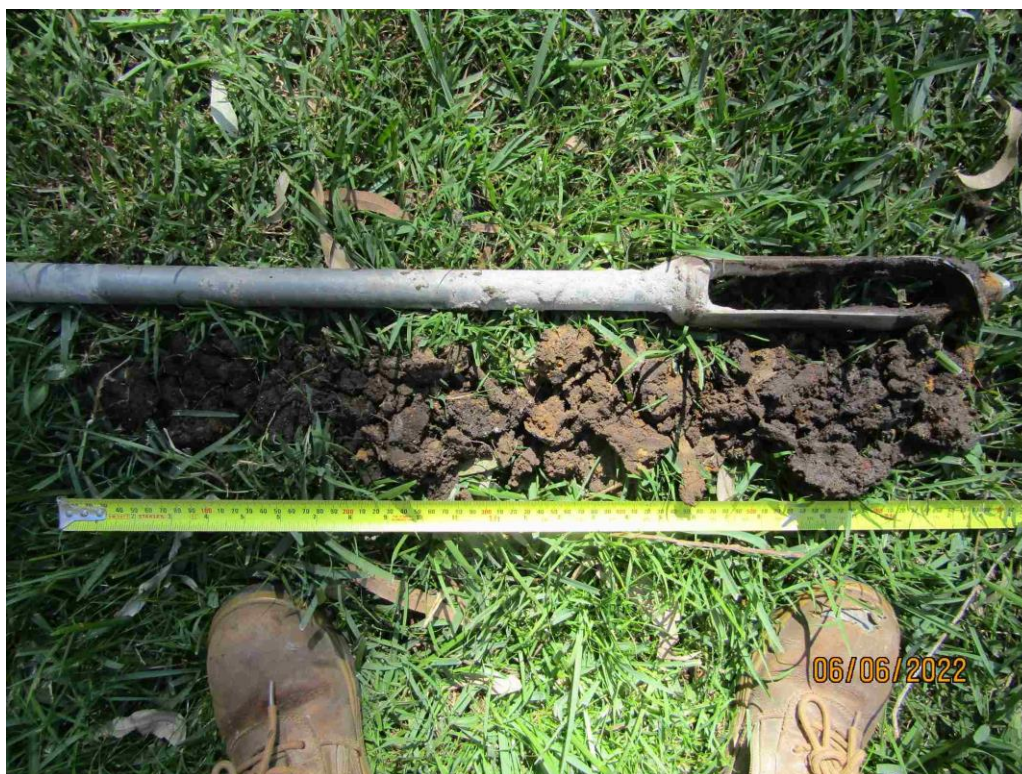
| Depth (m) | Material Encountered |
|---|---|
| 0.0 to 0.5 | <b>FILL</b> , sandy soil and clay, dark brown, light orange brown, damp. |
| 0.5 to 0.7 | <b>SANDY SOIL</b> , with trace sandy clay at base of hole, dark brown, orange, damp. |

Refusal @ 0.7m, auger grinding on rock surface. No watertable encountered.

Photo 8: AH1 – Downhole is from left to right.

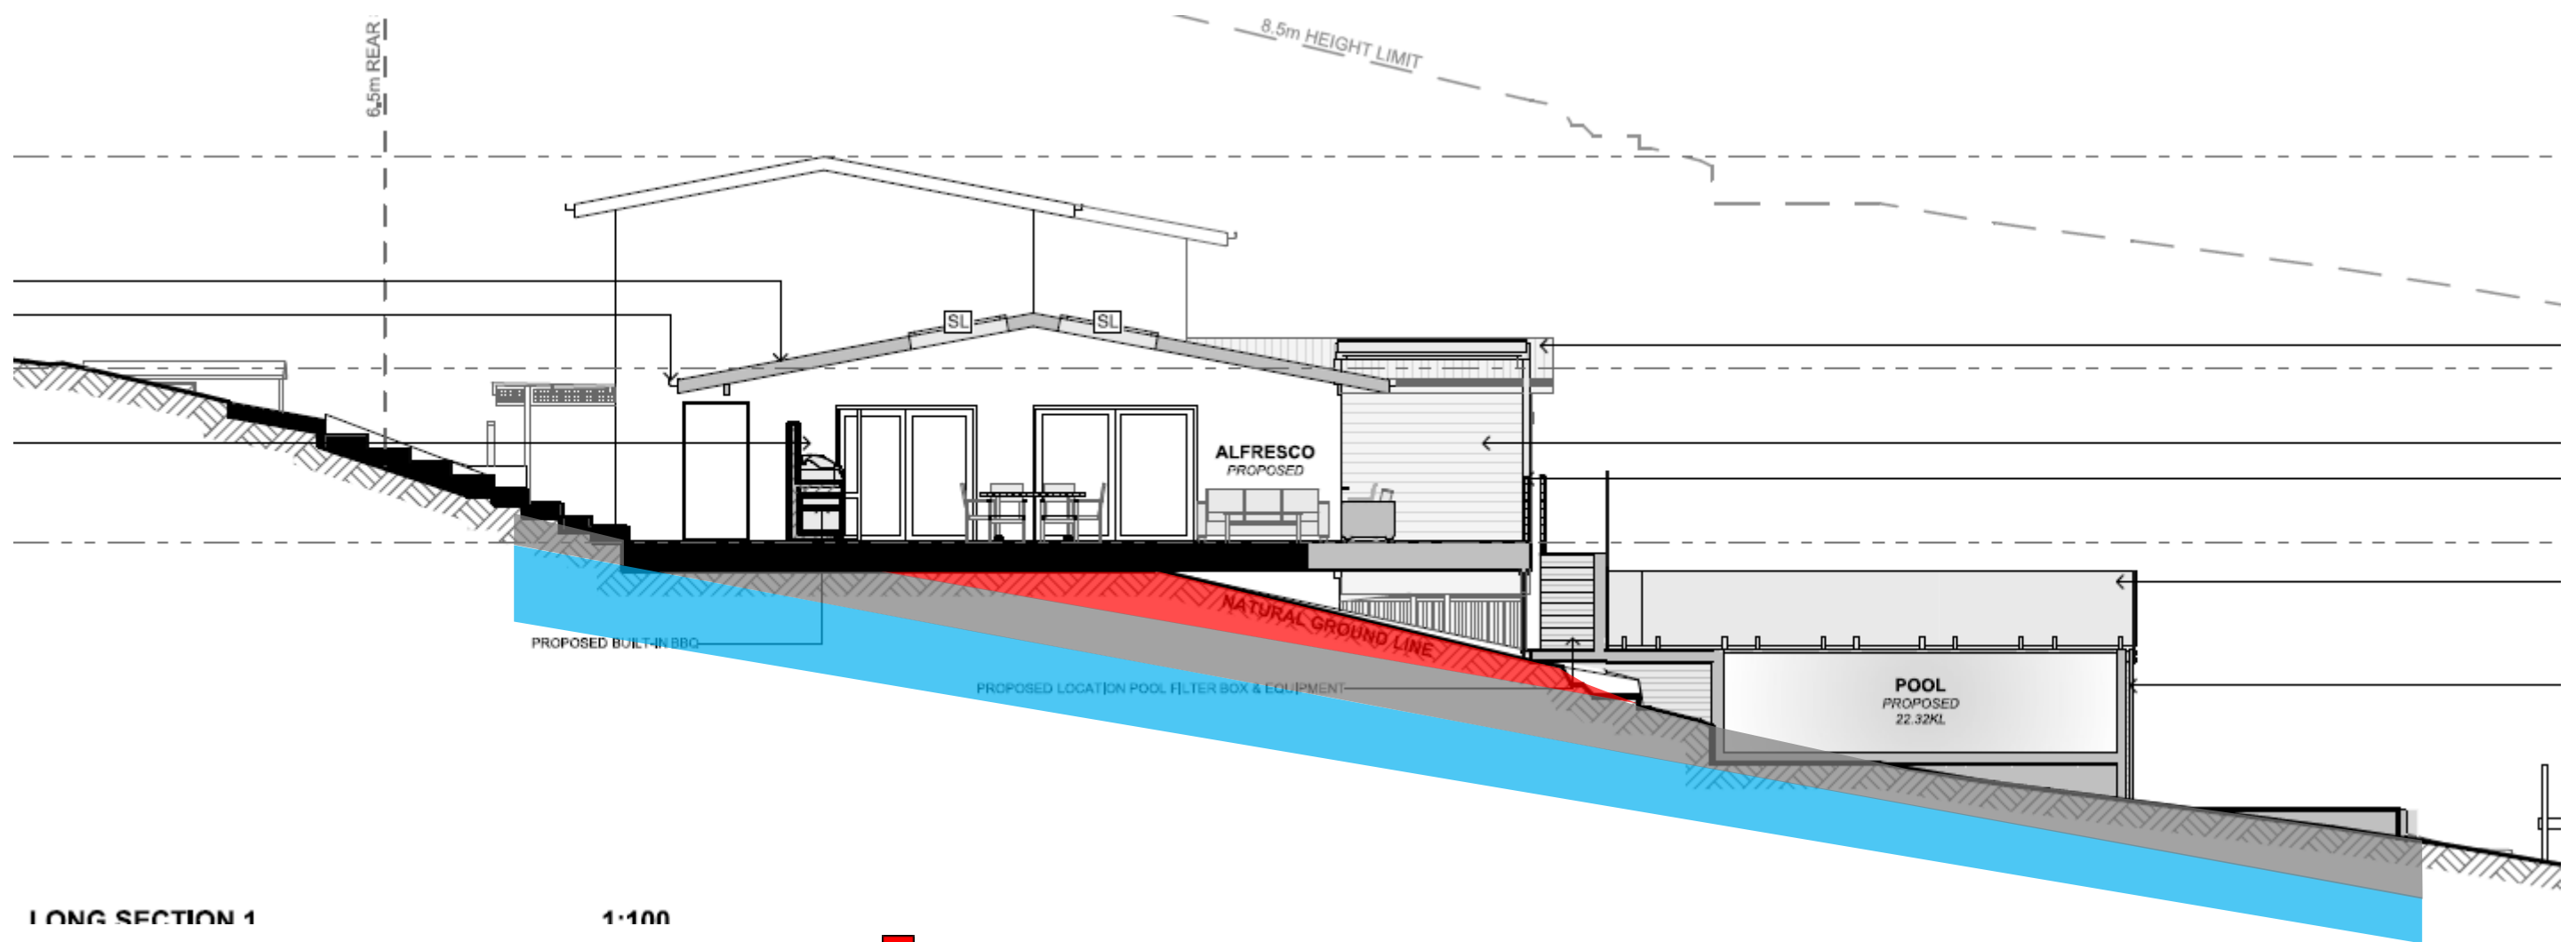
LONG SECTION 1

The site is underlain by fill, sandy soil and sandy clay over weathered rock. In the test locations, the depth to rock ranged from between ~0.2m to ~1.0m below the current surface, being shallower at the downhill side of the existing concrete crib retaining wall supporting the cut for the carport. The weathered rock is interpreted as Very Low Strength Rock or better. See Type Section attached for a diagrammatical representation of the expected ground materials.

- Fill
- Topsoil and Clay
- Narrabeen Group Rocks – Very Low Strength Rock or better - after being cut up by excavation equipment can resemble a stiff to hard clay.
