## ***Arboriculture Impact Assessment with Site-Specific Preliminary Tree Plan of Management***

**August 2024**

**90 Cabbage Tree Road Bayview NSW 2104**

**Prepared by: Kyle A Hill**

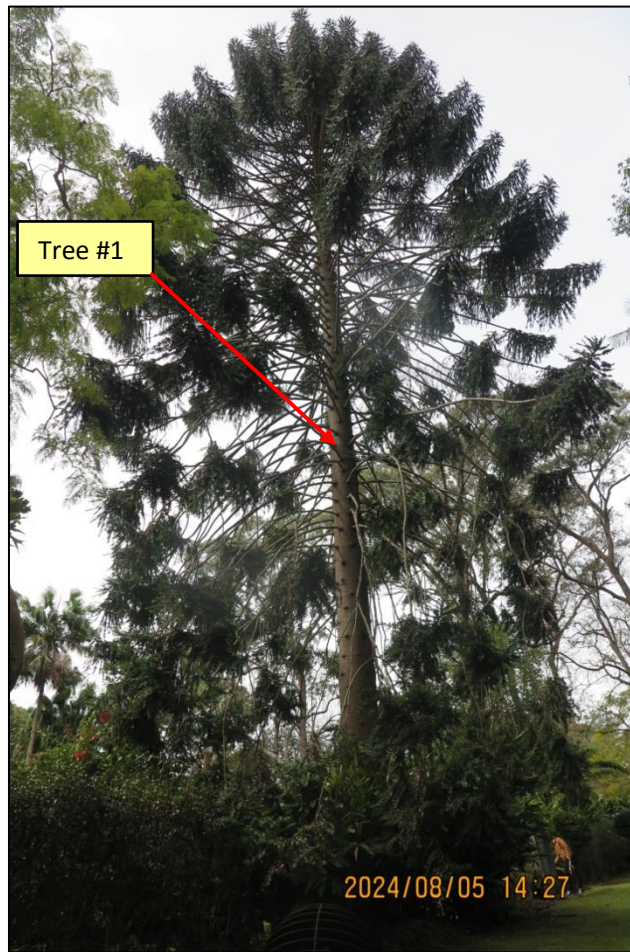
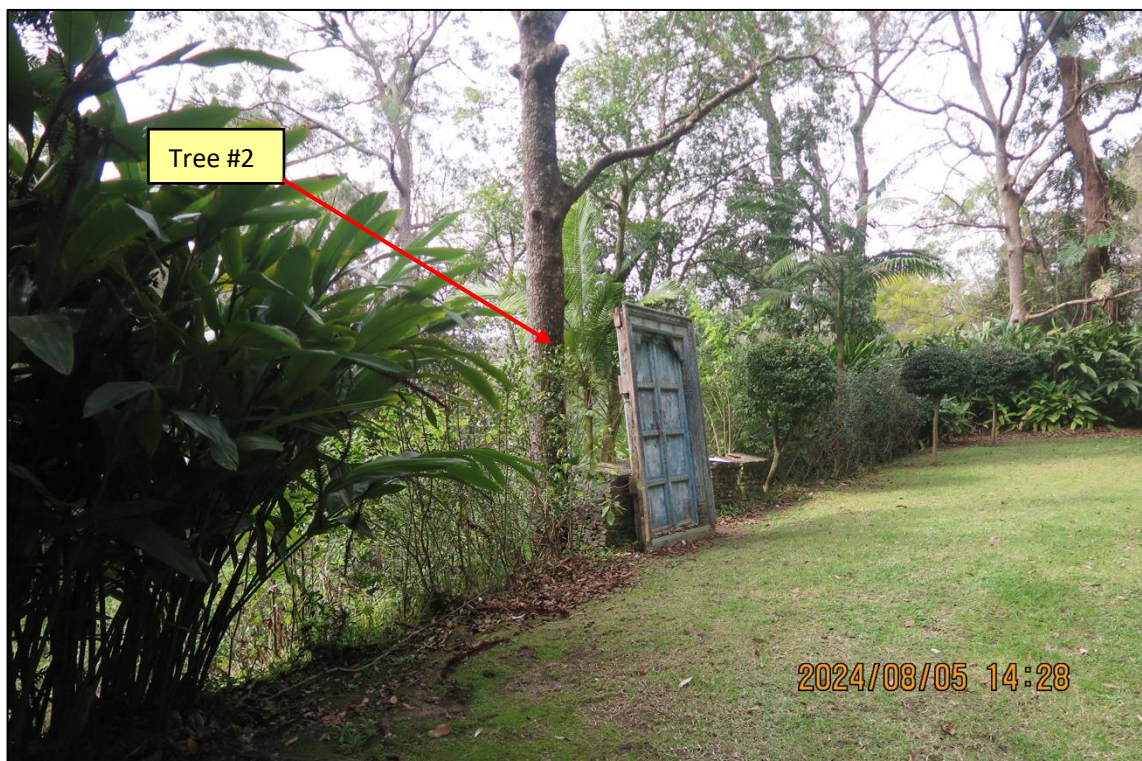
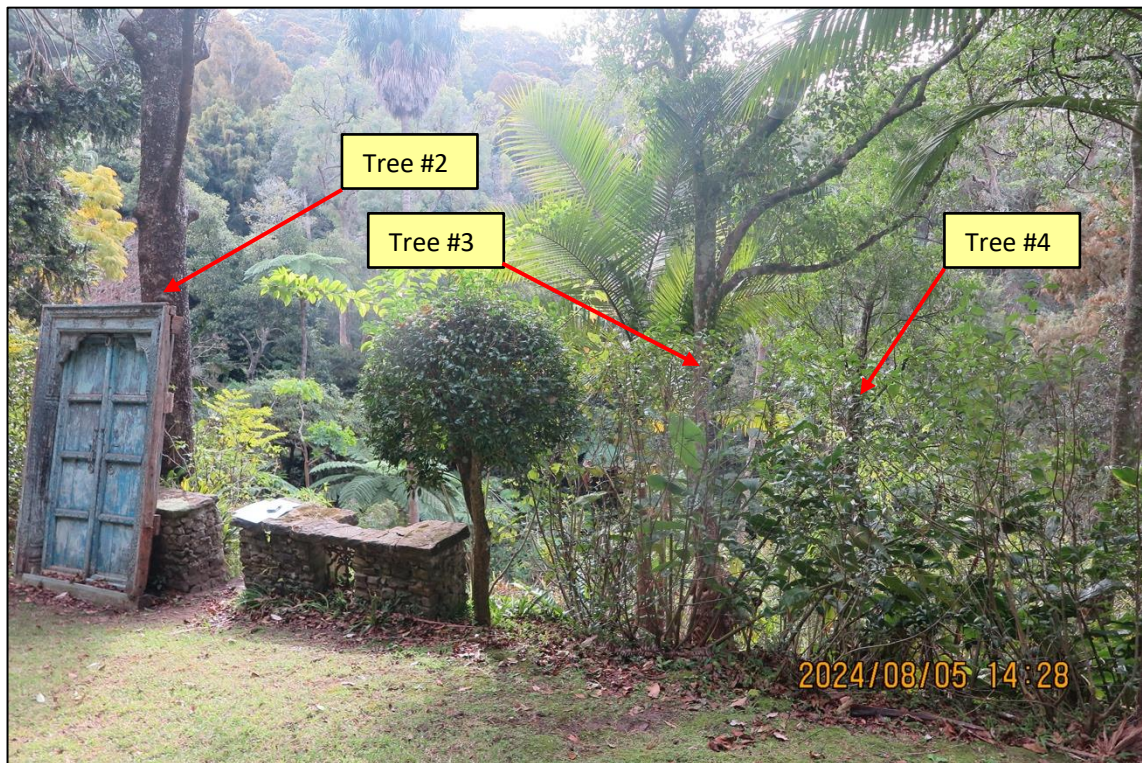
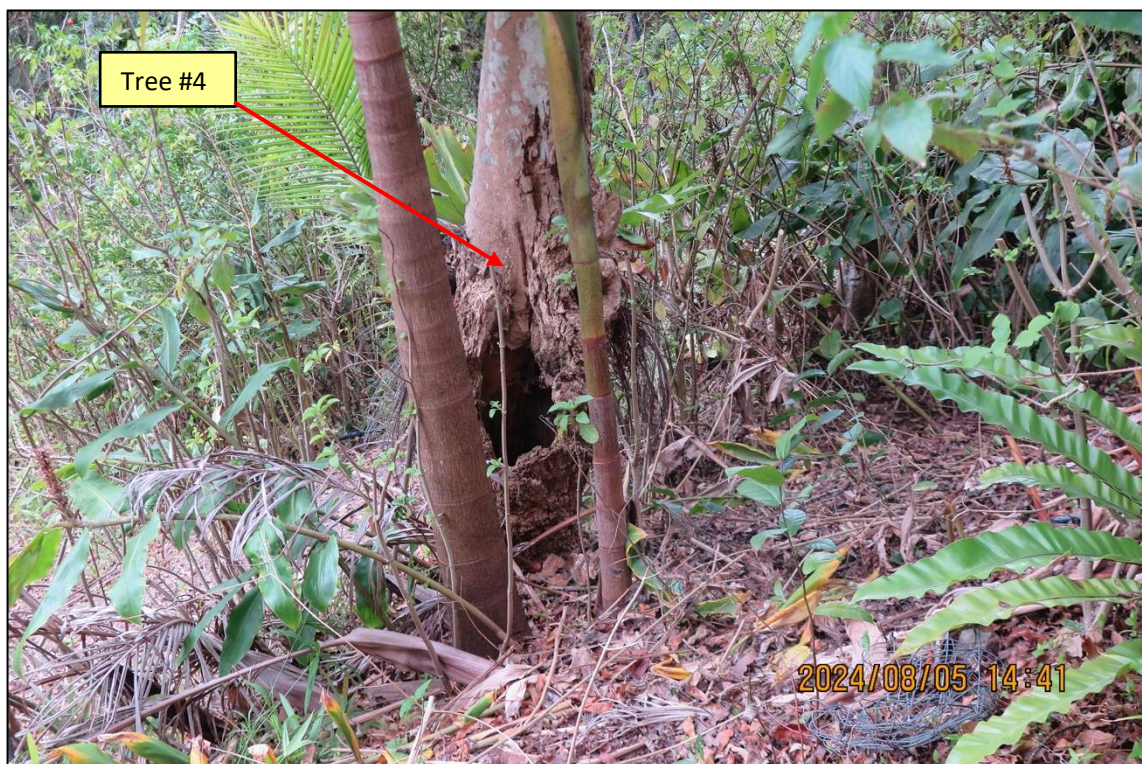
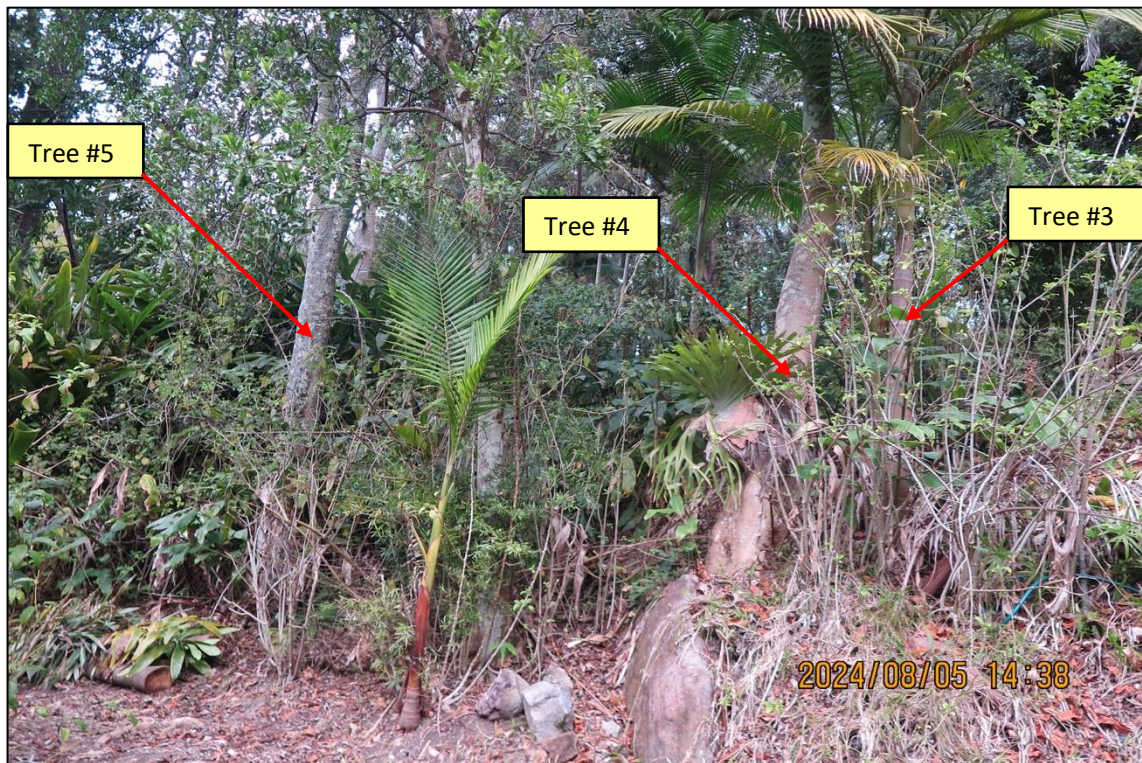
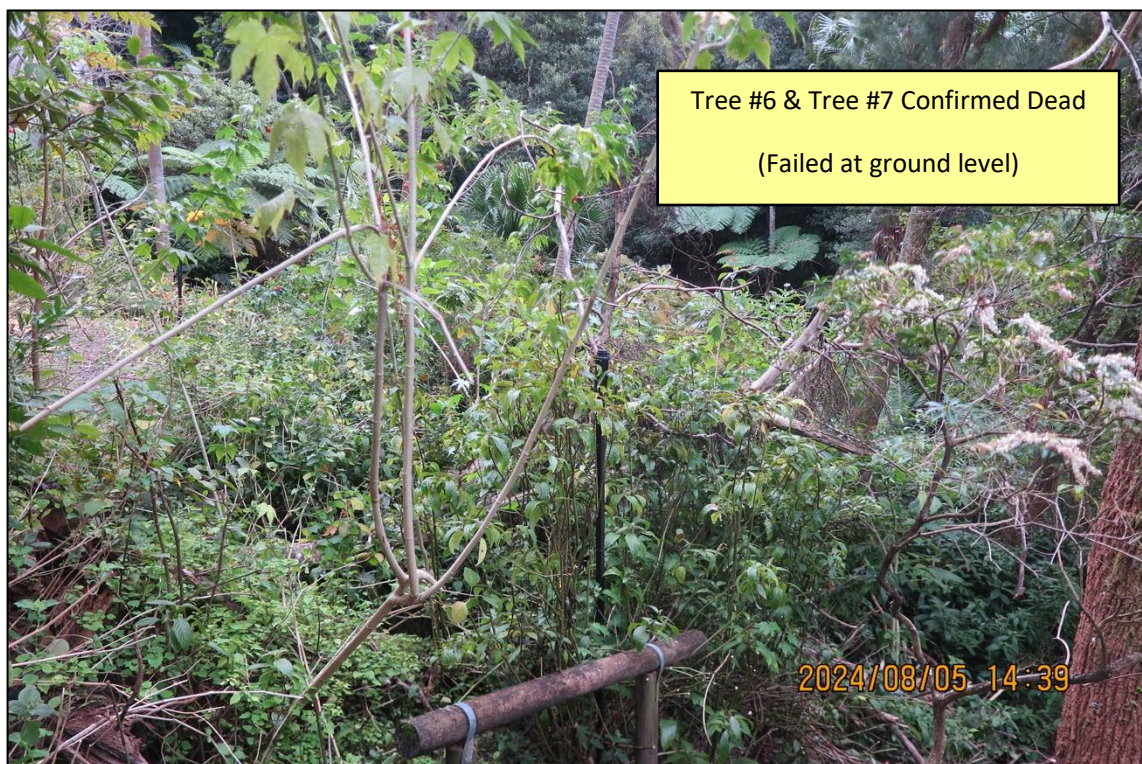
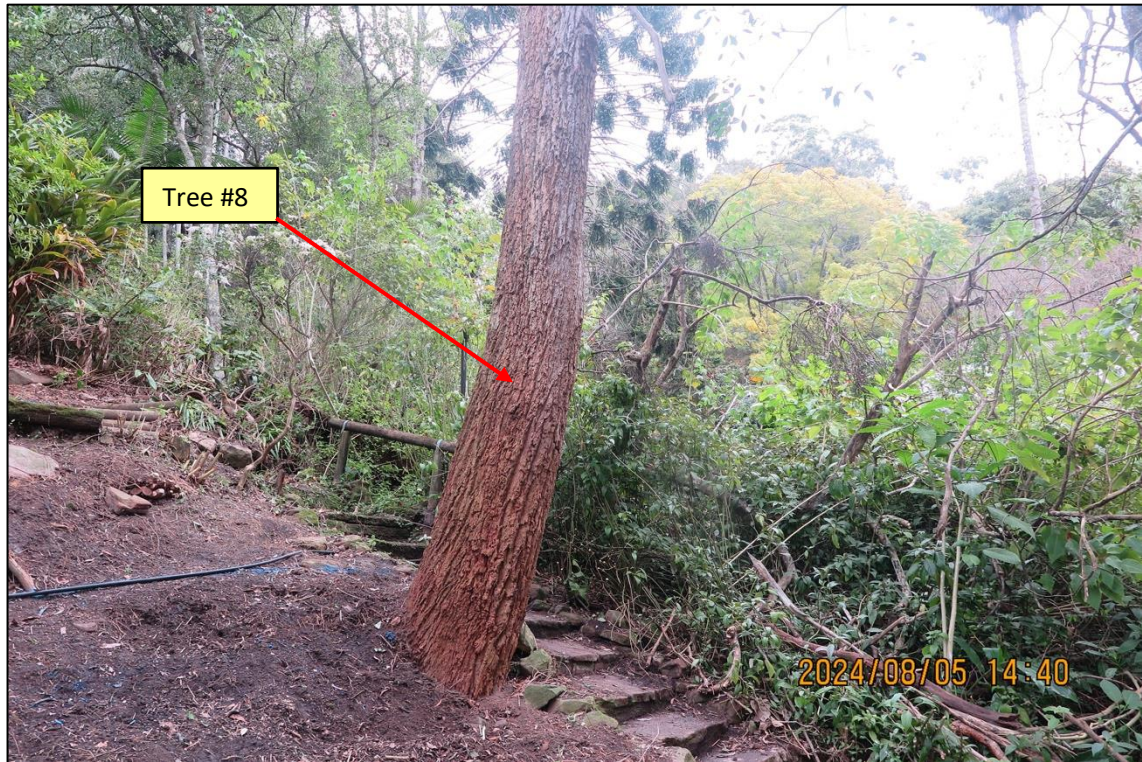
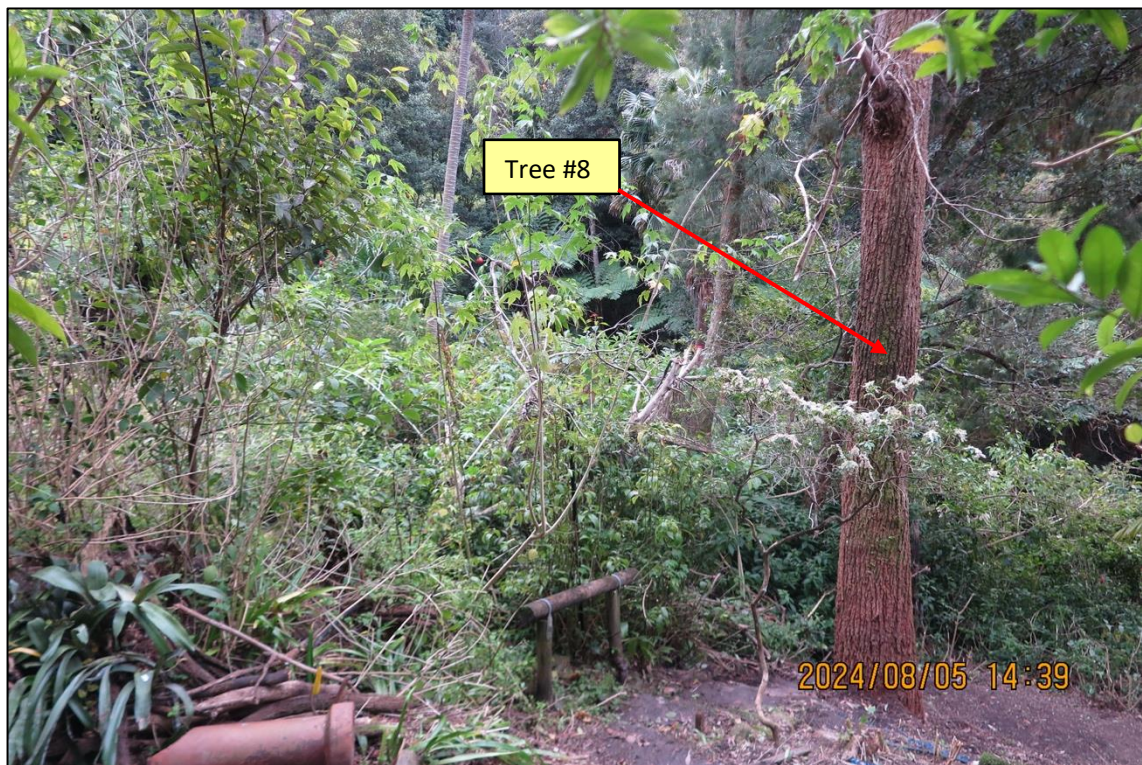
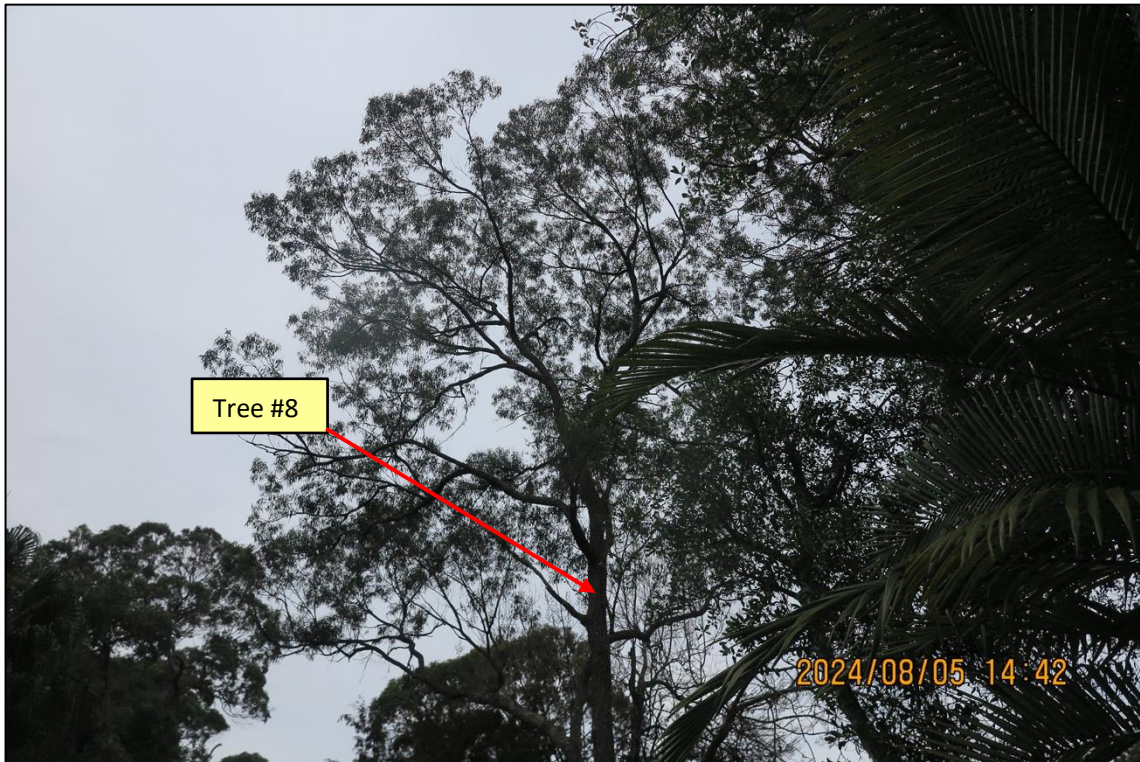
FIGURE 10: ABOVE & PREVIOUS PAGE PHOTOGRAPHS ILLUSTRATES THE EIGHT (8) DISCUSSED TREE LOCATIONS & SITE FEATURES

None of these trees display any adverse impact features with respect to the as raised uphill change of natural environment features. One (1) tree, Tree #4 displays very significant decay near its base. Our opinion is, this tree will fail in the short term (i.e., less than 5 years) regardless of any proposed works near it.

Tree #4, separate to any discussion relative to any proposed works is assessed as having only a short-term Useful Life Expectancy by virtue of it being very significantly impacted upon by decay pathogen activity nearly destroying its trunk base structural integrity.

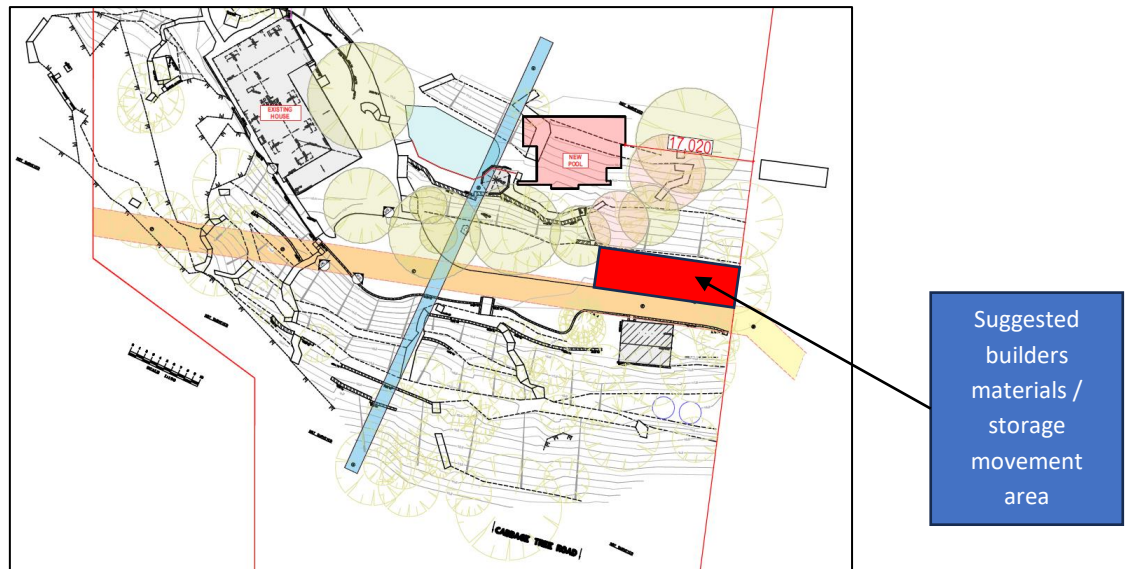
FIGURE 11: SOLID RED INFILLED BOW REPRESENTS OUR SUGGESTED AREA FOR THE STORAGE/MOVEMENT OF BUILDING MATERIALS.

We suggest a more appropriate area for the storage/movement of builder's materials to be adjacent to the subject site entrance levelled area. This area is mathematically well away from any tree proposed to be retained. See below area highlighted by a box with red infill to be our suggested builder's storage area.

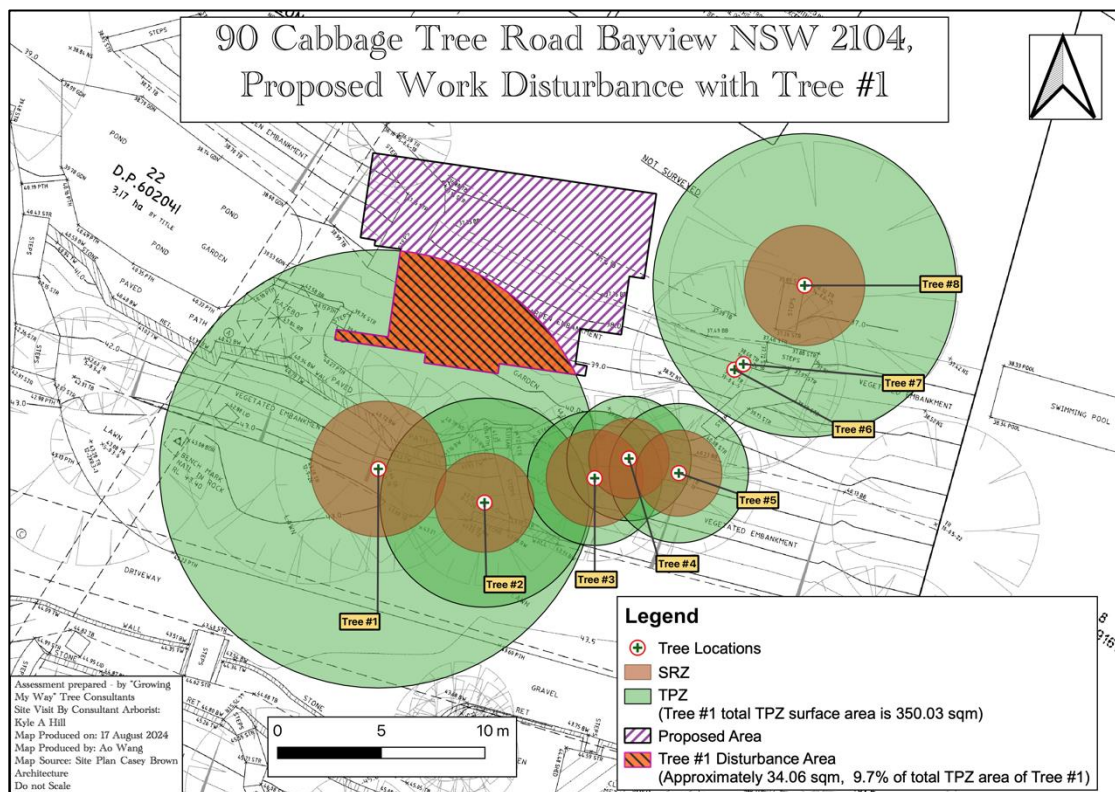
## 5.2 TPZ / SRZ Tree Disturbance Calculation Diagrams

By our calculation, the total TPZ surface area of Tree #1 is 350.03m<sup>2</sup>. The proposed works (swimming pool & surrounds) equates to an approximate 34.06m<sup>2</sup> mathematical disturbance of total TPZ surface area. This mathematically equates to an approximate 9.7% of total TPZ surface area, (defined by AS4970-2009 as a *Minor Encroachment*).
