Project: Long Reef Golf Club Additions and Alterations  
Site Location: Long Reef Golf Club, 2 Anzac Avenue, Collaroy NSW 2097  
Reference: 18543-GR-1-1  
Report Date: 3 April 2025

## Memorandum: Geotechnical Landslip Risk Assessment

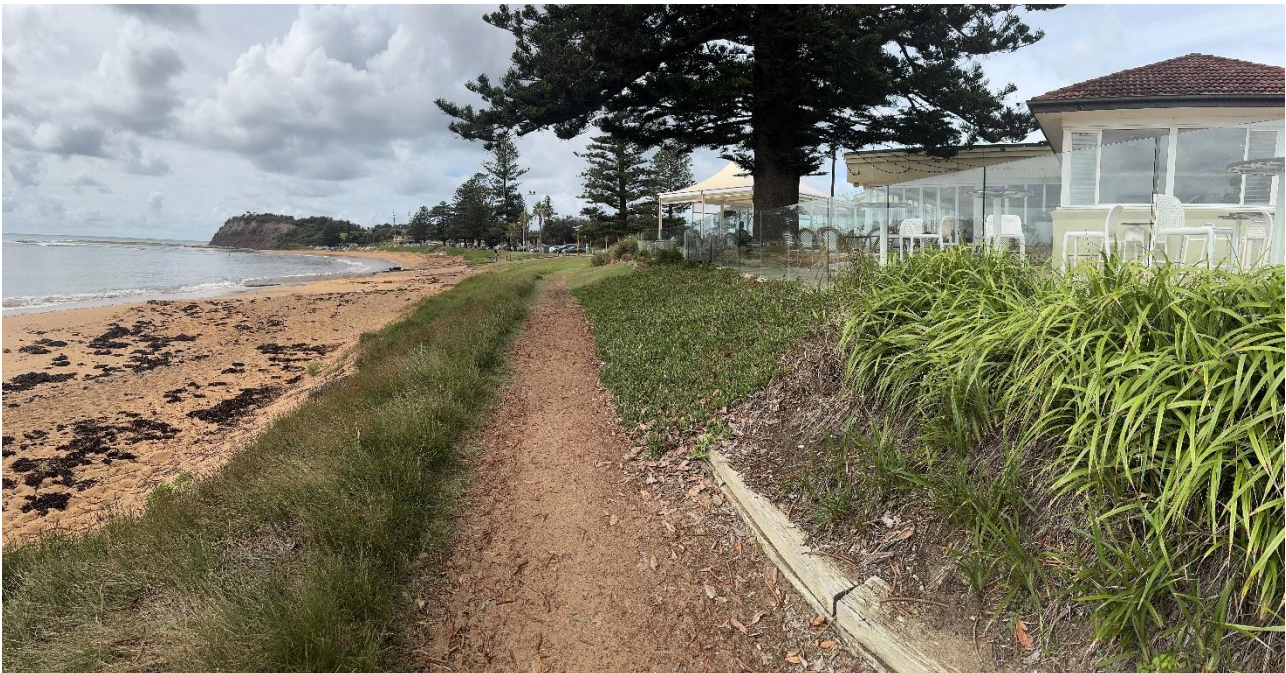
Ground level along the northeastern site boundary drops about 1m towards the Fisherman's Beach with an average grade of approximately 20%-30% as shown in Photo 1 below. Timber sleepers were observed within some sections of the toe of the slope.

Subsurface materials within this area are expected to include fill that has possibly placed during the previous construction phases for levelling purposes. However, this would need to be confirmed during the construction phase.

No signs of slope instability (e.g. tension cracks along the crest or signs of existing retaining structure movement) were observed within this area.

**Photo 1 - Existing Club Building Looking East at the Northeast Boundary, 27 March 2025**

At this stage, Alliance has not been provided with footing details for the existing buildings or proposed extensions. However, any new footings if required to be located within the slope's zone of influence should extend beyond the slope toe as well as erosion profile to ensure long-term stability. Drainage and water runoff should also be carefully managed to prevent localised erosion around the footings.

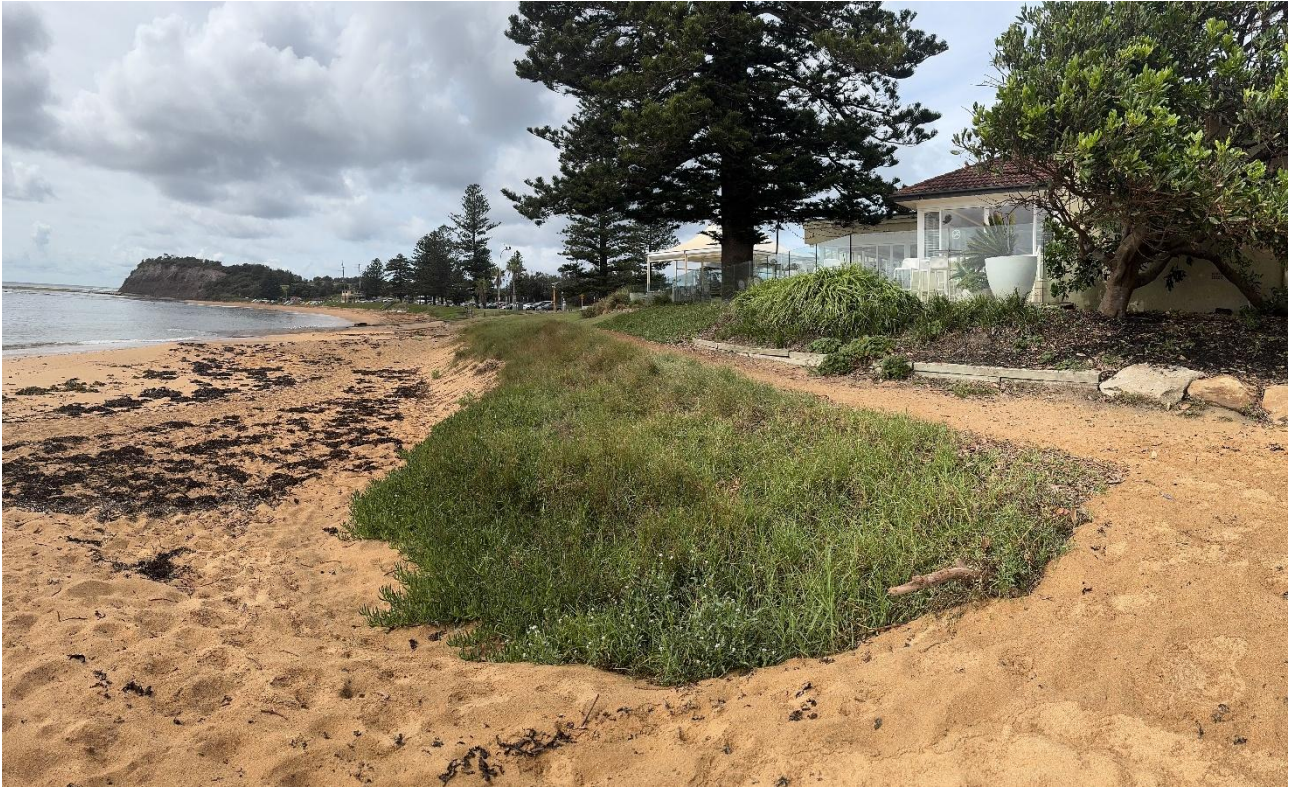
During Alliance's site visit on 27 March 2025, the site was observed to be generally flat, with no slope risk hazards detected. Approximately 350m east of the site, a headland with exposed rock outcrops was noted. However, given the significant distance from the proposed development, it is not expected to have any impact. Selected site photos from the visit are included in the report Attachment A.

**Photo 4 - The Site Looking East with Rock Outcrops at Headland Visible, 27 March 2025**

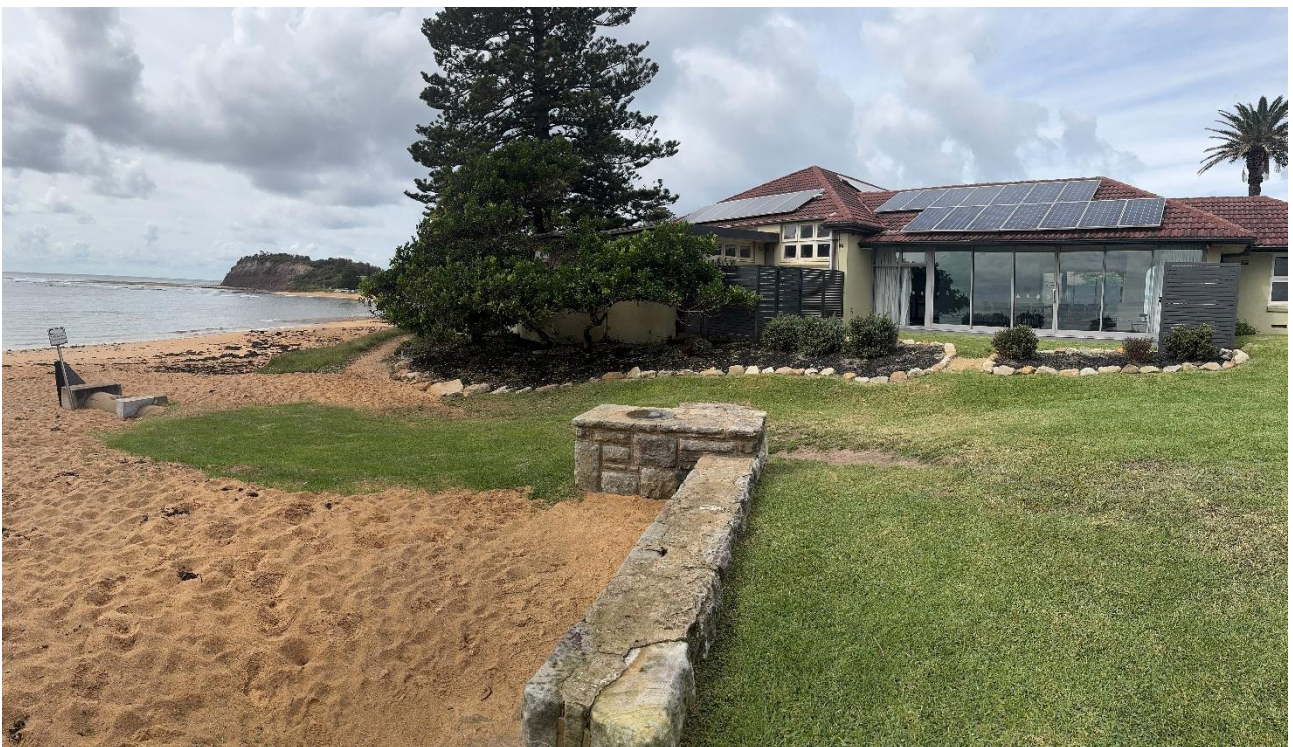
**Photo 5 - The Site Looking East with the Stormwater Pipe at the Western Side of the Existing Building, 27 March 2025**

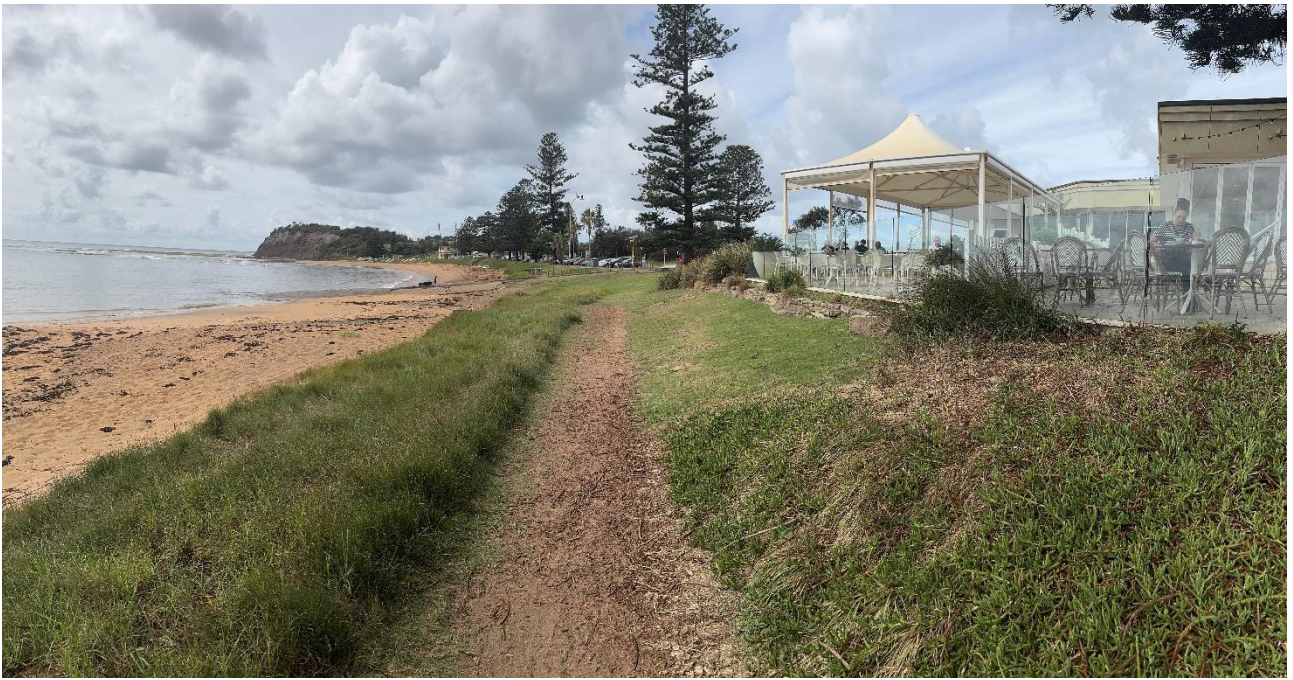
**Photo 6 - The Site Looking East with The Shoreline Approximately 1m Lower than the Club's Ground Floor, 27 March 2025**

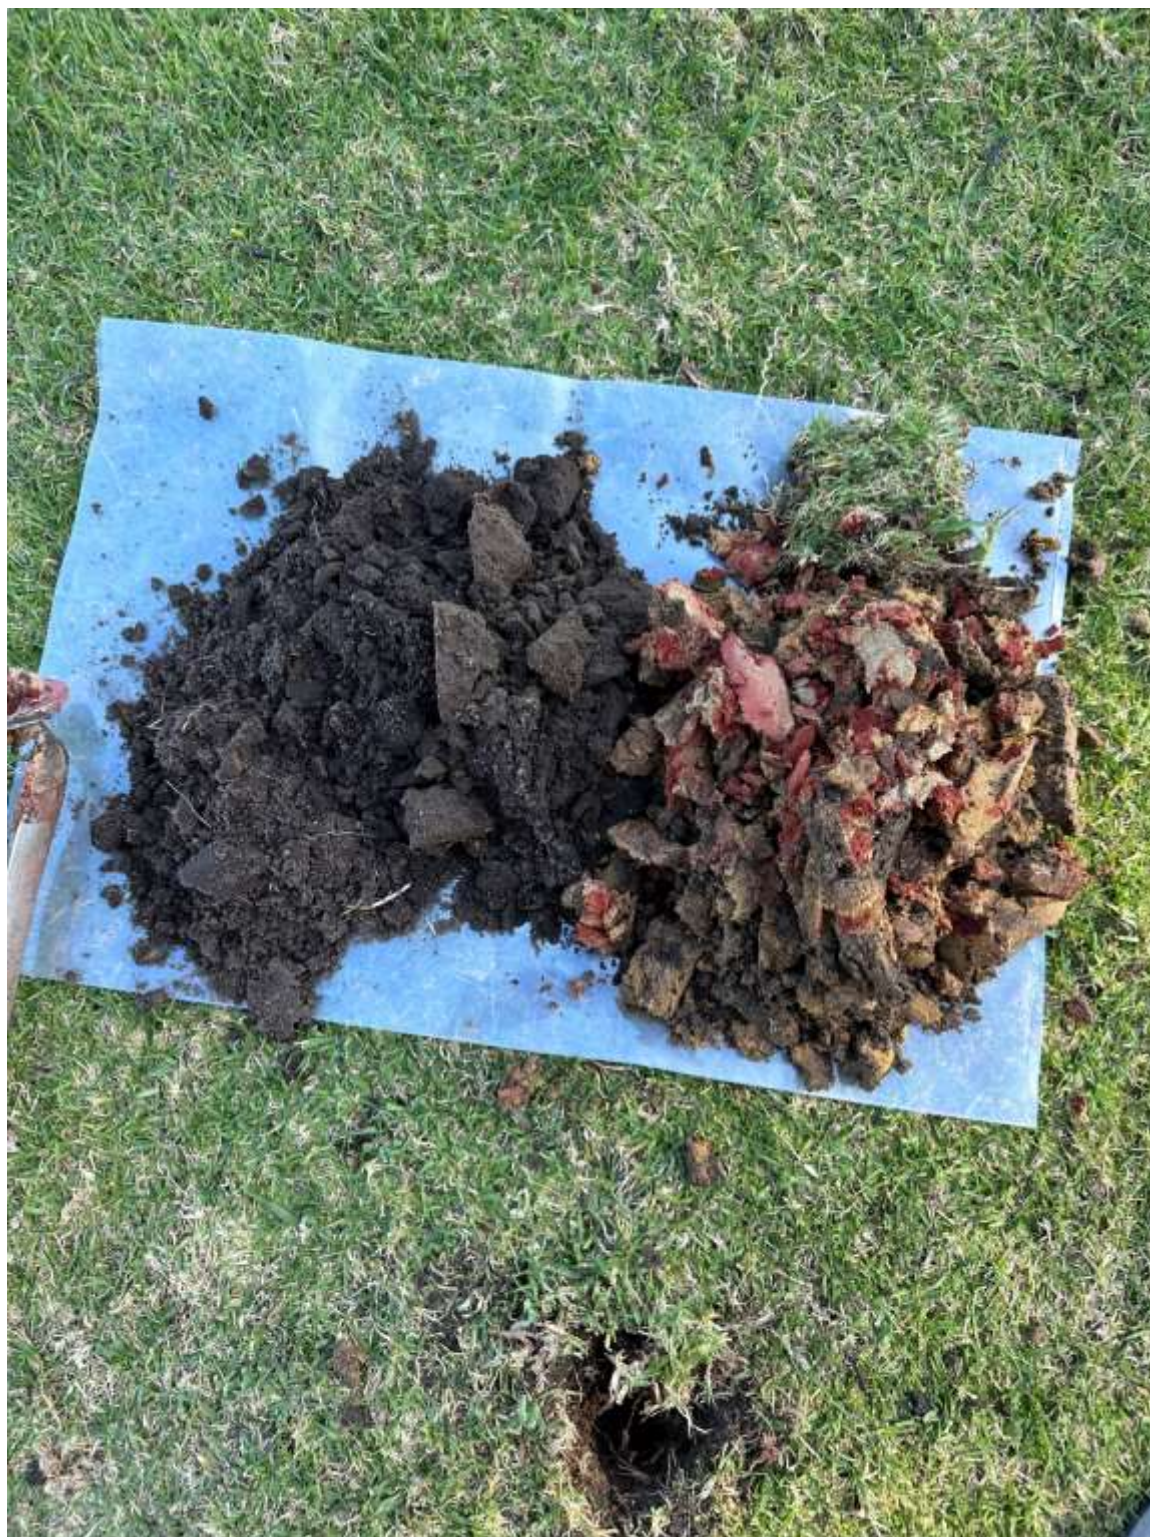
**Image 1 – Material from BH02**

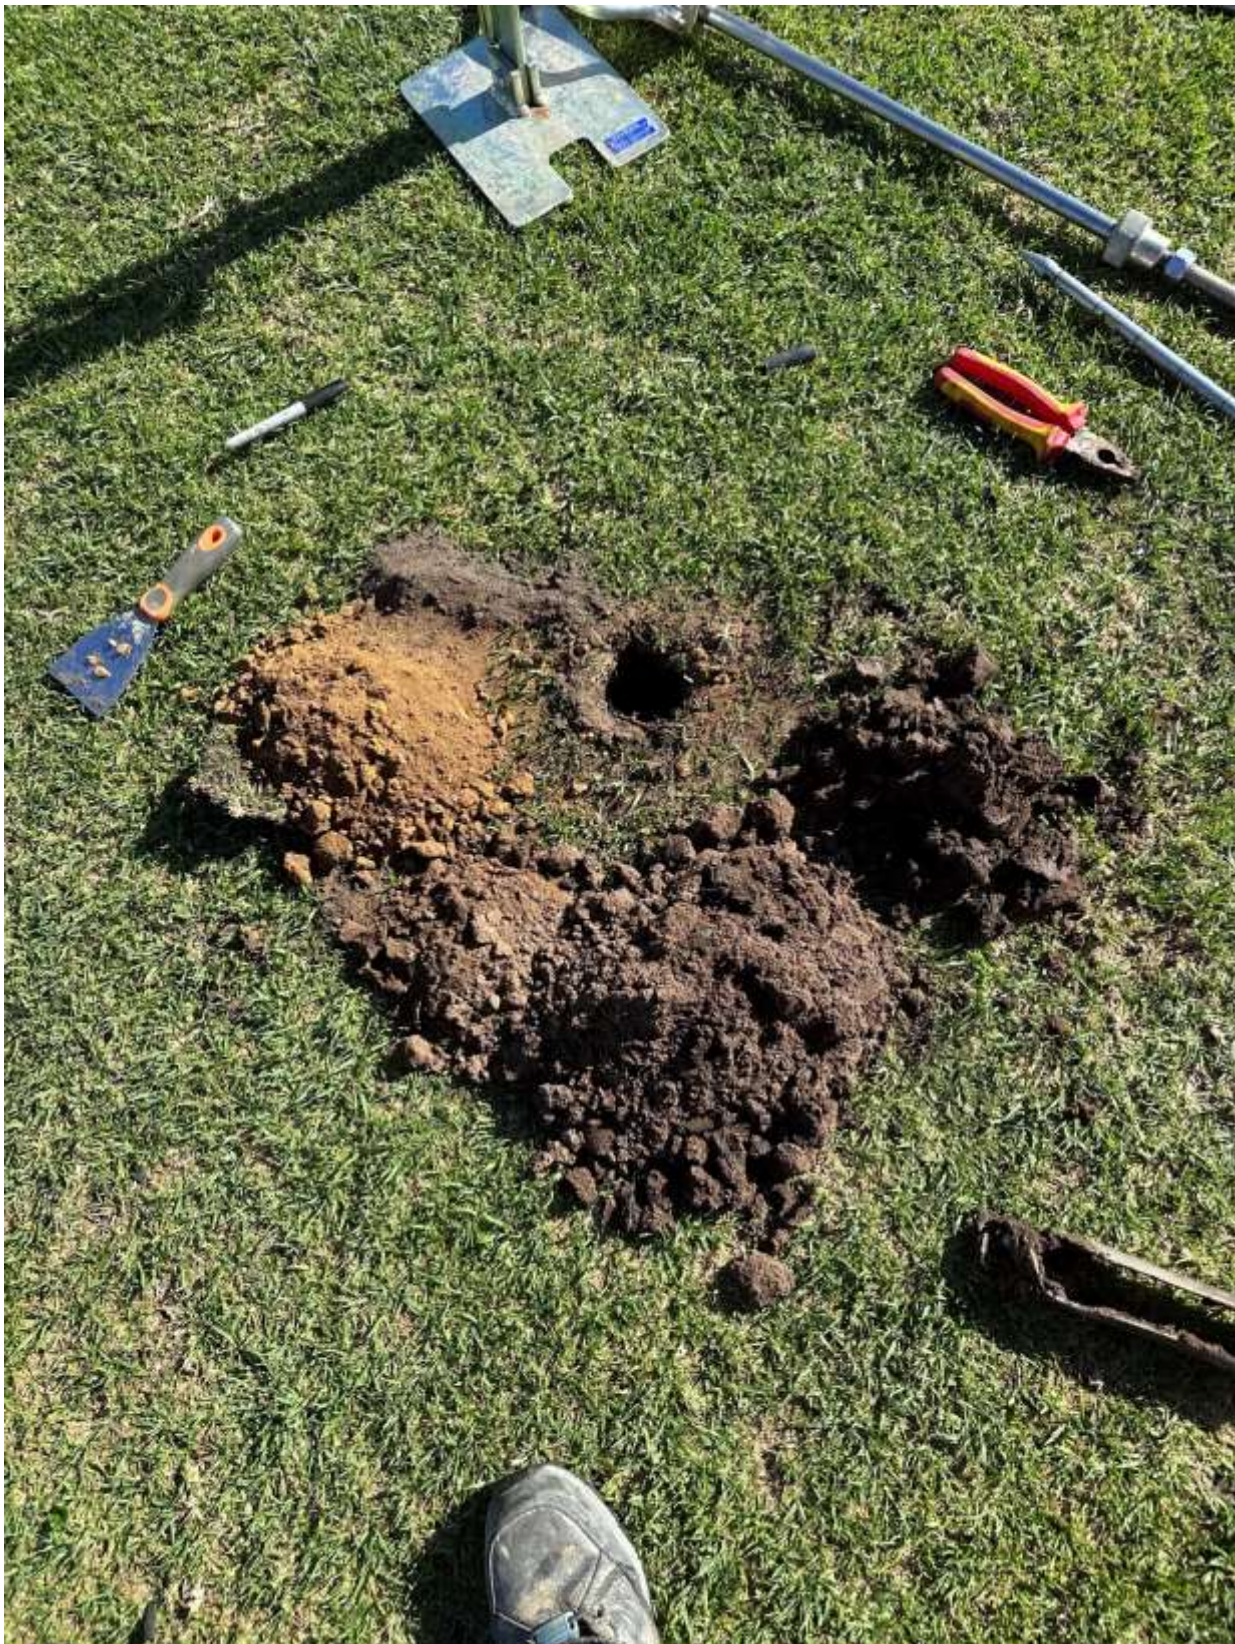
**Image 3 – Material from BH01**
