Report Title: Geotechnical Report 114 Grandview Drive, Newport
Report Date: 23/2/21
Author: BEN WHITE
Author's Company/Organisation: WHITE GEOTECHNICAL GROUP PTY LTD

GEOTECHNICAL INVESTIGATION:

Alterations and Additions at 114 Grandview Drive, Newport

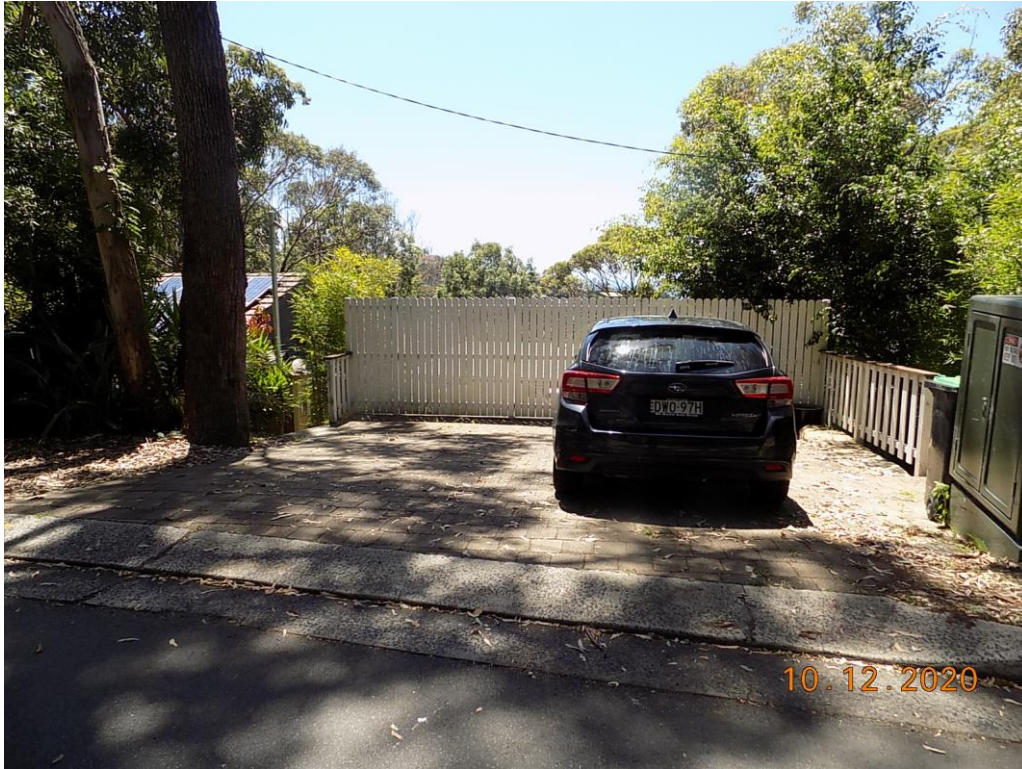
Photo 1

- 2.3** A brick-paved parking area extends directly off the road frontage (Photo 1). The fill for the parking area is supported by two stepped retaining walls (Photo 2). The upper wall is a stable treated timber retaining wall ~0.6m high and the lower wall is a stable ~1.2m high sandstone block retaining wall. An excavation has been made in the slope between the lower wall and the house for a level tile-paved area (Photo 3). This cut is supported by a stable rendered brick retaining wall reaching ~0.6m high. The single-storey timber framed and clad house is supported on vertical steel posts (Photo 4). Some of these posts were built directly off the outcropping Medium Strength Sandstone. A ~3m high sandstone rock face falls under the house (Photo 5).

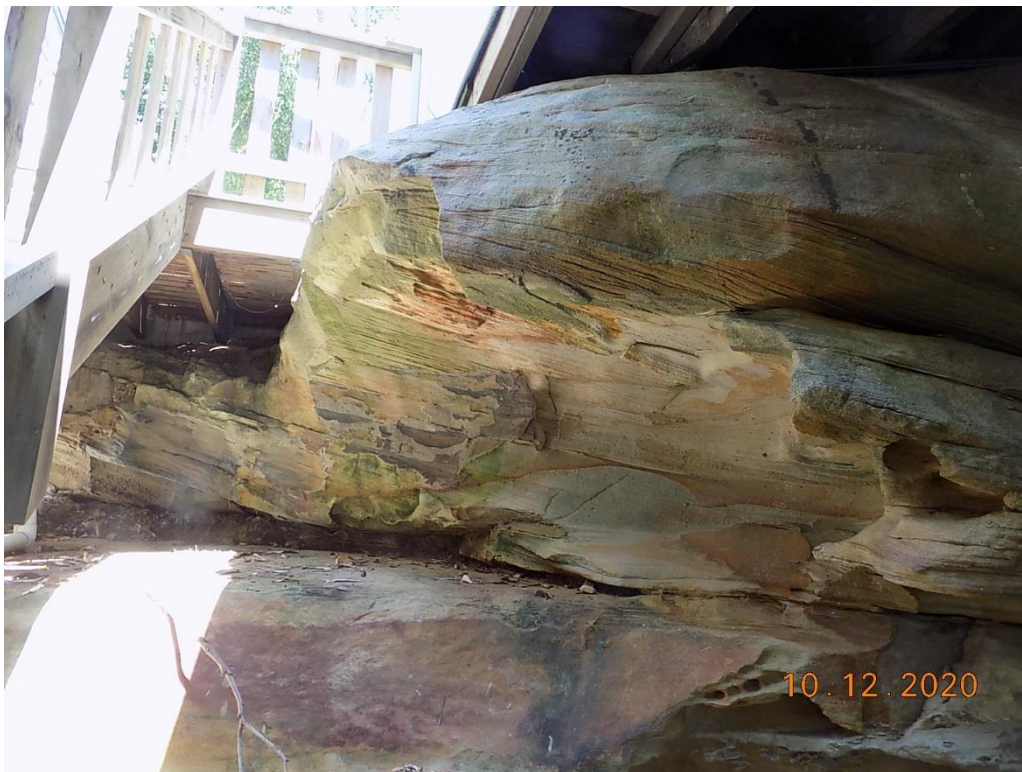
Photo 6

The S end of this rock face is undercut ~1.0m (Photo 6). The undercut joint block has a relatively thick cantilever arm relative to its overhang length, is bridged at both sides, and displays no cracking as observed from above or below. Thus, it is considered stable. No other significant geological defects were observed in the rock face. An excavation has been made in the slope under the house to create a level area. The cut has been taken entirely through sandstone and appears stable. Another excavation under the house footprint has been made below this. The S end of this cut is supported by a stable sandstone block retaining wall reaching ~1.5m high (Photo 7). The N end is unsupported by has also been taken entirely through sandstone and appears stable (Photo 8). The slope below has been terraced with three stable treated timber retaining walls (Photos 9 to 11). The upper two walls appear to have been anchored back into the slope. The slope that extends below to the lower boundary and beyond is undeveloped bushland (Photo 12).

No geotechnical hazards were observed beside the property. The moderate to steeply graded land surface that falls across the property and continues above and below is a potential hazard (**Hazard One**). The undercut rock face below the house is a potential hazard (**Hazard Two**).

HAZARDS	Hazard One	Hazard Two
TYPE	The moderate to steep slope that falls across the property and continues above and below failing and impacting on the property.	The undercut rock face failing and impacting on the house and proposed works (Photo 6).
LIKELIHOOD	'Unlikely' (10^{-4})	'Rare' (10^{-5})
CONSEQUENCES TO PROPERTY	'Medium' (20%)	'Major' (60%)
RISK TO PROPERTY	'Low' (2×10^{-5})	'Low' (6×10^{-5})
RISK TO LIFE	8.3×10^{-7} /annum	8.3×10^{-7} /annum
COMMENTS	'ACCEPTABLE' level of risk to life & property.	'ACCEPTABLE' level of risk to life & property.

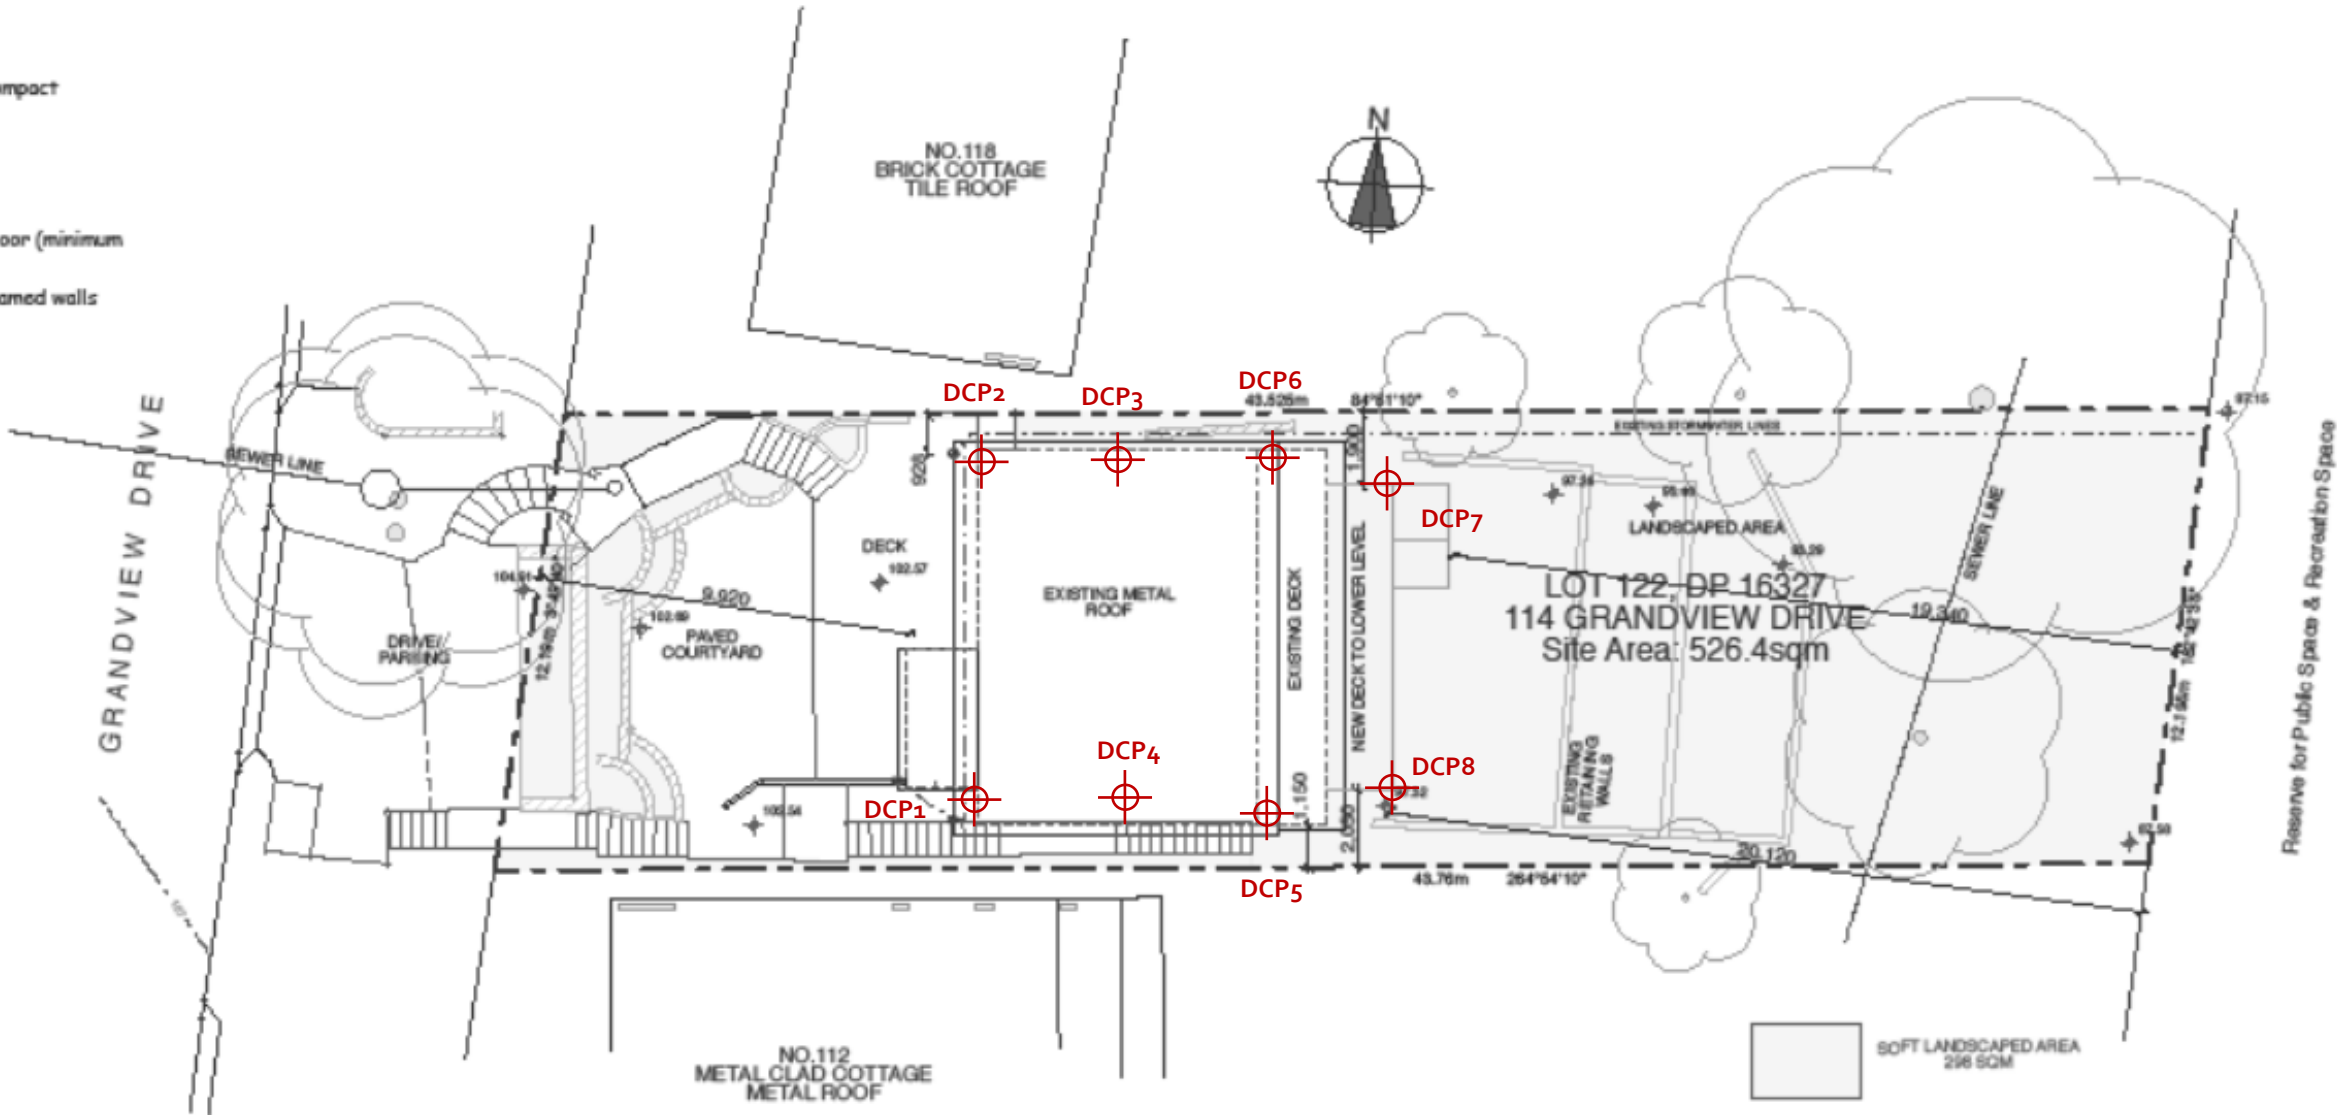
SITE PLAN – showing test locations

Eight Dynamic Cone Penetrometer (DCP) tests were put down to determine the relative density of the overlying soil and the depth to bedrock. The locations of the tests are shown on the site plan attached. It should be noted that a level of caution should be applied when interpreting DCP test results. The test will not pass through hard buried objects so in some instances it can be difficult to determine whether refusal has occurred on an obstruction in the profile or on the natural rock surface. This is not expected to be an issue for the testing on this site. However, excavation and foundation budgets should always allow for the possibility that the interpreted ground conditions in this report vary from those encountered

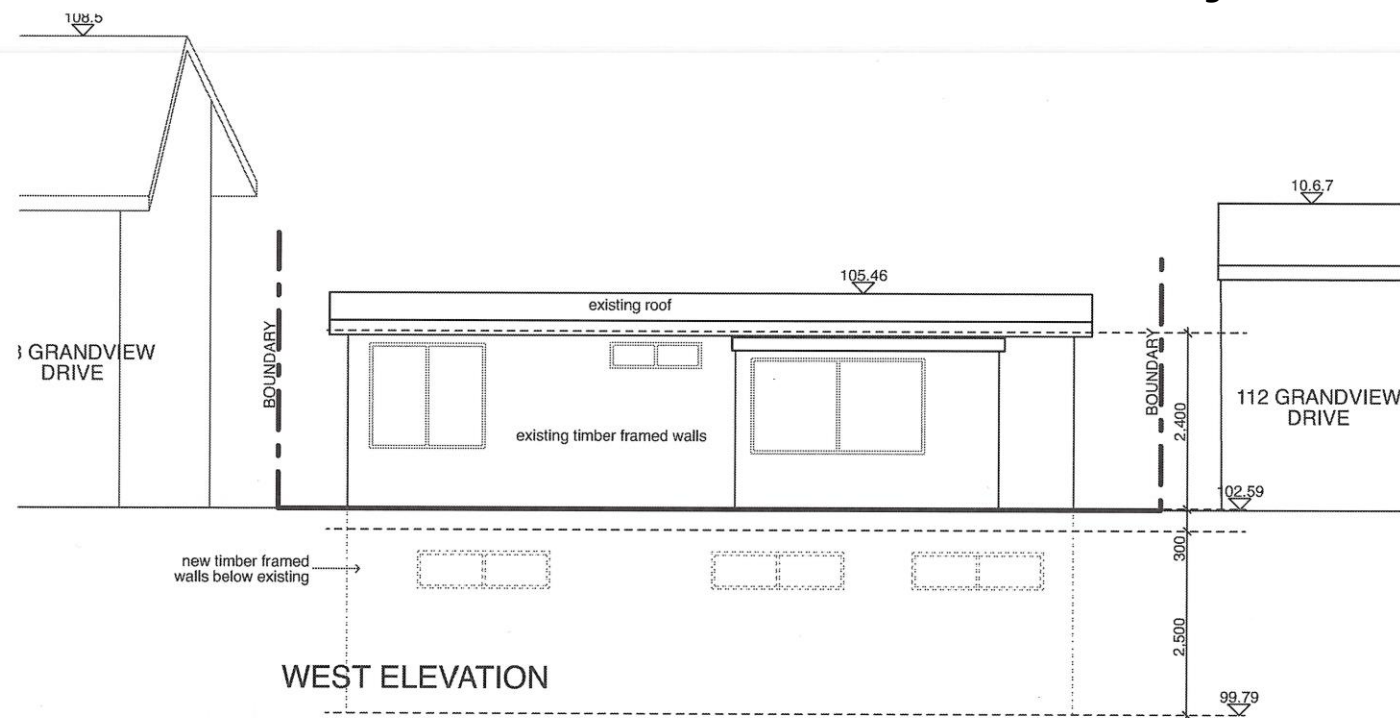
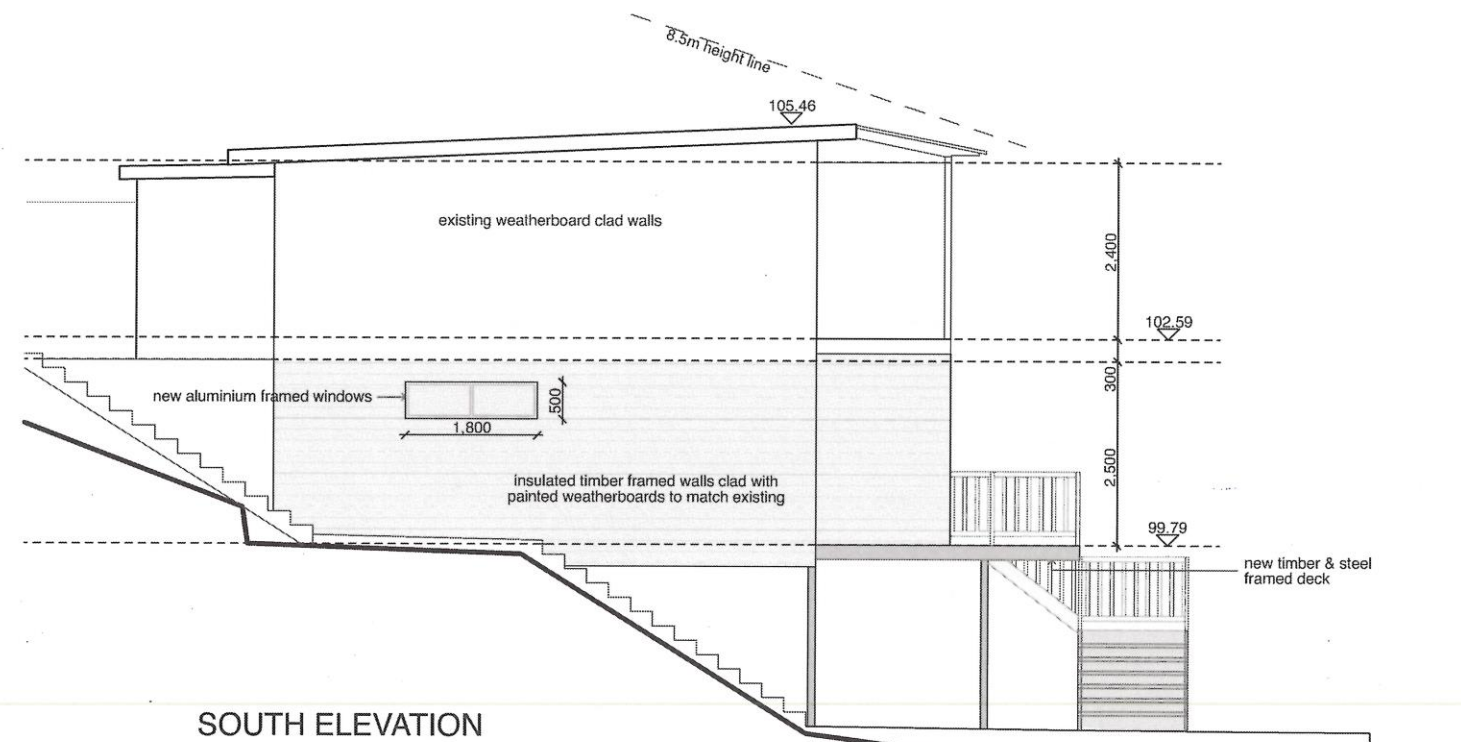
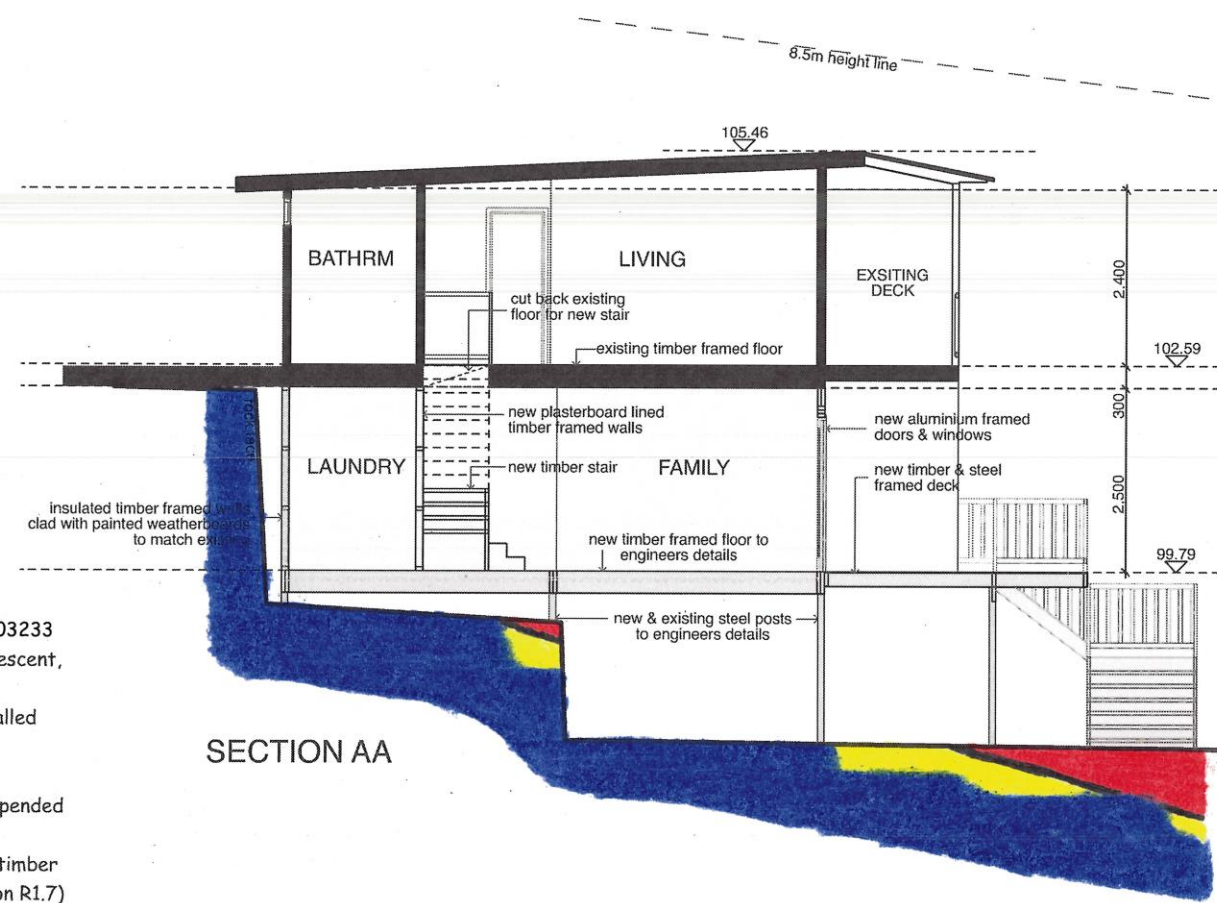
TYPE SECTION – Diagrammatical Interpretation of expected Ground Materials

The surface features of the block are controlled by the outcropping and underlying sandstone bedrock that steps down the property forming sub-horizontal benches between the steps. Where the grade is steeper, the steps are larger and the benches narrower. Where the slope eases, the opposite is true. Where the rock is not exposed, it is overlain by sandy soils over sandy clays that fill the bench step formation. Filling has been placed below the house for landscaping. In the test locations, where it was not exposed, the depth to rock ranged between 0.3 to 1.2m below the current surface, being slightly deeper due to the presence of fill and due to the stepped nature of the underlying bedrock. The outcropping sandstone on the property is estimated to be Medium Strength or better and similar strength rock is expected to underlie the entire site. See Type Section attached for a diagrammatical representation of the expected ground materials.

- Fill
- Topsoil
- Sandy Clay – Firm to Stiff
- Hawkesbury Sandstone – Medium Strength
