rainTree consulting

6 September 2021

1 BEATTY STREET – BALGOWLAH, NSW
PROPOSED SWIMMING POOL
ARBORICULTURAL IMPACT ASSESSMENT REPORT
Ref No. 14021

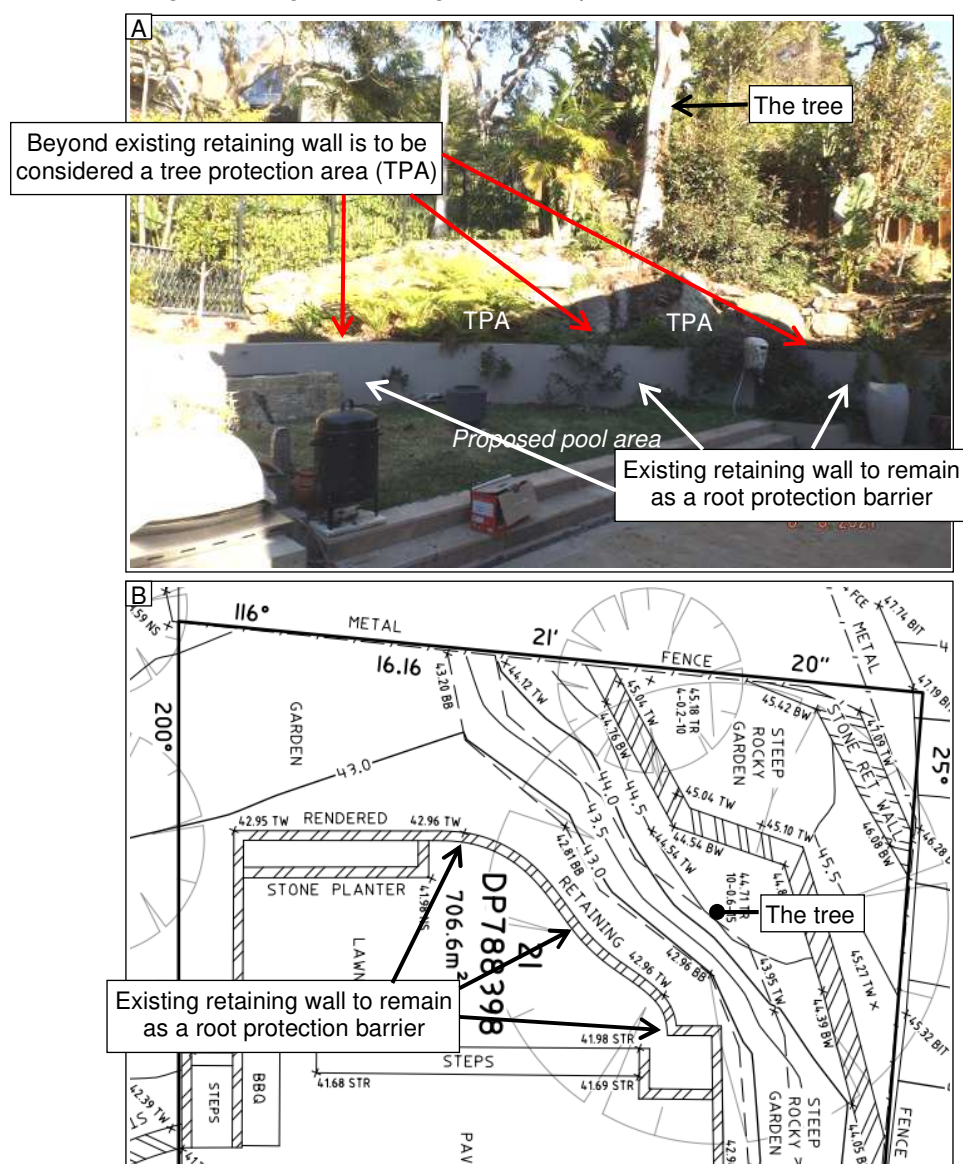
Figure 1, Showing retaining wall acting as a root protection barrier

- A small inground swimming pool and associated infrastructure is proposed within notional Structural Root Zone (SRZ) & Tree Protection Zone (TPZ) radiuses. In mitigating impacts to the tree, the design proposes to retain an existing retaining wall forming a root protection barrier within the SRZ.

- No new works (excavation) is proposed within the trees 2.7m SRZ. Within the SRZ between the retaining wall and tree a significantly large structural root >200mm(Ø) descends towards the rear of the existing retaining wall. This structural root is critically important in maintaining anchorage. To avoid consequences resulting from root damage by development activities the large root and secondary roots within the SRZ must not be damaged or disrupted.

- From the existing retaining wall there is to be no excavation or soil disturbance within the trees 2.7m SRZ. The SRZ behind the existing retaining wall is to be considered a development activity exclusion area. Should excavation for pool services or boundary fence be required within the critical protection zone as shown within Appendix- C Item 2, arboricultural tree root investigations are to be conducted to identify the location, distribution and impact to underlying tree roots. The management of the tree shall be based on the results of the investigation and further advice from an appointed site arborist.

2) No excavation shall occur within the 6.6m TPZ or beyond the existing retaining wall as shown within Figure 1 and Item 2 of Appendix- C without prior project arborist notification, advice and/or site supervision.

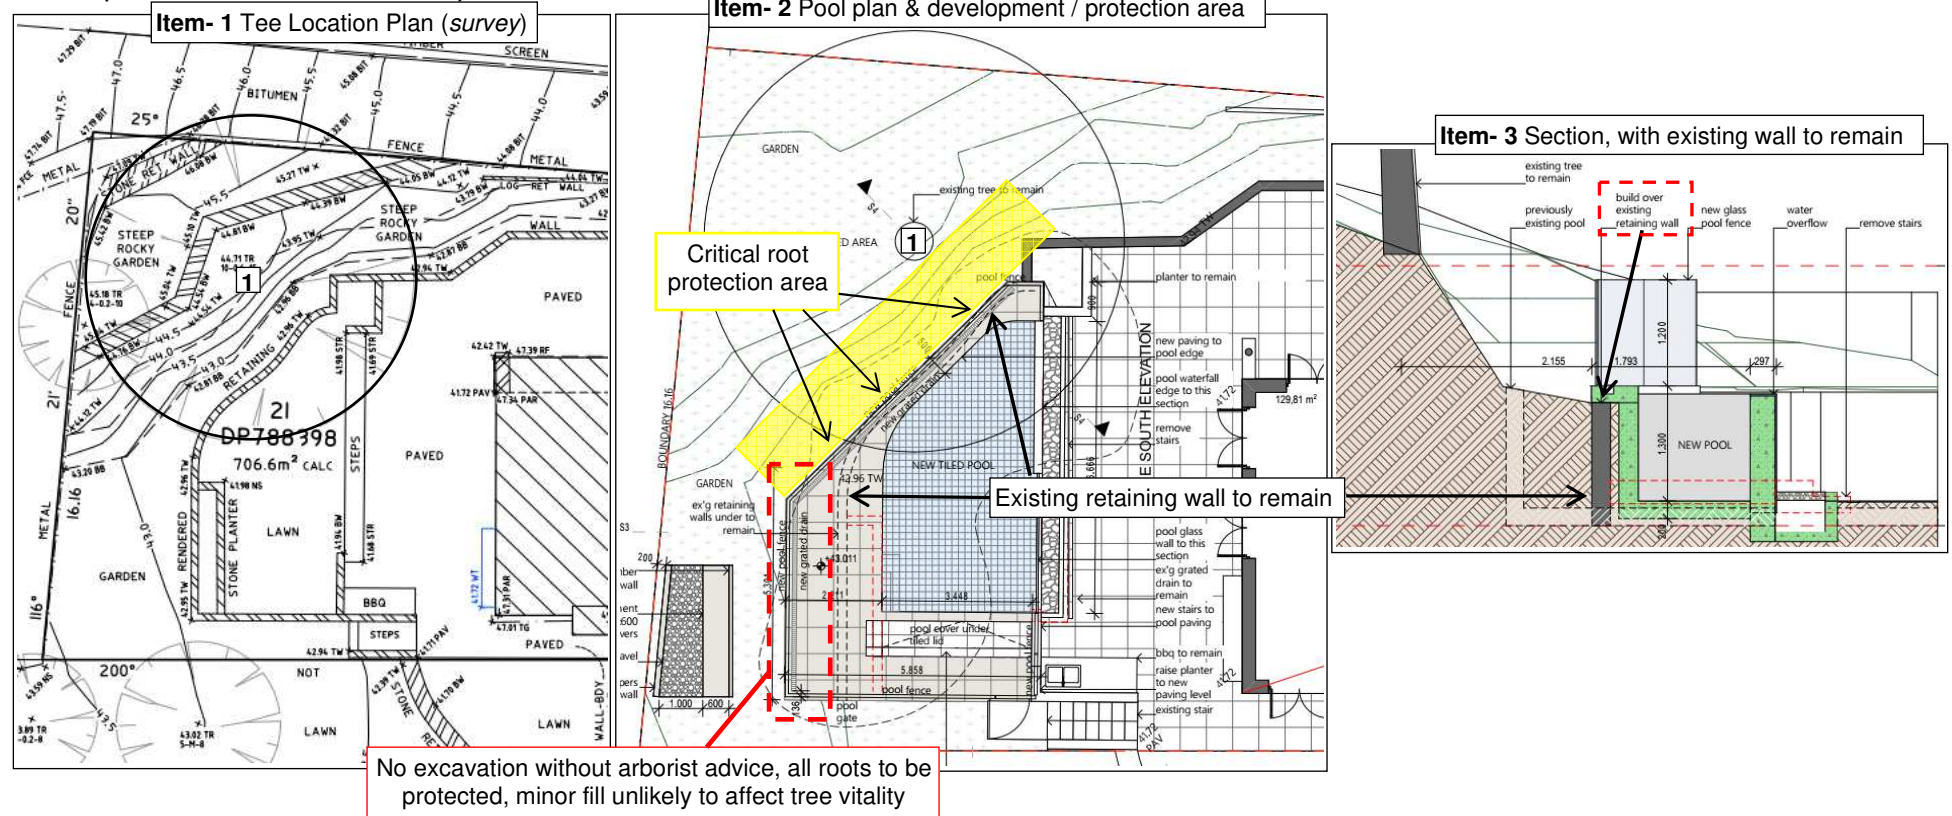
Development area & tree location plan

- Within the 6.6m TPZ the design footprint proposes a negligible to very Minor (<10%) TPZ encroachment indicating a very low level impact or minor new TPZ occupancy by design. As a guide to minimising development impacts within the tree protection zone the following guidelines are provided to appropriately manage minor incursions within the TPZ.

Tree No:	Species	Height x Span	DBH mm	SRZ TPZ	Age	Tree vitality	Significance	VTA	RV	ULE	Comments
1	Angophora costata Angophora	16 x 13	550	2.7m 6.6	SM	Poor / declining	3- High	4	3	3	Environmentally stressed, in considerable decline with large diameter deadwood, decline in central canopy and lower branch scaffolds N & W sides, located at edge of embankment

- To avoid additional root disturbances within the 6.6m TPZ no continuous strip footings or trench excavation shall occur to accommodate the proposed pool addition as shown within Item 2 of Appendix - C. The minor addition or proposed finished level at RL43.01 shall be suspended design utilizing tree sensitive construction techniques to avoid damage to underlying tree roots.
