## **GEOTECHNICAL INVESTIGATION:**

### **New Pool at 13 Redman Street, Seaforth**

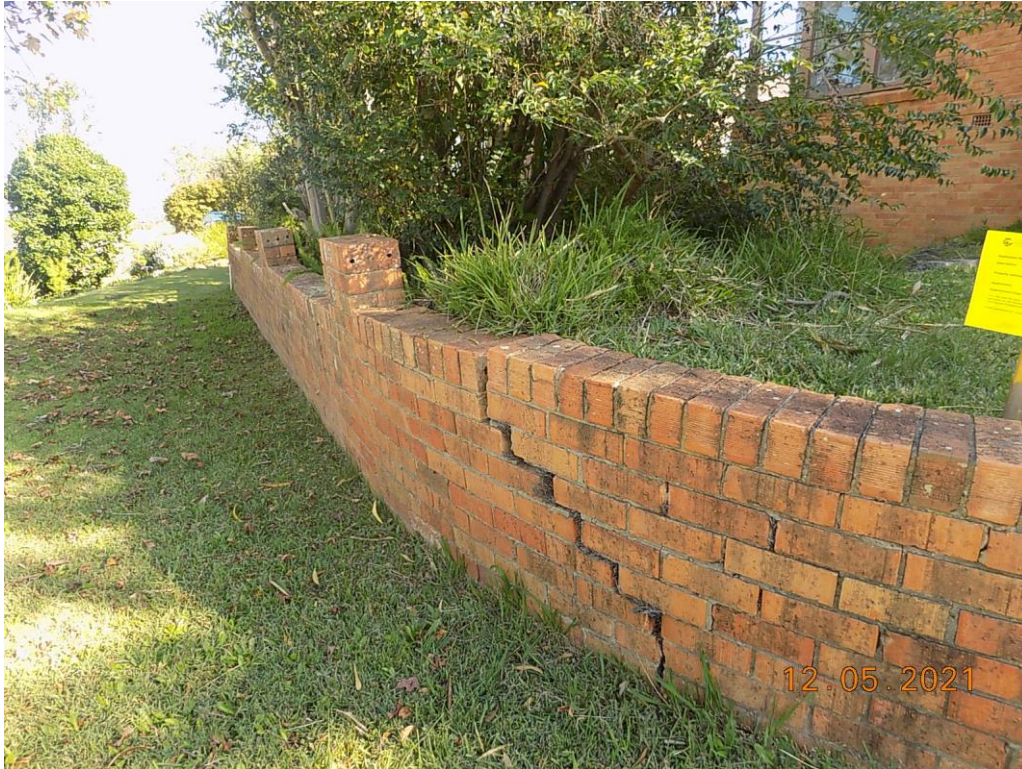
Photo 1

- 2.3** Between the road frontage to Redman Street and the house is a gently sloping lawn-covered fill. The fill is supported by a brick retaining wall that is tilting downslope to a maximum of 8° from vertical, and displays stepped cracking through the mortar (Photo 1). The wall will be demolished as part of the proposed works for the separate approved DA. The single-storey brick house is also to be demolished as part of the separate approved DA (Photo 2). A concrete driveway extends from Peacock Street to a parking area on the uphill side of the house (Photo 3). A moderately sloping lawn

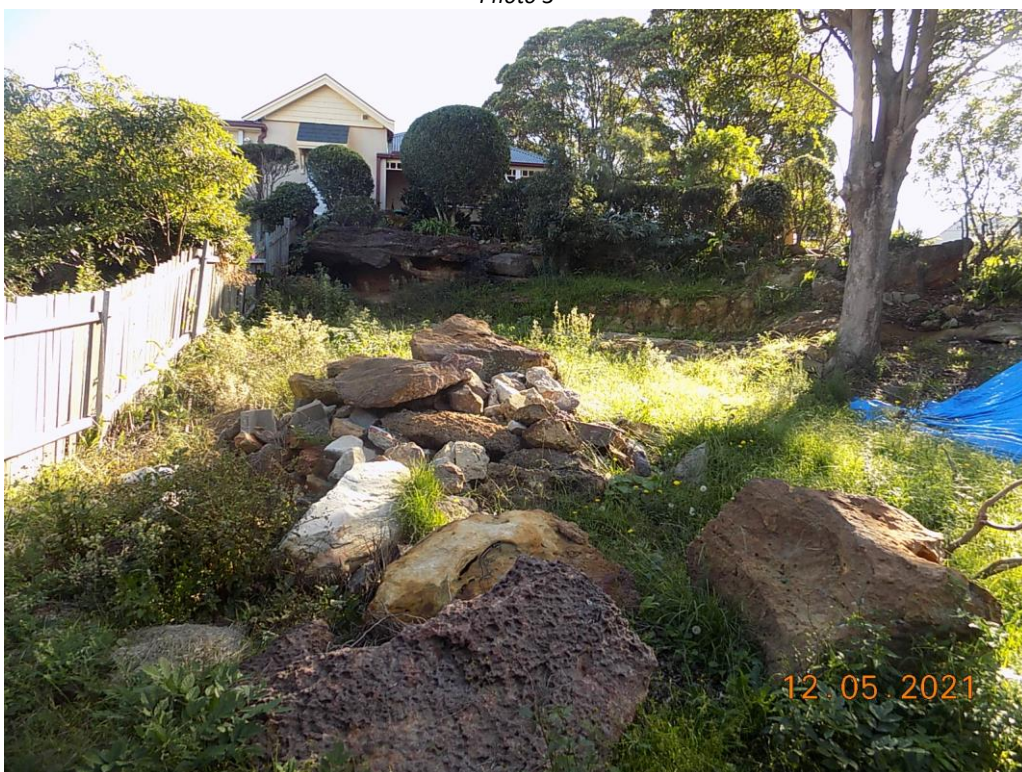
Photo 4

area rises to the upper common boundary. Sandstone bedrock can be observed to be outcropping across the uphill side of the property (Photo 4). A portion of the sandstone bedrock above the property is undercut ~0.7m and will be retained as part of the proposed works (**See Section 12 for advice regarding the undercut rock**) (Photos 5 & 6).

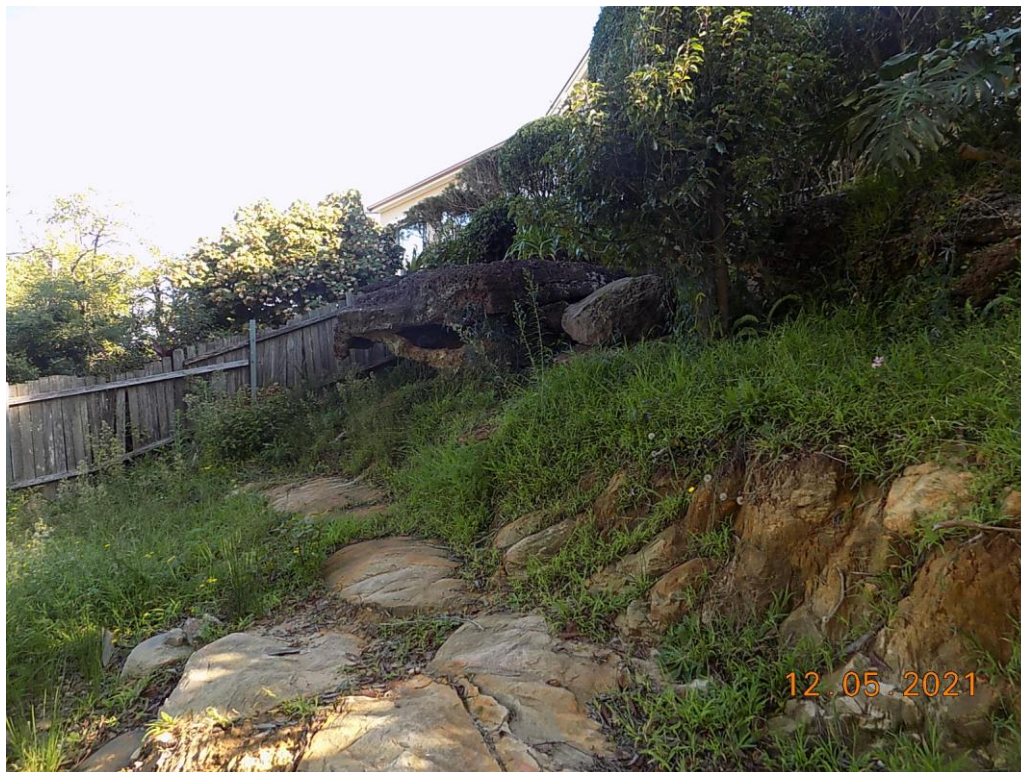
Photo 5

No geotechnical hazards were observed beside the property. The moderately graded slope that rises across the property and continues above and below is a potential hazard (**Hazard One**). The undercut rock face (Photos 5 & 6) failing and toppling onto the work site during the excavation process is a potential hazard (**Hazard Two**). The vibrations from the proposed excavations are a potential hazard (**Hazard Three**). The proposed excavation is a potential hazard until retaining walls are in place (**Hazard Four**).

Excavations through rock should be carried out to minimise the potential to cause vibration damage to the neighbouring houses to the S and W, and the undercut rock outcrop on the uphill side of the property (Photo 5 & 6). The S and W Neighbouring common boundaries will be as close as ~3.2m and the neighbouring houses will come as close as 10.0m to the proposed excavation. The undercut sandstone outcrop will be close to flush with the excavation (Photos 5 & 6). To preserve the integrity of the exposed sandstone outcrop, no pneumatic hammering

is to be used until saw cuts have been installed around the perimeter of the outcropping rock to reduce vibration (Photos 5 & 6).
