# Geotechnical Assessment

**Project:** Alterations & Additions  
1158 Barrenjoey Road, Palm Beach NSW

**Ref:** AG 24143  
27 June 2024

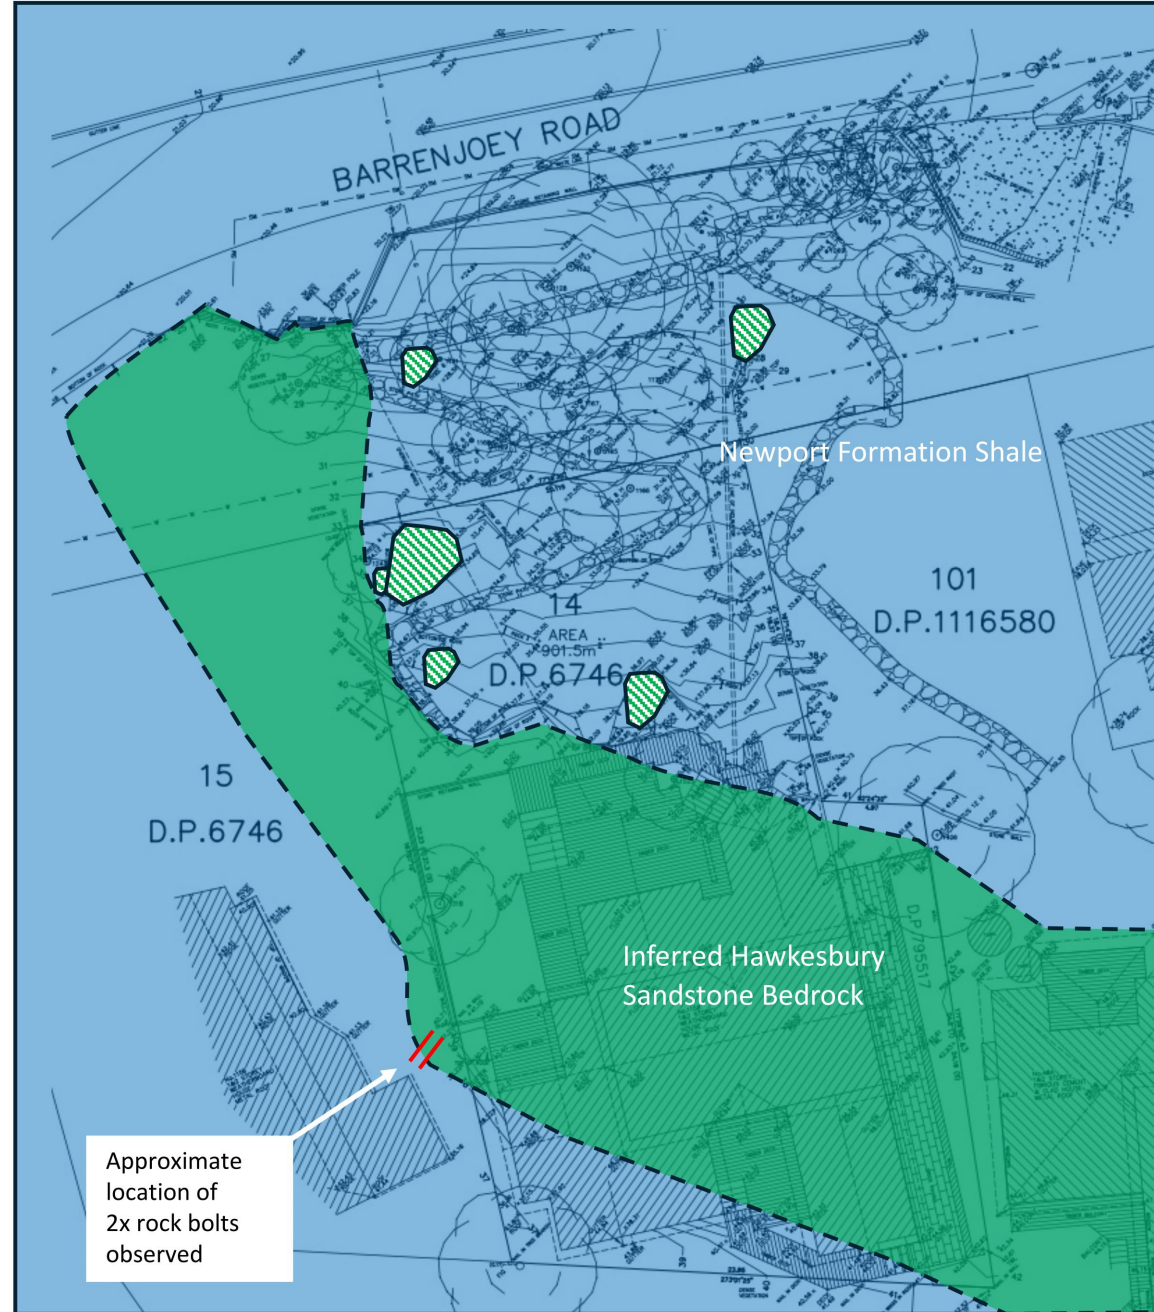
**GEOLOGICAL INTERPRETATION**  
SCALE NTS

- Newport Formation Shale
- Inferred Hawkesbury Sandstone Bedrock
- Sandstone Boulder / Detached Block Joint

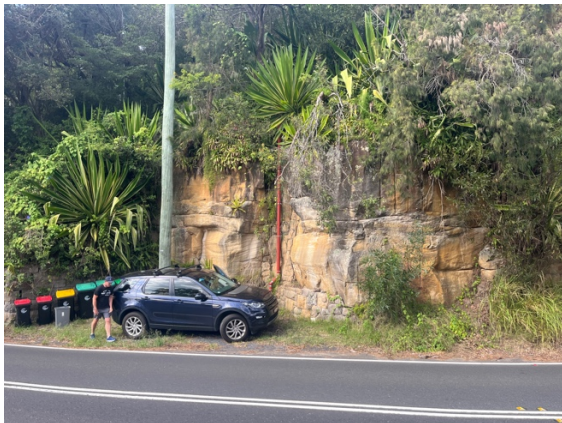
**Photo 3:** Existing parking area at site frontage with outcropping sandstone bedrock

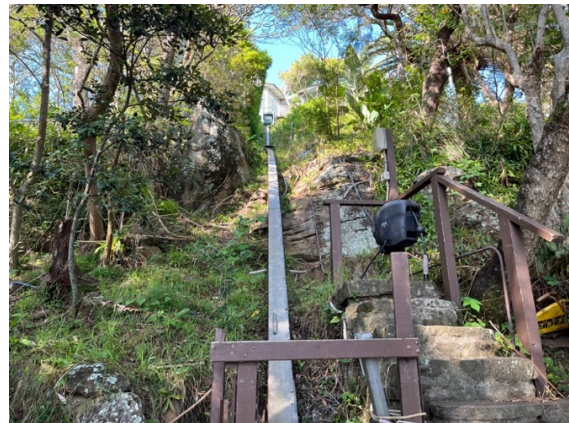
**Photo 4:** Inclinator access from site frontage to house, with outcropping sandstone bedrock and boulders along the path of travel

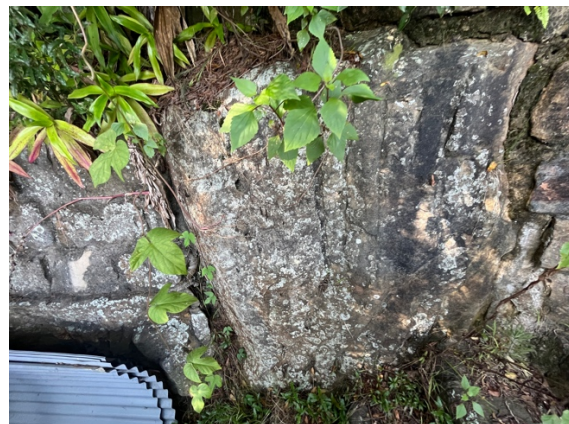
**Photo 6:** Outcropping bedrock with detached block joints in the general area of the proposed driveway works

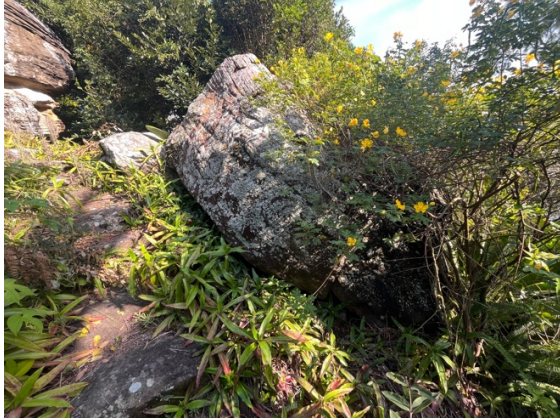
**Photo 7:** Large sandstone boulder sits on the soil profile to the north west of the house

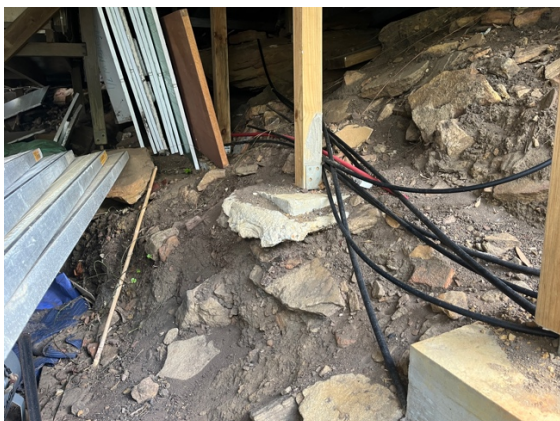
**Photo 11:** Example of footings on fill under the rear of the house

<p><b>Footings</b></p>	<p>All pad, strip or piered footings should be founded on and socketed into the in situ underlying weathered bedrock. For fully cleaned footings in at least low strength bedrock, the allowable bearing pressure is <b>400kPa</b>. Higher allowable bearing capacities may be achievable subject to inspection and certification of excavated footings by AscentGeo.</p> <p>Pier footings should be of sufficient diameter to enable effective base cleaning to be carried out during construction.</p> <p>To mitigate the risk of differential settlement, it is essential that all footings are founded on competent bedrock of similar consistency. This may require excavation through sandstone floaters or the relocation of planned footings.</p> <p>If depth to bedrock and anticipated strength of rock is required for the structural design, further geotechnical investigation in the form of mechanical drilling and laboratory testing of recovered samples will be required, following vegetation clearing and initial excavation to provide suitable site access.</p> <p><b>It is essential that the foundation materials of all footing excavations be inspected and approved by AscentGeo before steel reinforcement and concrete is placed. This inspection should be scheduled while excavation plant and operators are still on site, and before steel reinforcement has been fixed or the concrete booked.</b></p>

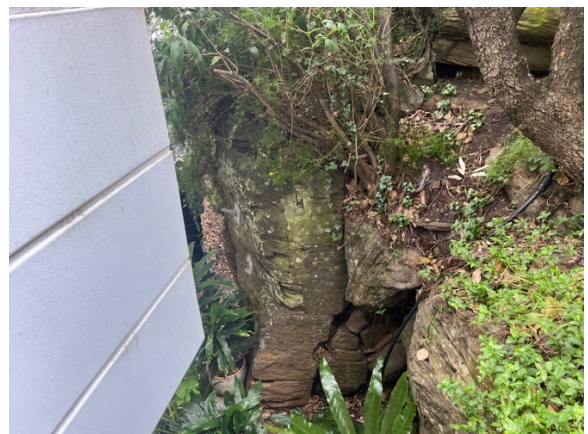
**Photo 12:** Observed stabilisation works (rock bolts) on the adjoining property. Location is towards the south western corner of the subject site
