REPORT ON GEOTECHNICAL ASSESSMENT

PROPOSED NEW ALTERATIONS AND ADDITIONS

41 ROBERTSON ROAD, SCOTLAND ISLAND, NSW

Project No.: 2012-074.1

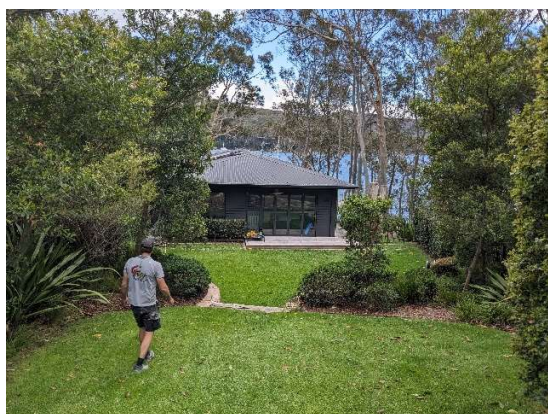
The southern portion of the site comprises gently north sloping lawn, with water tanks near the front, southern boundary. The area contains some mature trees, with sandstone block retaining walls up to 1.0m in height and in good condition, with ground level garden beds along the western site boundary.

Photograph: 1 – Southern side of site showing lawn area, looking north

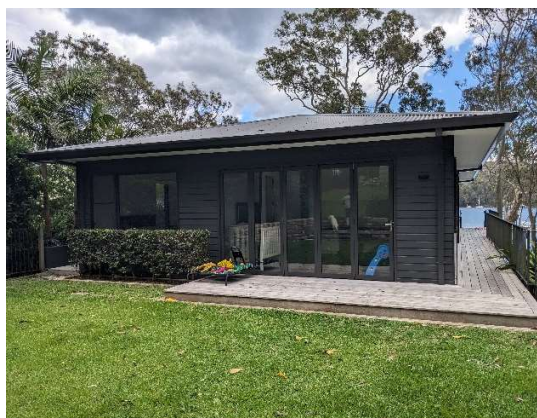
Photograph: 2 – Southern side of existing weatherboard dwelling

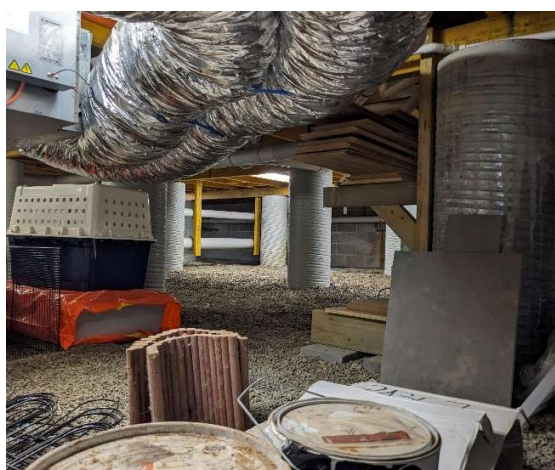
The site dwelling comprises one and two-storey sandstone and weatherboard structure, with timber decking to the north. An inspection of the subfloor indicated the structure is founded on concrete piers founded at unknown depth, however based on previous work on the site is understood to be on competent bedrock. The structure appears to be in good condition with no visible cracking or signs of excessive settlement visible.

Photograph: 3 – Concrete piers below existing dwelling as viewed from subfloor access

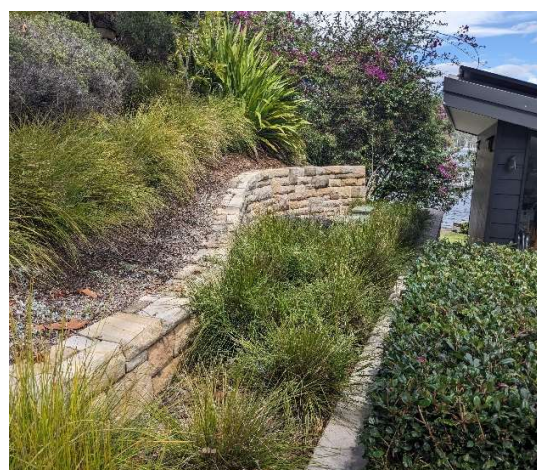
Below the house to the site slopes very steeply down to the waterfront, with an elevated timber staircase leading down. The slope is vegetated with sandstone block retaining walls up to 1.0m in height each and in good condition, while sandstone boulders are visible to the east. A 2.30m high rendered retaining wall which appeared in good condition supports the lower portion of the slope.

Photograph: 4 – Slope below existing house with vegetation and sandstone block retaining walls

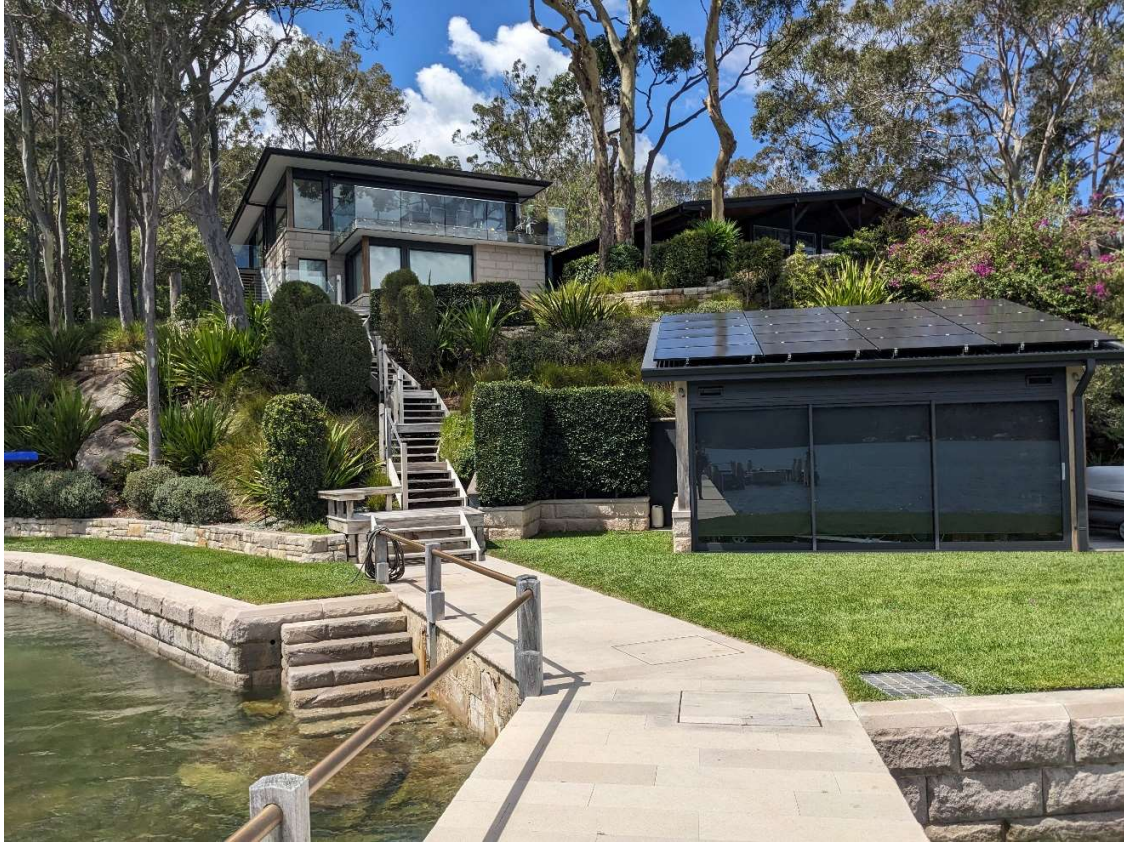
At the waterfront the site contains a weatherboard boathouse studio structure built against the rendered retaining wall. The structure appears to be in good condition, with a stone sea wall supporting this area. Sandstone bedrock outcrops were exposed below the base of both sea walls as a low rock platform.

Photograph 5 – Site as viewed from pier, showing boathouse and main dwelling structure, looking south
